Julian Sewer Service Area Sewer Master Plan

January 2013

County of San Diego
Wastewater and Water Engineering
5555 Overland Avenue
San Diego, CA 92123

ATKINS

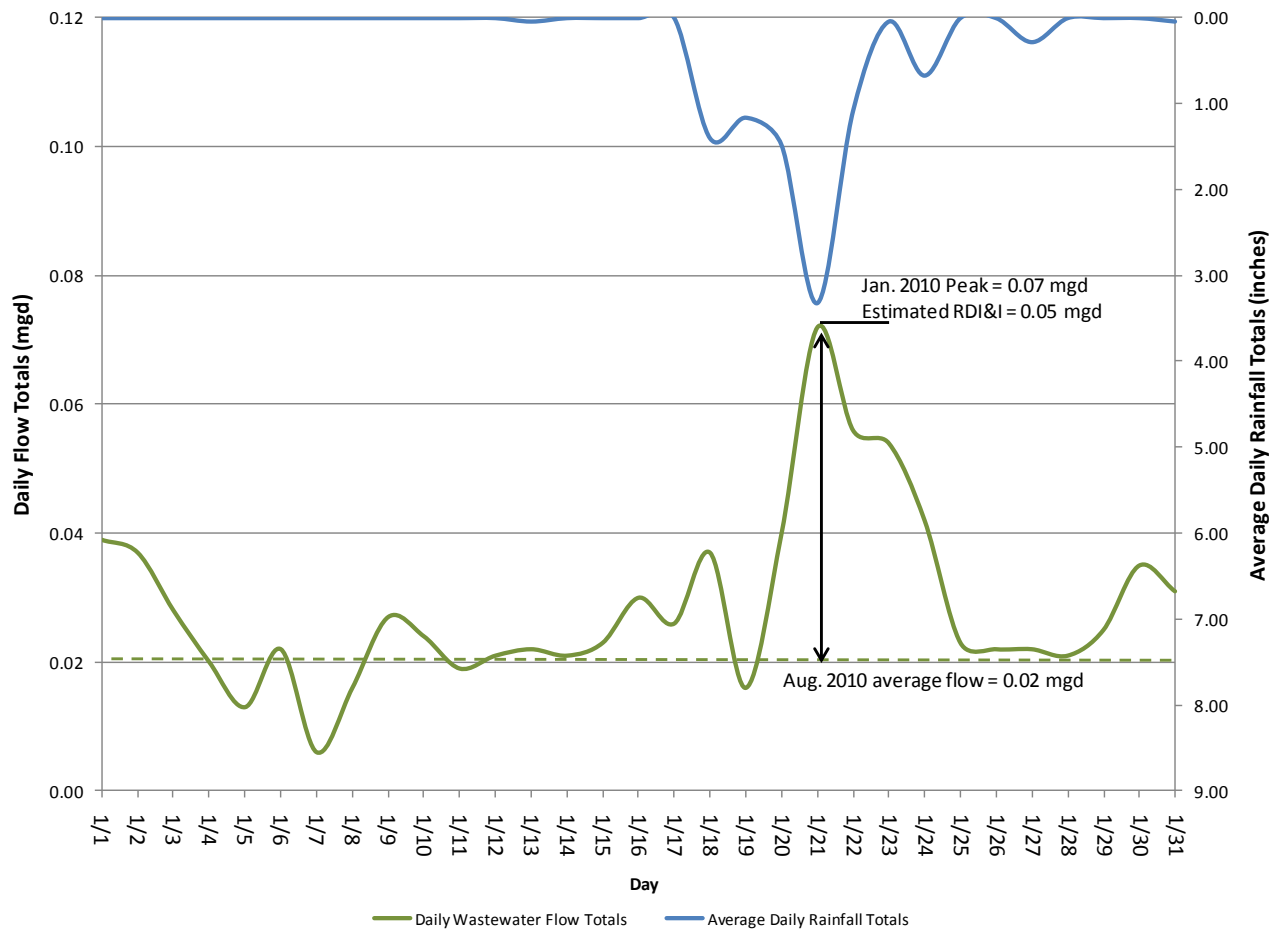
Figure 4-2 Julian SSA Wet Weather Flow Assessment

As shown on Figure 4-2, the January storm event produced a peak increase of approximately 0.05 mgd, almost tripling the average flow at the JWPCF from a storm event that averaged over three inches of rain during its 5 day period. The high level of inflow and infiltration observed at the JWPCF suggests there may be inflow and potentially illicit connections into the Julian SSA

collection system. The County may wish to investigate these connections using smoke testing to determine the potential locations.

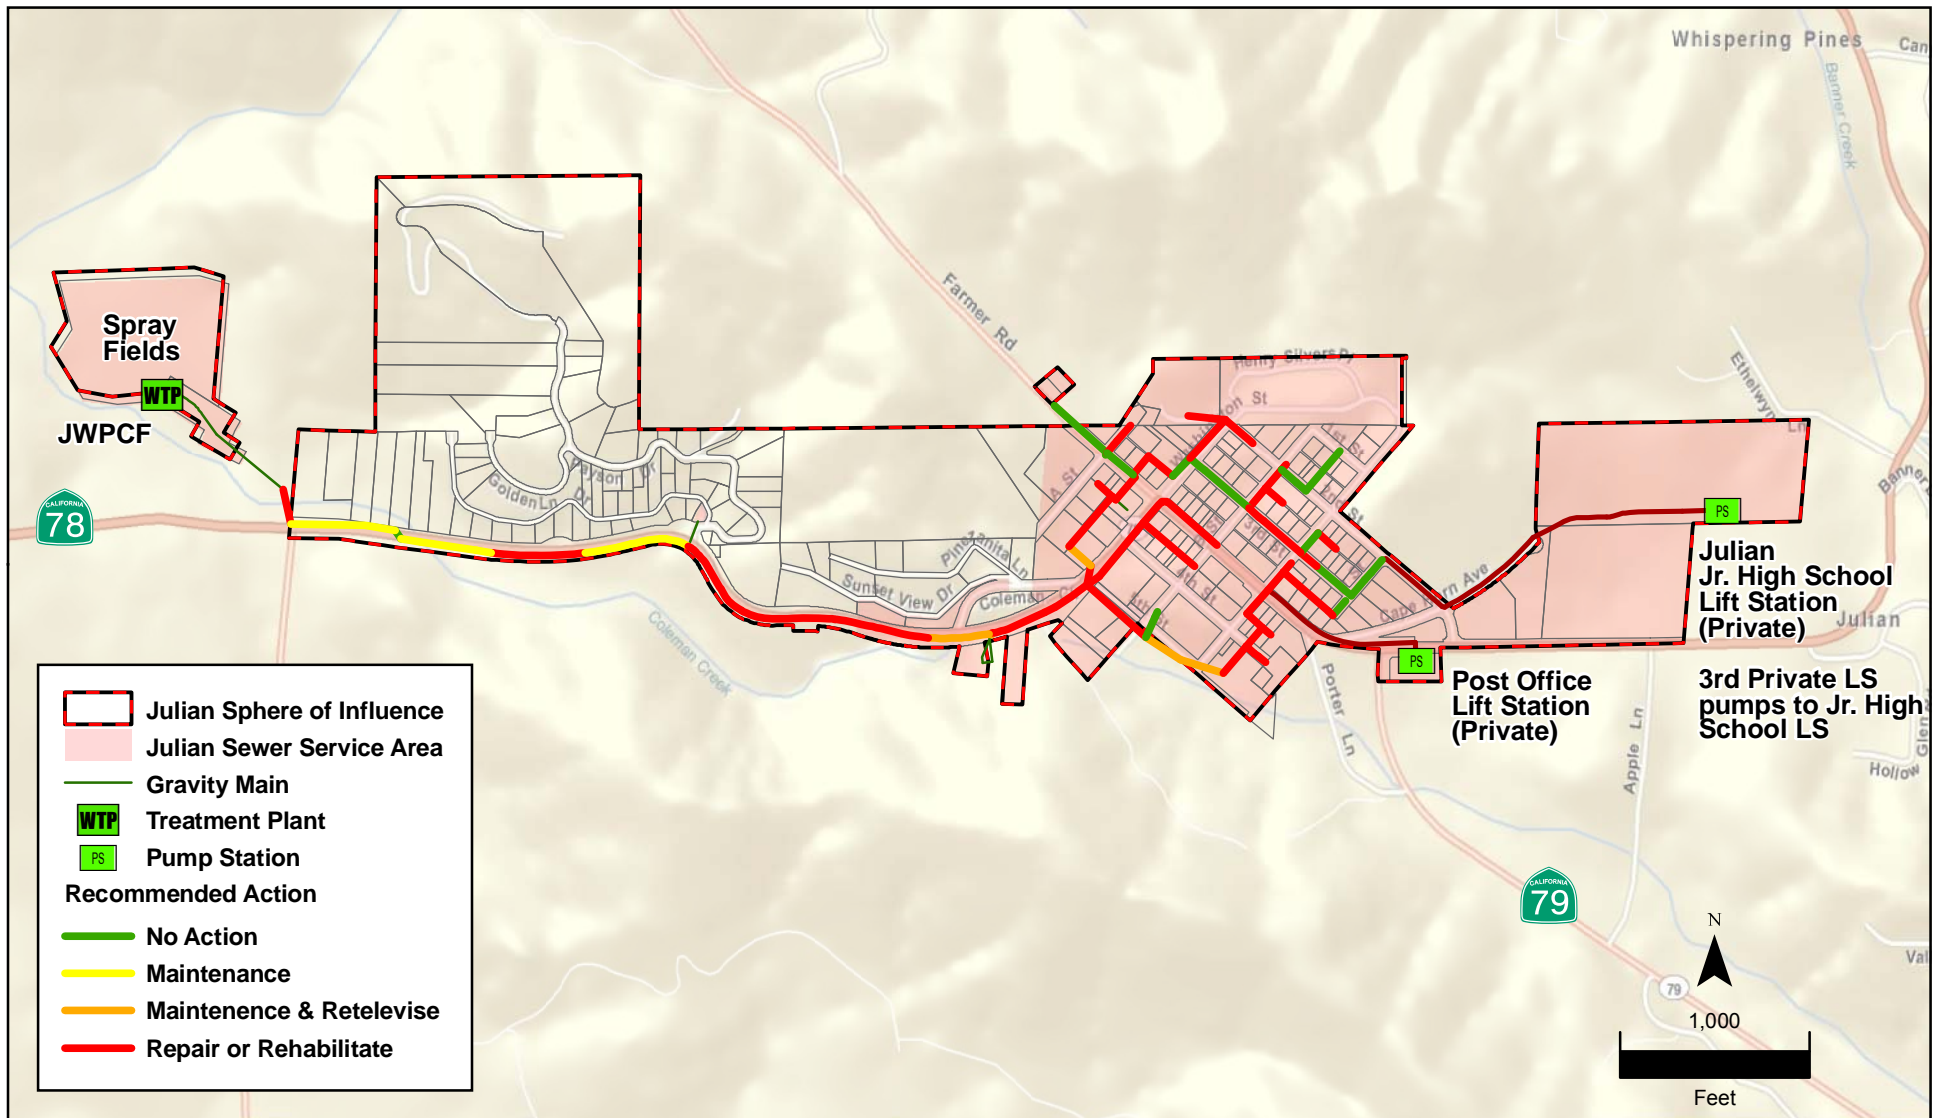
Figure 5-5 illustrates the locations of the recommended actions in the Julian SSA. The recommendations include No Action, Maintenance, Maintenance and Re-Televise, and Repair/Rehabilitate. Assessment findings and detailed pipeline recommendations are included in Appendix K.

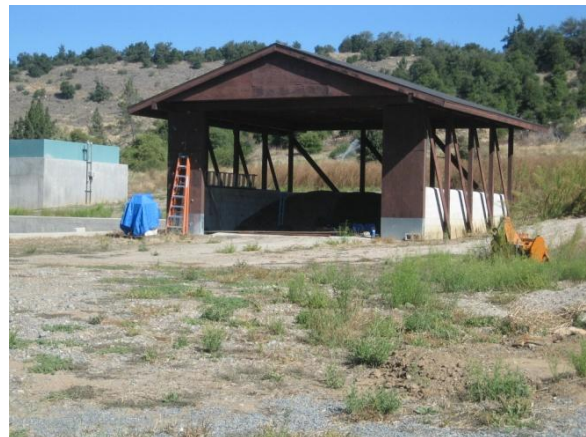
The dried sludge storage building needs to be enclosed so that blowing rain and snow do not re-moisten the already dried sludge. The current building has three walls with 5-foot high masonry walls and openings from the walls to the roof. The majority of the wall openings should be covered with a portion of the openings fitted with shutters to allow cross ventilation when the weather is sunny, and the floor should be sloped toward the fourth wall opening. The opening in the fourth wall could be brought in to minimize the exposure to the elements; however, it must remain large enough to accommodate the skip loader that is used to load and transport the sludge. Skylights should be installed in the roof to provide lighting.

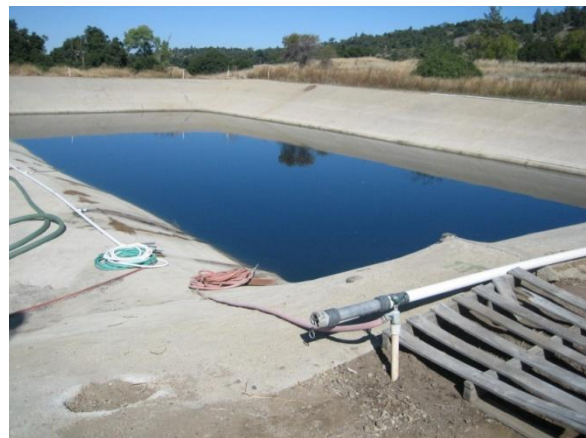
The concrete-lined effluent storage basins located at the west-side of the wastewater treatment plant needs to be relined. Cracks in the concrete allow high groundwater in the winter months to seep into the basins which effectively reduces the amount of effluent storage. There are two effluent storage basins, each with a capacity of approximately 300,000 gallons.
