**PHASE I  
ENVIRONMENTAL SITE ASSESSMENT**

**FINES-EDEN HILLS PROPERTY  
1805 COUNTRY CLUB DRIVE  
ESCONDIDO, CALIFORNIA**

**GEOCON PROJECT NO. 09524-06-03**

**DECEMBER 7, 2012  
SDC PDS RCVD 02-28-13  
SP13-001, GPA13-001,  
REZ13-001, ER13-08-002**

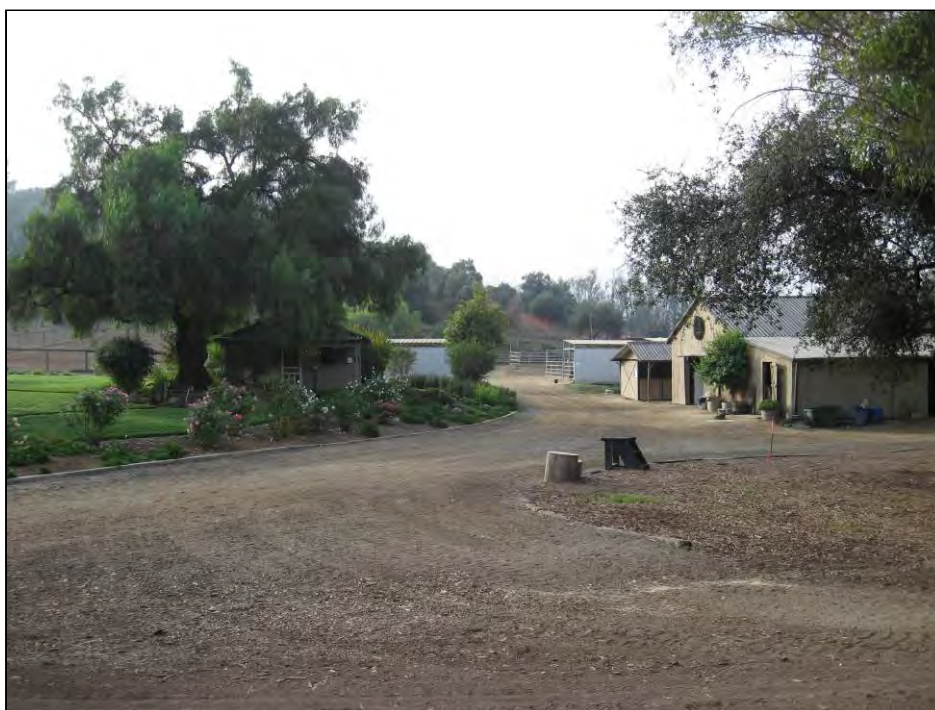
barn, an stable with 15 stalls, a tack building, two residential 5<sup>th</sup>-wheel trailers, an office, and a residential structure (Photograph Nos. 6 through 8). A sewer access manhole is located adjacent to the northeastern corner of the storage barn on the southeastern portion of the Site (Photograph No. 9). We observed a 2-foot by 2-foot storm drain inlet adjacent to the horse pens (Photograph No. 10). Construction debris was observed near the 5<sup>th</sup> wheel trailers (Photograph No. 8).

**Photograph #6**  
**Horse training support structures on the eastern portion of the Site.**

The assessment has revealed no evidence of RECs on the Site. We recommend conducting an asbestos and lead survey at the Site prior to building demolition to determine if the existing building materials require special abatement or removal activities.

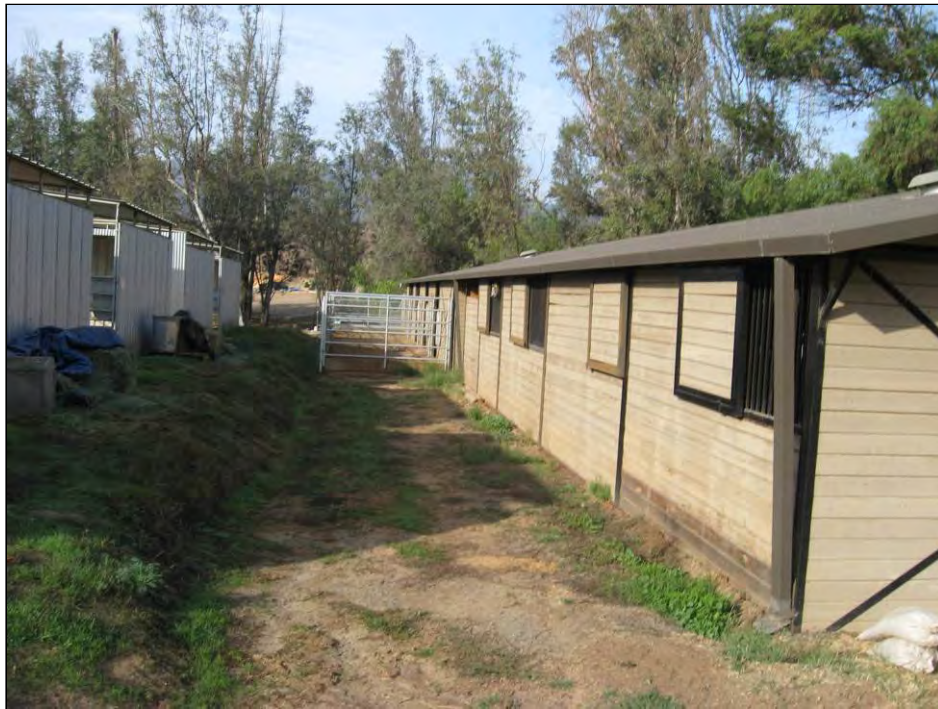
**Photograph #7**  
**Horse stable (right) and pens (left) on the eastern portion of the Site.**

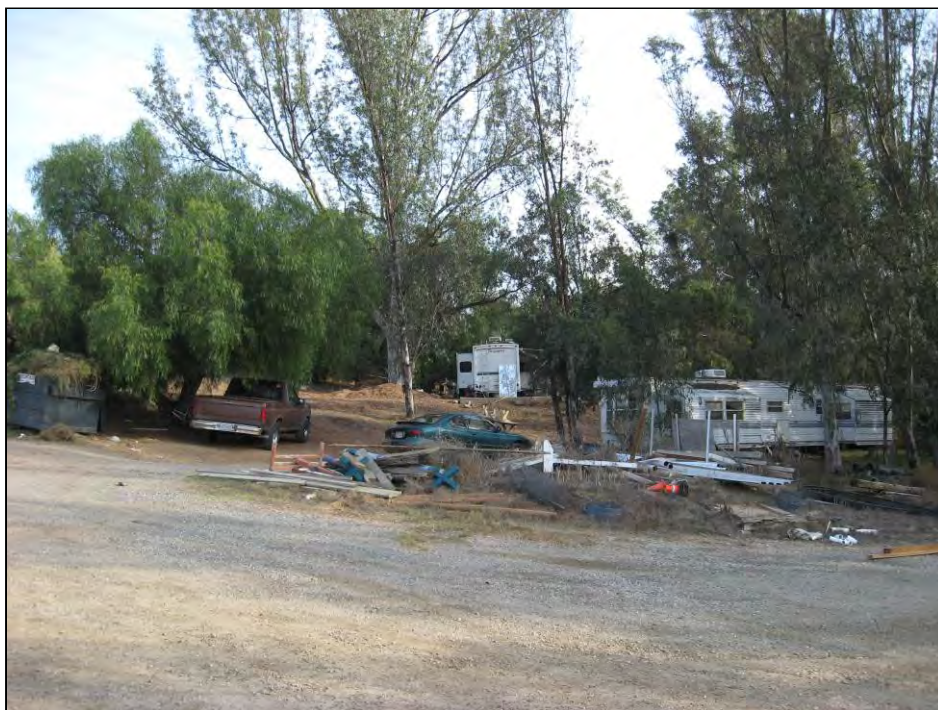
**Photograph #8**  
**Residential 5<sup>th</sup> wheel trailers and construction debris on south-central portion of the Site.**

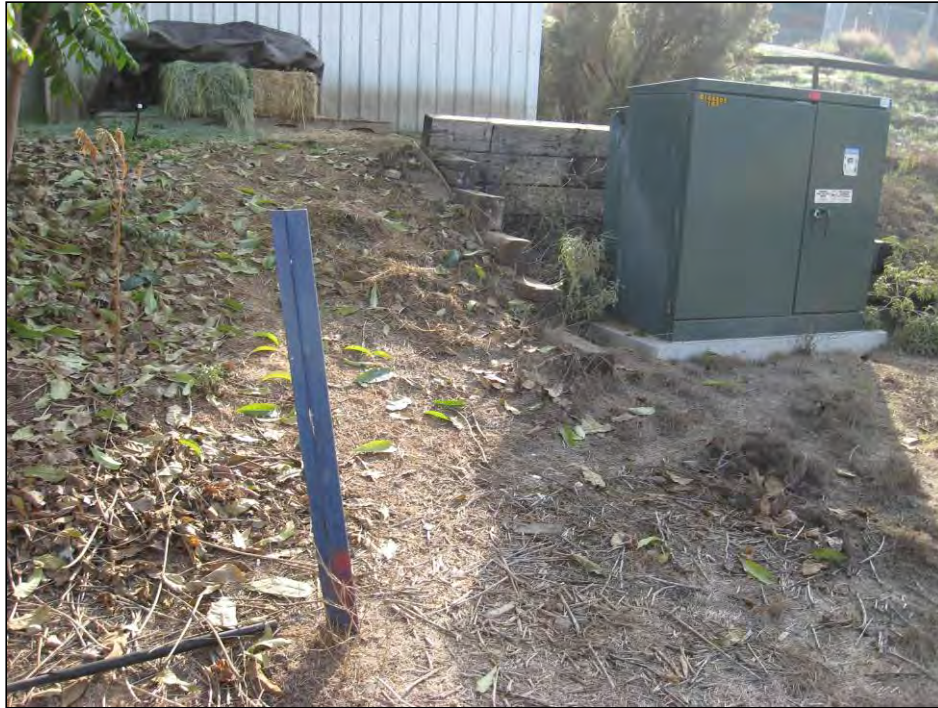
A pad-mounted electrical transformer is adjacent to the public restroom facility near the southeastern Site boundary (Photograph No. 11). No staining that would indicate evidence of a release was observed adjacent to the transformer. A municipal water pipeline marker was observed adjacent to the pad mounted transformer.

**Photograph #11**  
**Pad-mounted electrical transformer and municipal water pipeline marker on the southern portion of the Site.**

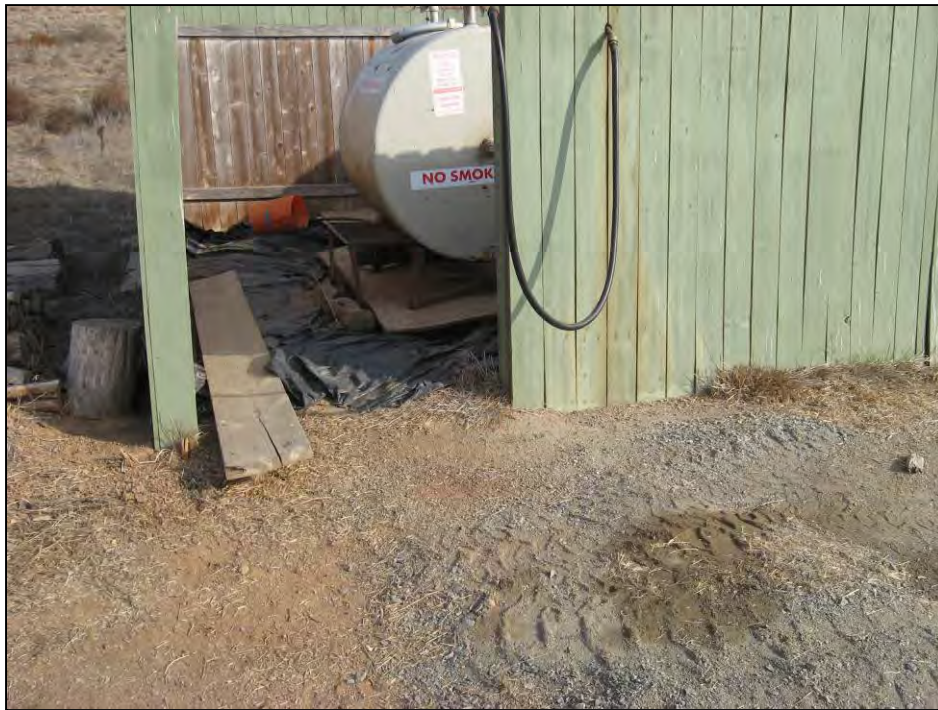
We observed a 200-gallon steel AST containing dyed diesel fuel in the south-central portion of the Site. The diesel AST is enclosed by a wood fence and underlain by torn plastic sheeting (Photograph No. 14). We observed *de minimis* soil staining adjacent to the south of the diesel AST. A 55-gallon hydraulic oil drum is located behind the diesel AST within the fenced area (Photograph No. 15). No staining that would indicate a release was observed adjacent to the oil drum.

**Photograph #14**  
**200-gallon diesel AST in the south-central portion of the Site.**

We observed *di minimis* staining adjacent to the 200-gallon diesel AST. If abundant areas of soil staining or odors are observed during additional grading observations, we recommend retaining an environmental professional to observe and possibly sample areas of potential impact to determine if further action is warranted.

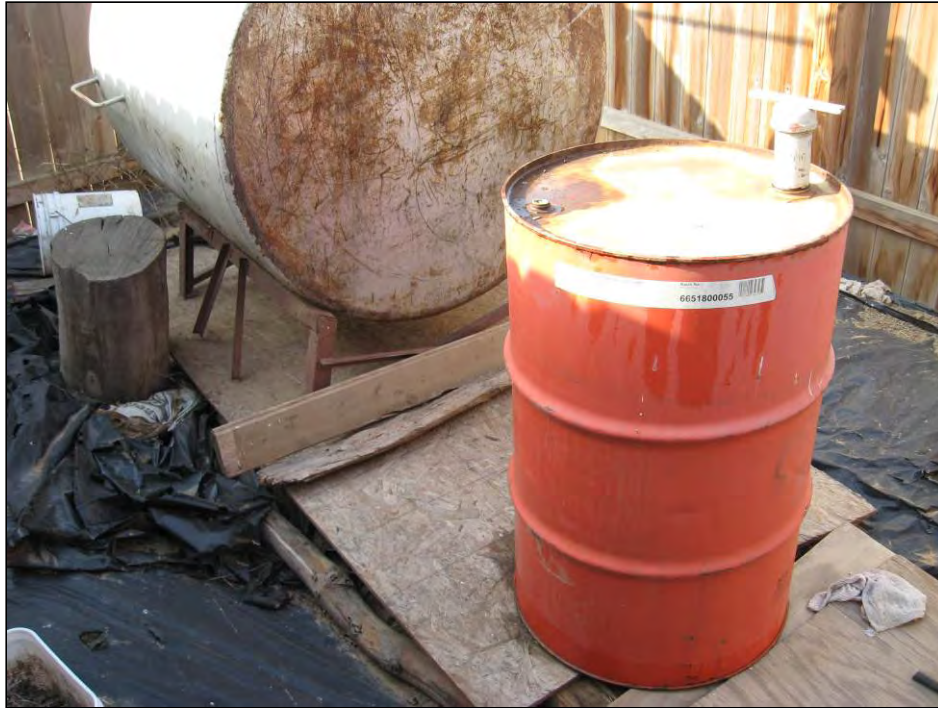
**Photograph #15**  
55-gallon hydraulic oil drum located adjacent to the diesel tank.

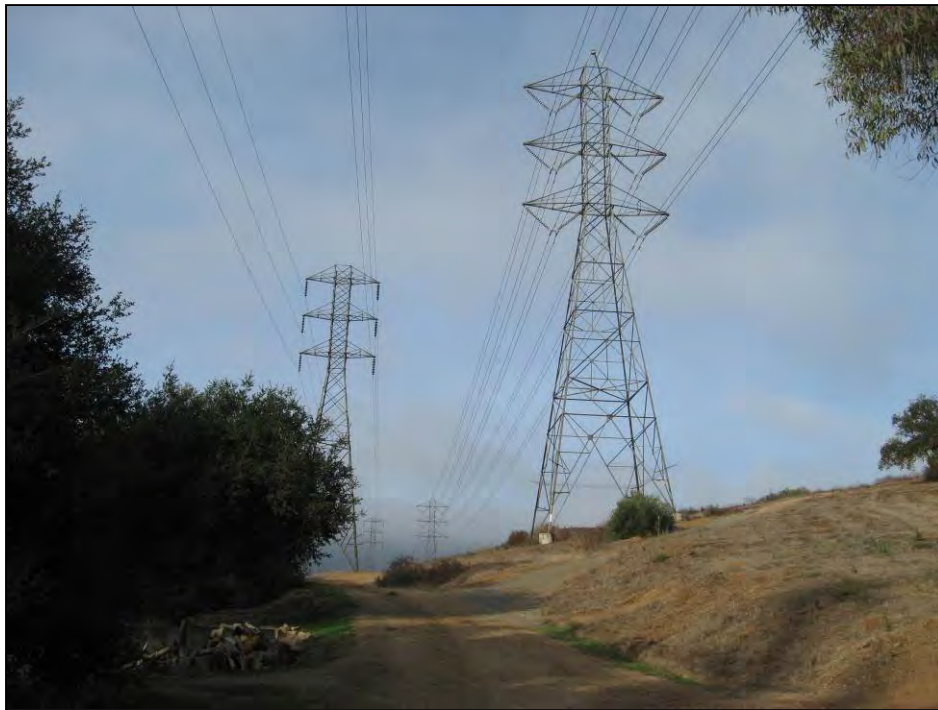
Two high tension power line towers are located on the south-central portion of the Site and support power lines that cross over the Site from east to west (Photograph No. 16). We also observed a pole-mounted transformer and power lines on the northwestern portion of the Site (Photograph No. 17).

**Photograph #16**  
High tension power lines extending across the south-central portion of the Site.

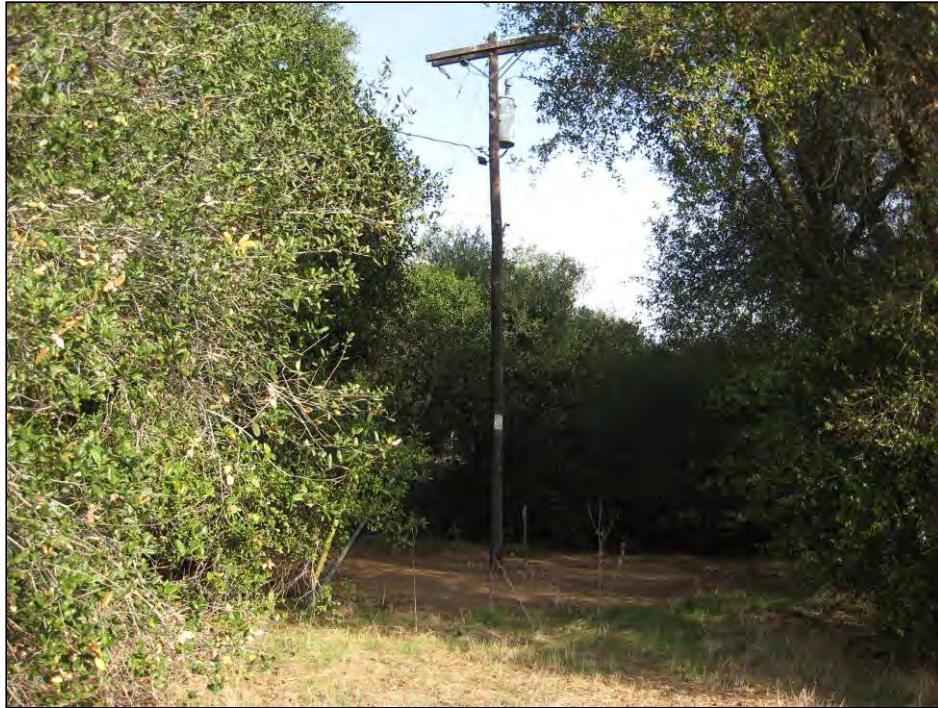
**Photograph #17**  
**Pole mounted transformer in the northwestern portion of the Site.**
