Valley Center Road Corridor Concept Plan

# Appendix G: Themes Technical Memorandum

TO: Kevin Johnston, County of San Diego  
FROM: Dawn Wilson, PE TE  
DATE: June 10, 2020

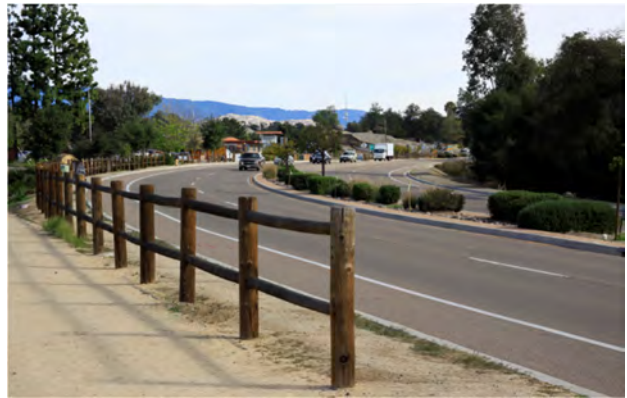
*Figure 1: Valley Center Road near Canyon Road at "The Curve" with Raised Medians.*

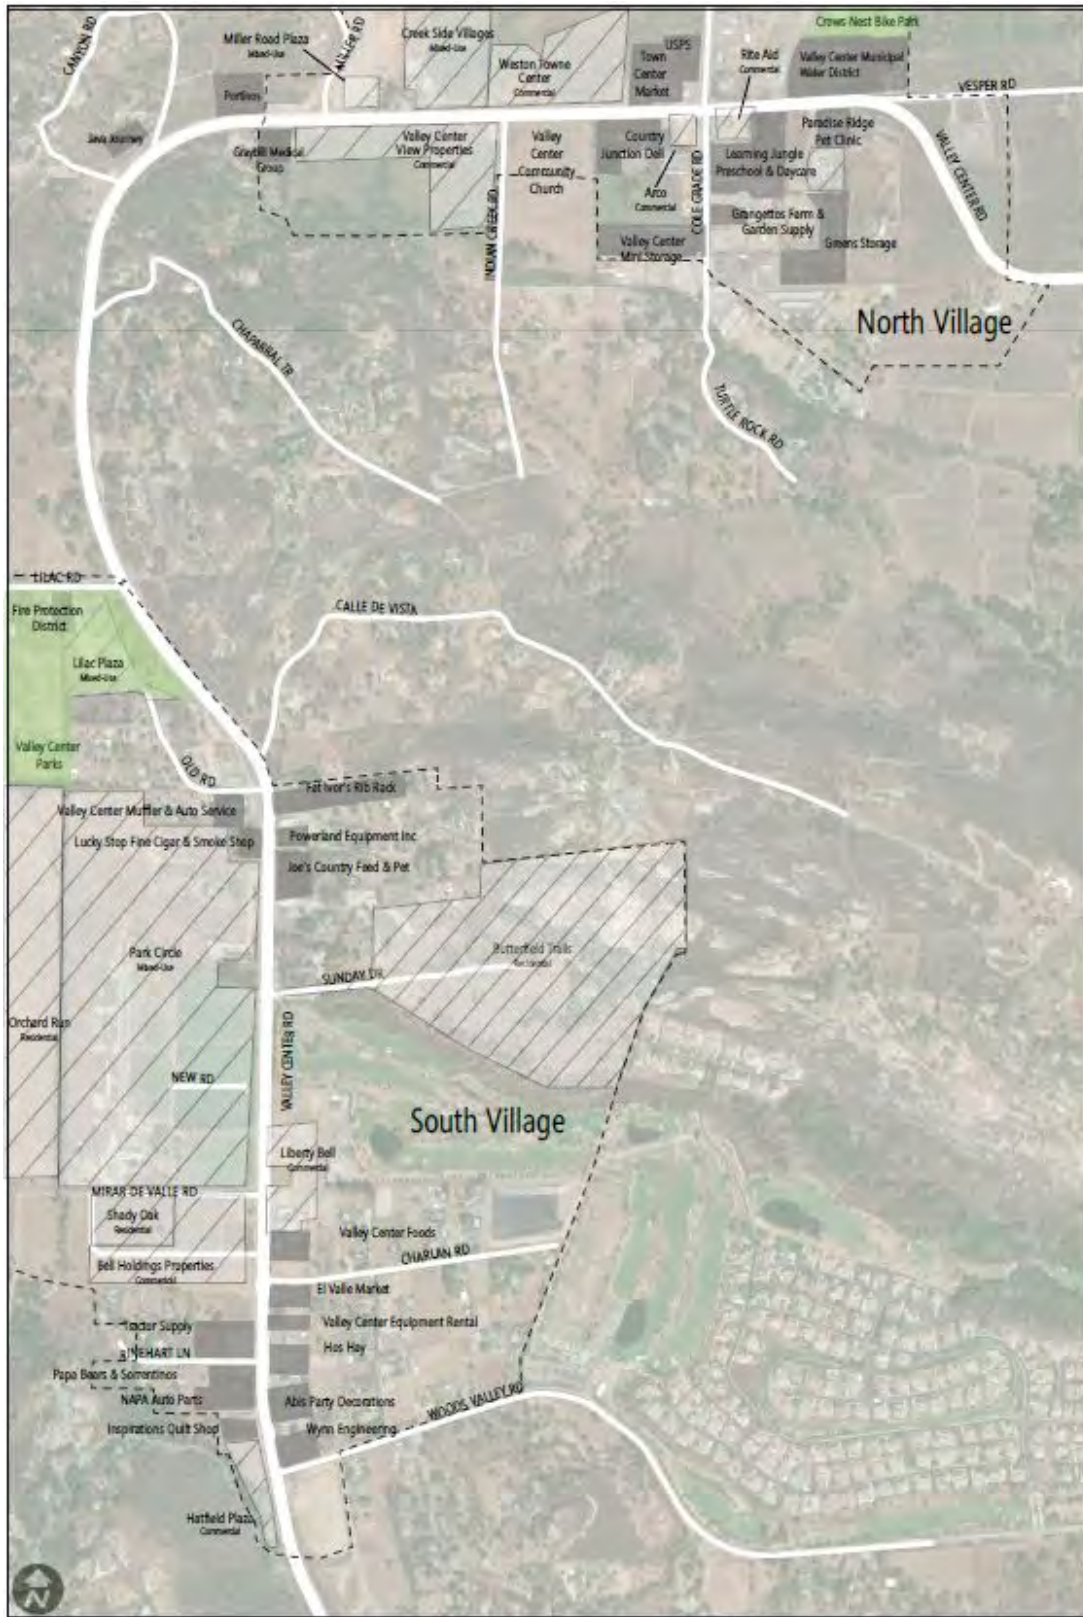
Figure 2: Study Area With North & South Village Boundaries

The study area shown in Figure 2 covers the segment of Valley Center Road through the two Villages of Valley Center. The South Village is centered around the Valley Center Road and Mirar De Valle intersection and extends from Banbury Drive in the south to Lilac Road in the north. The North Village is centered around the Valley Center Road and Indian Creek Road intersection and extends just west of Miller Road on the west and to the area of the Valley Center Road and Vesper Road intersection on the east. The Villages are areas where higher intensity development and wider range of land uses are planned.

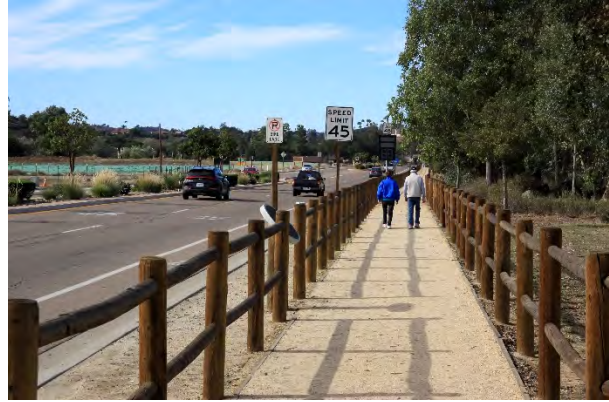
*Figure 3: Heritage Trail with split rail fencing (looking westbound on Valley Center Rd.). The Heritage Trail will remain unchanged with all concepts.*

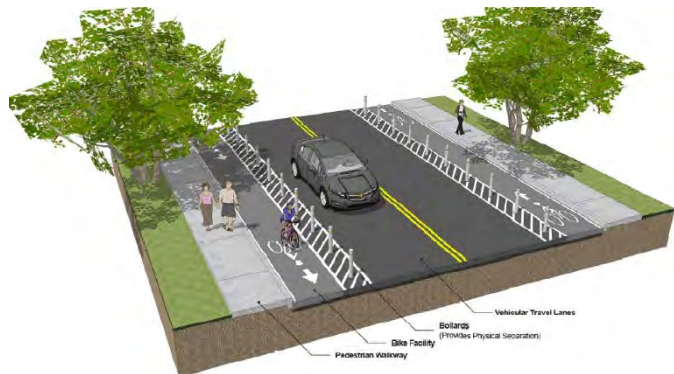
*Figure 4: Illustration from County of San Diego ATP, Class IV Bikeway with Bollards Concept (referred to as flexible delineator posts in the concept development)*

The ATP includes recommendations to upgrade the existing Class II bike lanes to Class IV Separated Bikeways the length of the corridor. This recommendation was incorporated into the Mobility Element for this Valley Center Road corridor as part of the adoption of the ATP.

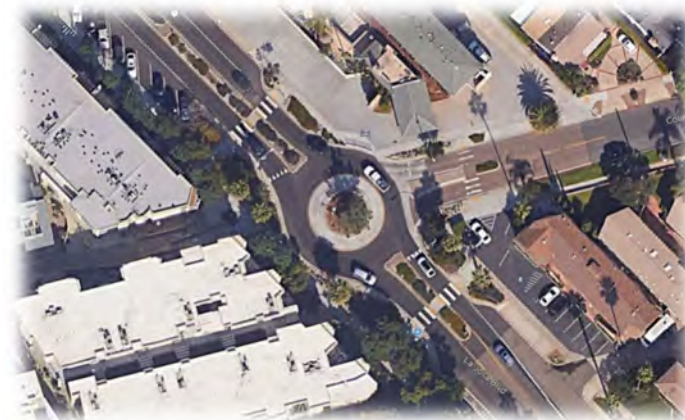
Figure 6: Single Lane Roundabout at La Jolla Boulevard & Colima Street

Roundabouts are one of the safest types of intersections since they are designed for lower speed driving, generally 25 to 35 MPH and all traffic is moving in the same direction. In addition, left turn movements across oncoming traffic is eliminated. Most significantly, roundabouts reduce the severity of crashes such as T-bone and head-on collisions. Figure 6 shows an example of an existing three-legged single-lane roundabout at La Jolla Boulevard and Colima Street.

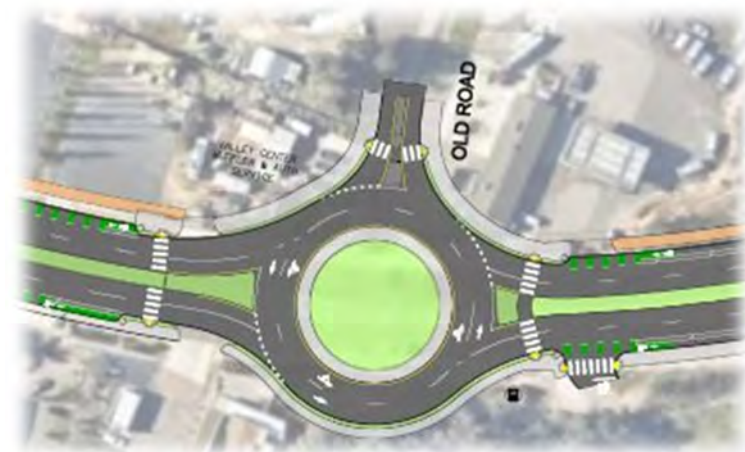
Figure 7: Theme 1 - Two-Lane Roundabout at Valley Center Road & Old Road

Two-lane roundabouts are larger than single lane roundabouts and therefore require more right of way and are more expensive to construct. Similar to a single-lane roundabout, two-lane roundabouts generally have lower maintenance and operational costs compared to a signalized intersection.

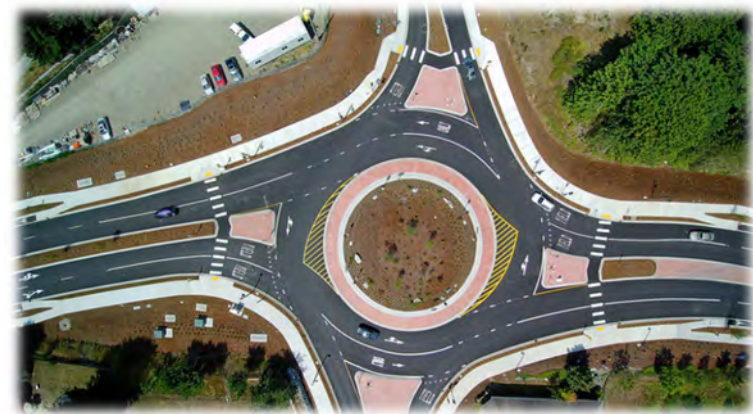
Figure 8: Two-Lane Roundabout at Tremont Street & Pottery Avenue in Washington

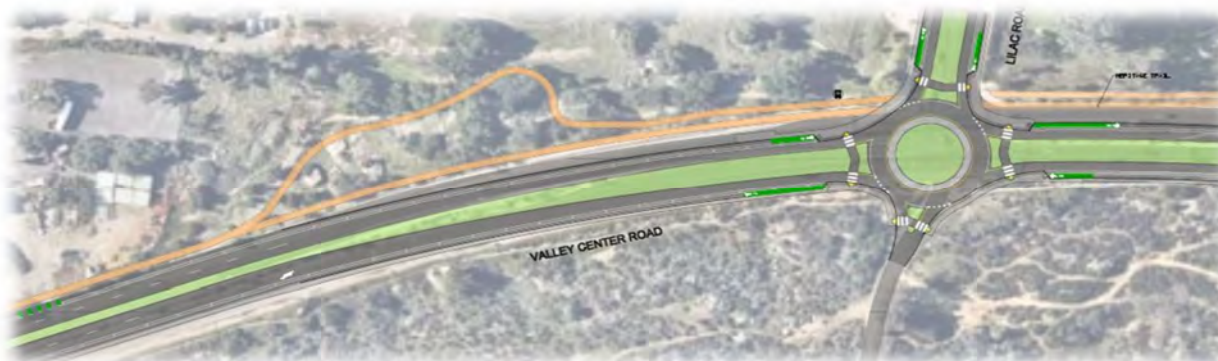
Figure 10: Theme 2 - Single-Lane Roundabout with taper at Valley Center Road & Lilac Road

The taper would not affect the bicyclists since the bike lane is maintained in a similar manner to a single-lane roundabout without a taper. A shared bicycle-pedestrian path of sufficient width to accommodate both types of users around the perimeter of the roundabout would still be provided.

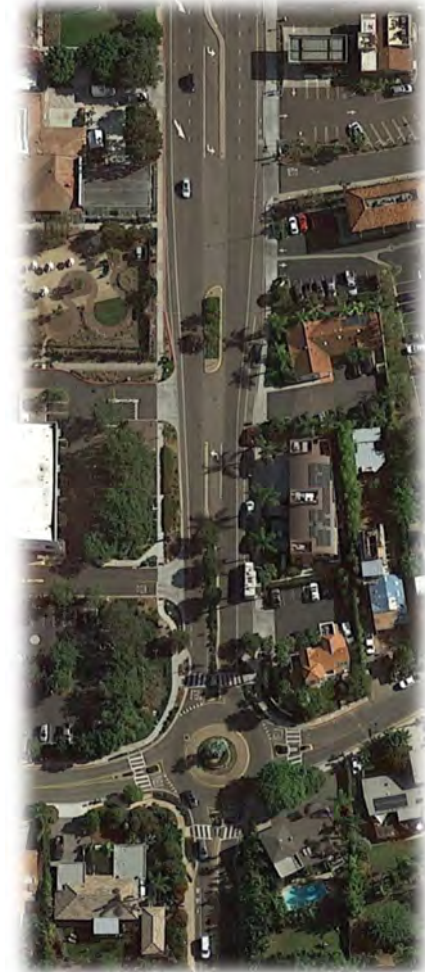
Figure 9: Single-lane Roundabout with taper at Santa Fe Drive & Devonshire Drive in Encinitas

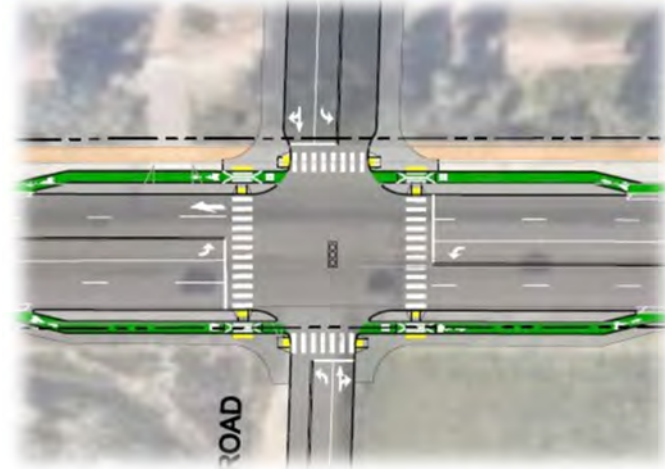
Figure 11: Theme 2 – Curb extensions at Valley Center Road & Indian Creek Road

Road classification, lane width, road width, sidewalks, curb radii, and on-street parking should all be considered when designing curb extensions. Appropriate signage for vehicles, bicyclists, and pedestrians should be provided at all potential conflict points. Placement of street furniture and landscaping on curb extensions should ensure that sight lines are not obstructed and properly maintained.

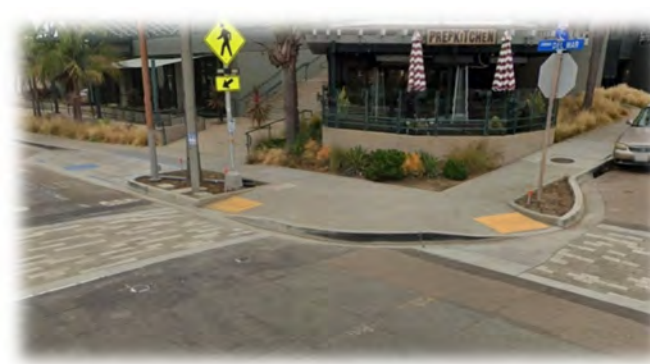
Figure 12: Curb extensions at Camino Del Mar & 12<sup>th</sup> Street in Del Mar

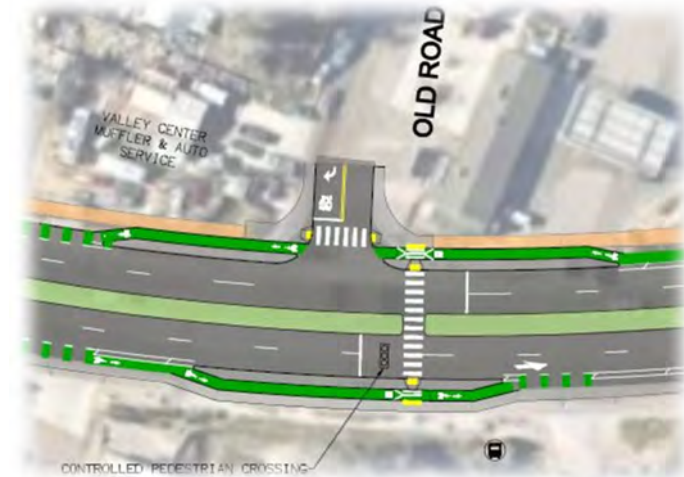
Figure 13: Theme 2 - Controlled Ped Crossing at Valley Center Road & Old Road

These crossings provide a clear indication for the assignment of right of way at the marked crosswalk. Both the driver and the pedestrian or bike are provided a clear indication of when to stop or wait and when to proceed. The signal or HAWK is activated by the pedestrian using a push-button. Pedestrians must wait for the WALK sign to proceed. During that time, autos are provided a RED light and are required to stop.

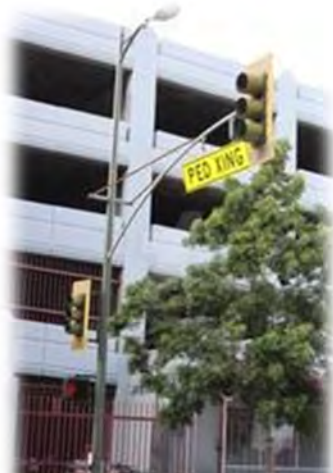
Figure 15: Ped Signal Example

Operates as a traditional signal with the green priority given to vehicles until activated by the pedestrian. Utilizes traditional green, yellow and red vehicular indications and traditional pedestrian signal heads (with or without countdown timer). Figure 15 shows an example of a ped signal.

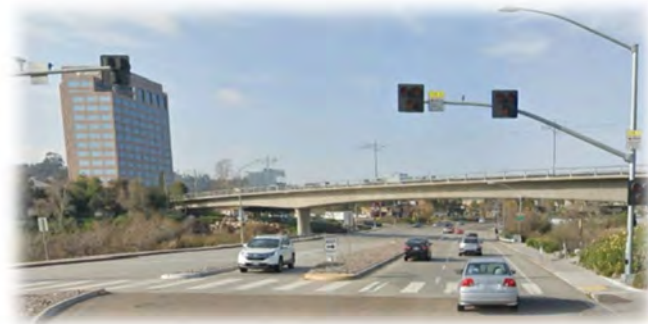
Figure 14: HAWK signal on Mission Center Road in Mission Valley

HAWK signals are traffic devices used to assist pedestrians and bicyclists crossing a busy street. When a pedestrian activates the system by pressing a button, overhead signal flashing indicates to the motorists a pedestrian wishes to cross the street and vehicles are required to stop and wait for the pedestrian to cross. HAWKs are best in mid-block situations, not intersections where minor streets have no visibility to a signal. Figure 14 shows an existing HAWK signal on Mission Center Road in Mission Valley.

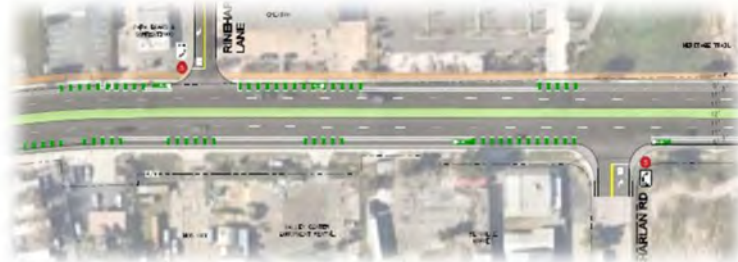
Figure 18: Theme 1 - Raised Landscaped Median on Valley Center Road in South Village

Medians with natural landscaping also serve as natural bio-swales for managing stormwater. Figure 18 shows Theme 1 with a raised landscaped median along Valley Center Road within the South Village.

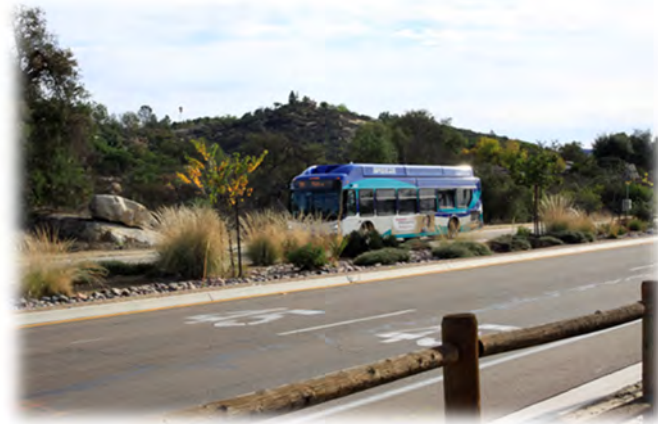
Figure 16: Raised Landscaped Median on Valley Center Road west of Lilac Road

Continuous raised medians may restrict vehicular access at intersections and driveways. They may be used to concentrate left-turn movements at specific locations and tend to result in an increase of the frequency of U-turns at a signalized intersection or at gaps in the median. However, raised medians can improve safety by providing a physical barrier between opposing directions of traffic thus reducing vehicle conflicts. Figures 16 and 17 show existing raised medians with landscaping along Valley Center Road.

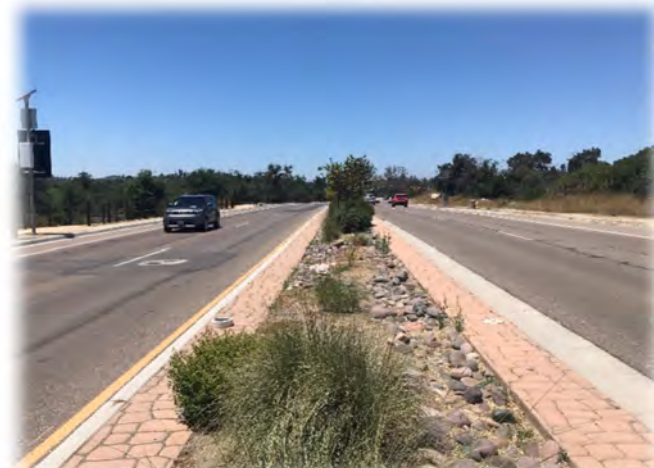
Figure 17: Raised Landscaped Median on Valley Center Road west of Cole Grade Road

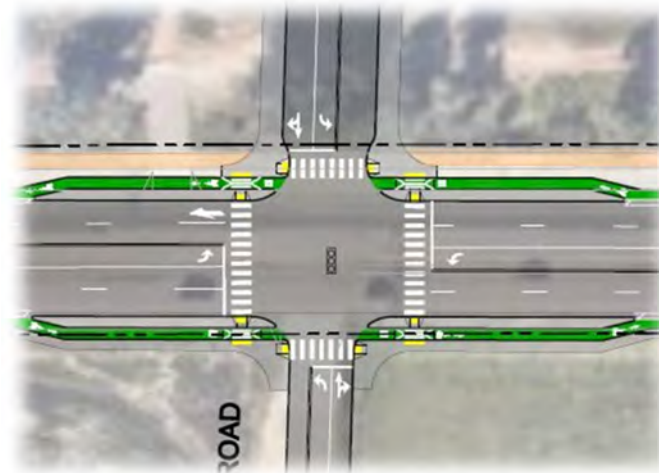
Figure 19: Theme 2 – Marked Crosswalk at Valley Center Road & Indian Creek Road

Marked crosswalks indicate a preferred location for pedestrians to cross a roadway, and alert motorists to anticipate pedestrians. Marked crosswalks are complemented by curb ramps and ADA access signage with improved visibility of the crossing. At signalized intersections, pedestrian countdown signal heads help inform pedestrians of how much time they have left to cross. Marked crosswalks at locations other than signalized intersections or roundabouts should be coupled with either a pedestrian signal or HAWK on Valley Center Road. Due to the high speed and four lanes of traffic, uncontrolled marked crossings are not recommended. Figure 19 shows marked pedestrian crosswalks at the intersection of Valley Center Road and Indian Creek Road for Theme 2.

Pedestrian crosswalks are typically 10 feet in width with white or yellow markings. However, design and installation of marked crosswalks should comply with the County of San Diego Roadway Standards and California Manual on Uniform Traffic Control Devices standards. Crosswalks should remain visible and may require ongoing maintenance to minimize fading.

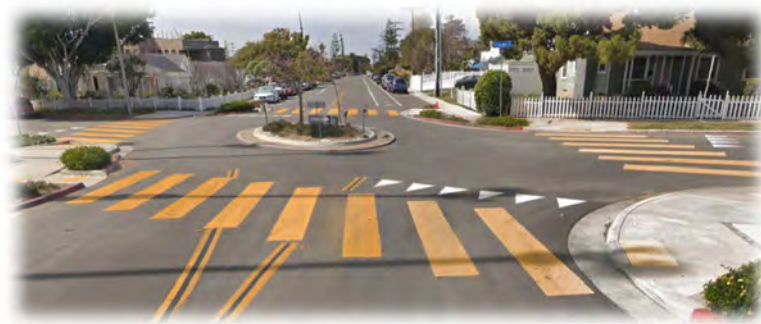
Figure 20: Marked Crosswalk at La Jolla Hermosa Avenue & Colima Street in La Jolla

High visibility crosswalks, also known as continental crosswalks, increase awareness in motorists and pedestrians at established pedestrian crossing locations. Some crossing locations include pedestrian refuge islands to shorten a pedestrian's crossing distance and provide pedestrians a refuge. A yellow crosswalk indicates a school crossing, whereas a white crosswalk indicates a standard crosswalk. An example of a marked pedestrian crosswalk is shown in Figure 20.

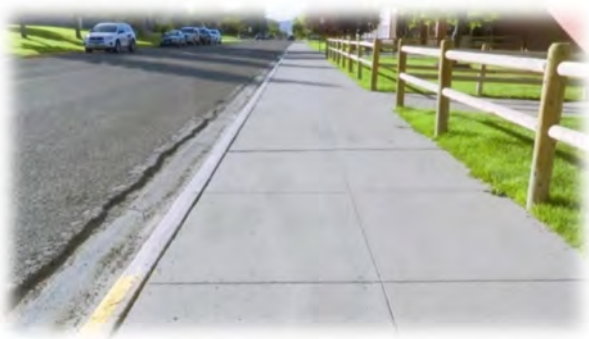
Figure 22: Example of Sidewalk

Sidewalks are primarily used by pedestrians but sometimes used by bicyclists, specifically younger and unexperienced riders. Sidewalks provide pedestrians and bicyclists a connection to parks, schools, restaurants, retail shops, libraries, public transit and other attractions. Figure 22 shows an example of a sidewalk with a clear path of travel for pedestrians.

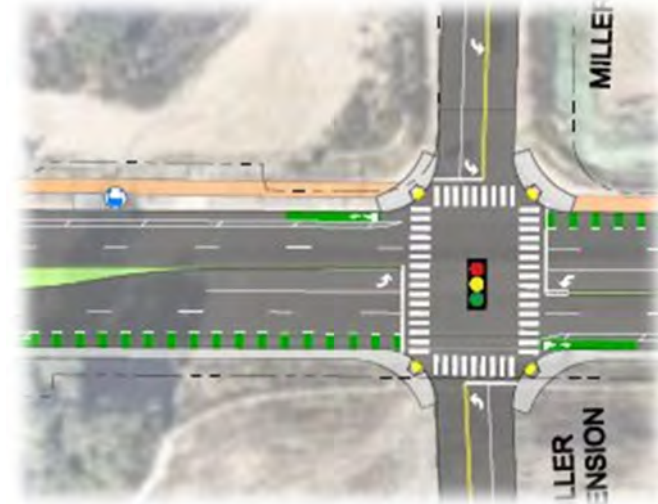
Figure 23: Theme 1 – Class IV Bikeway along Valley Center Road near Miller Road

Along Valley Center Road, 5-foot Class IV bike lanes with 3-foot buffers are proposed. However, design and installation of Class IV bikeways should comply with the County of San Diego Roadway Standards and California Manual on Uniform Traffic Control Devices standards. Specialized street sweeping equipment might be necessary to maintain these bikeways.

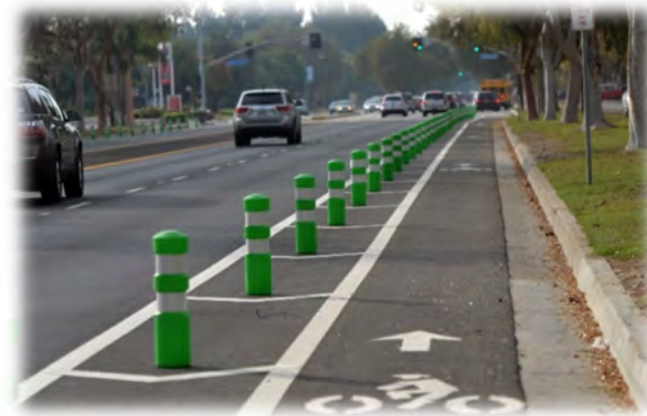
Figure 24: Class IV Bikeway with buffer and flexible delineator posts along Leucadia Boulevard looking westbound

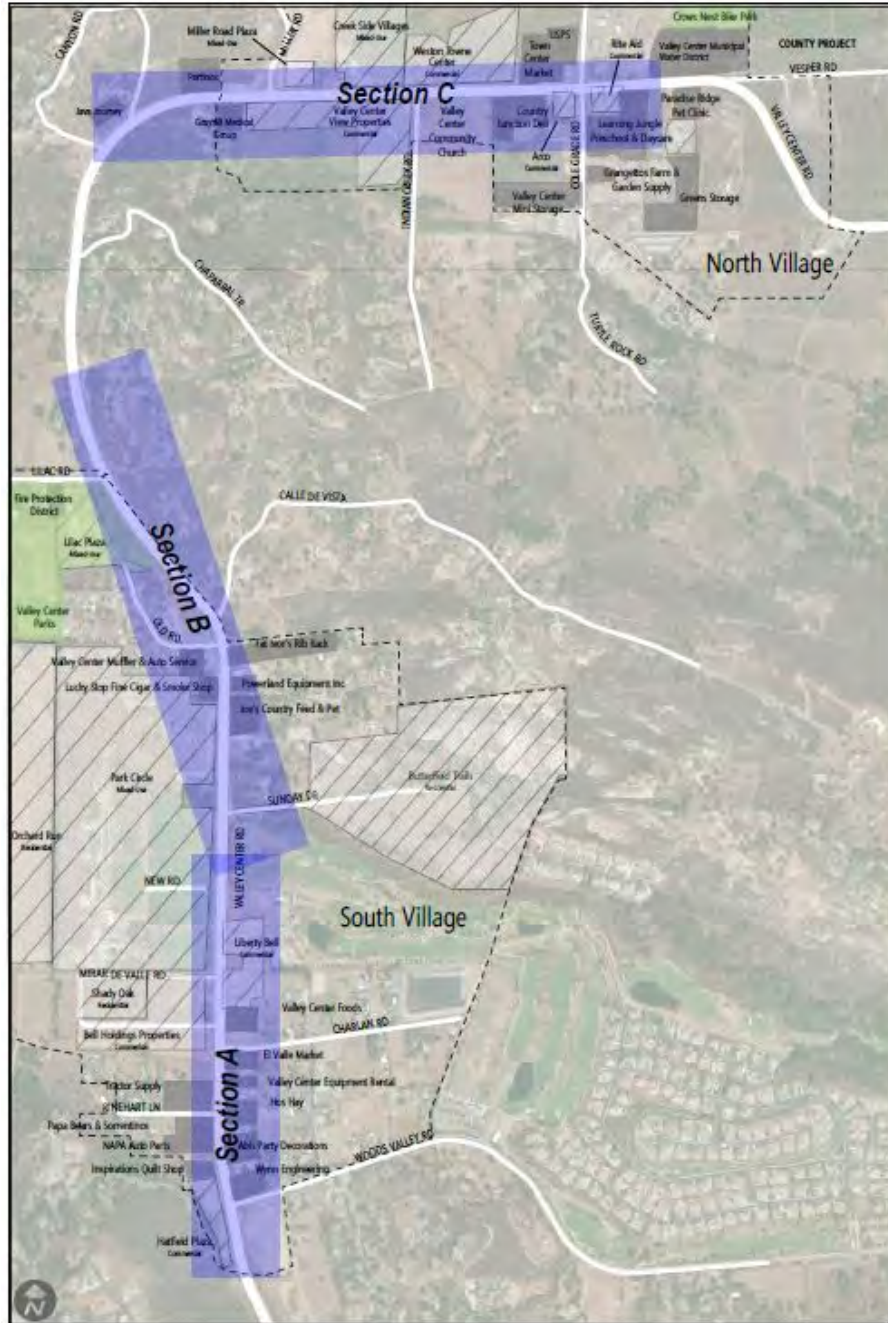
Figure 30: Theme Key Map

The key map below illustrates the extent of each of the sections. For each of the sections, the key elements of Existing Conditions, Theme 1, Theme 2 and Theme 3 are shown in Figure 30.

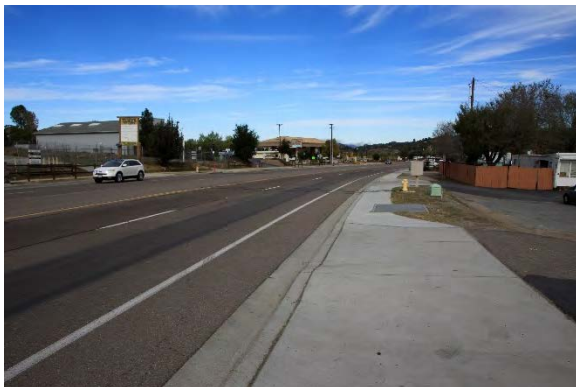
Figure 1: Looking northbound near Woods Valley Road

Valley Center Road from Woods Valley Road to Cole Grade Road is a four-lane facility with striped bike lanes on both sides of the road and a variety of median types. From Woods Valley Road to Mirar De Valle Road, Valley Center Road has a striped two-way left-turn lane allowing vehicular access to multiple businesses in the South Village, refer to **Figure 1**. Further north on Valley Center Road between Lilac Road and Cole Grade Road, Valley Center Road includes raised landscaped medians with openings at driveways and side streets to accommodate left-turning movements, refer to **Figure 2**. On-street parking is not permitted along the corridor.

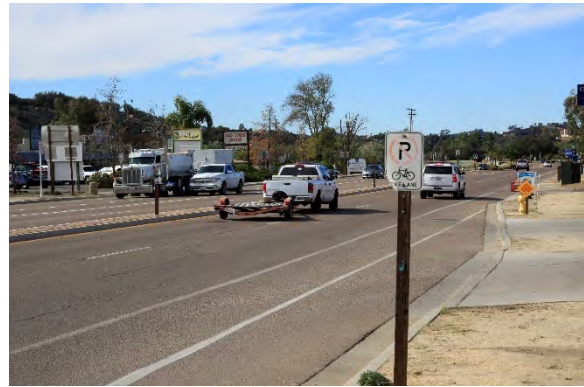
Figure 2: Looking westbound near Cole Grade Road

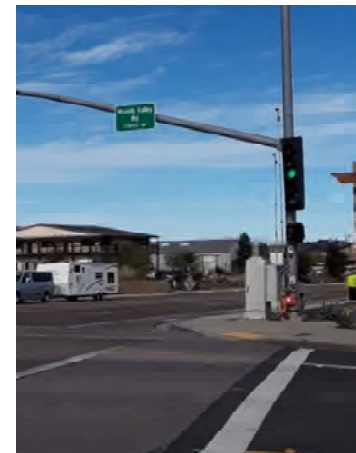
Figure 3 – Intersection Count Location

**Figure 3** shows peak period traffic counts being collected by a camera system at the intersection of Valley Center Road and Woods Valley Road.

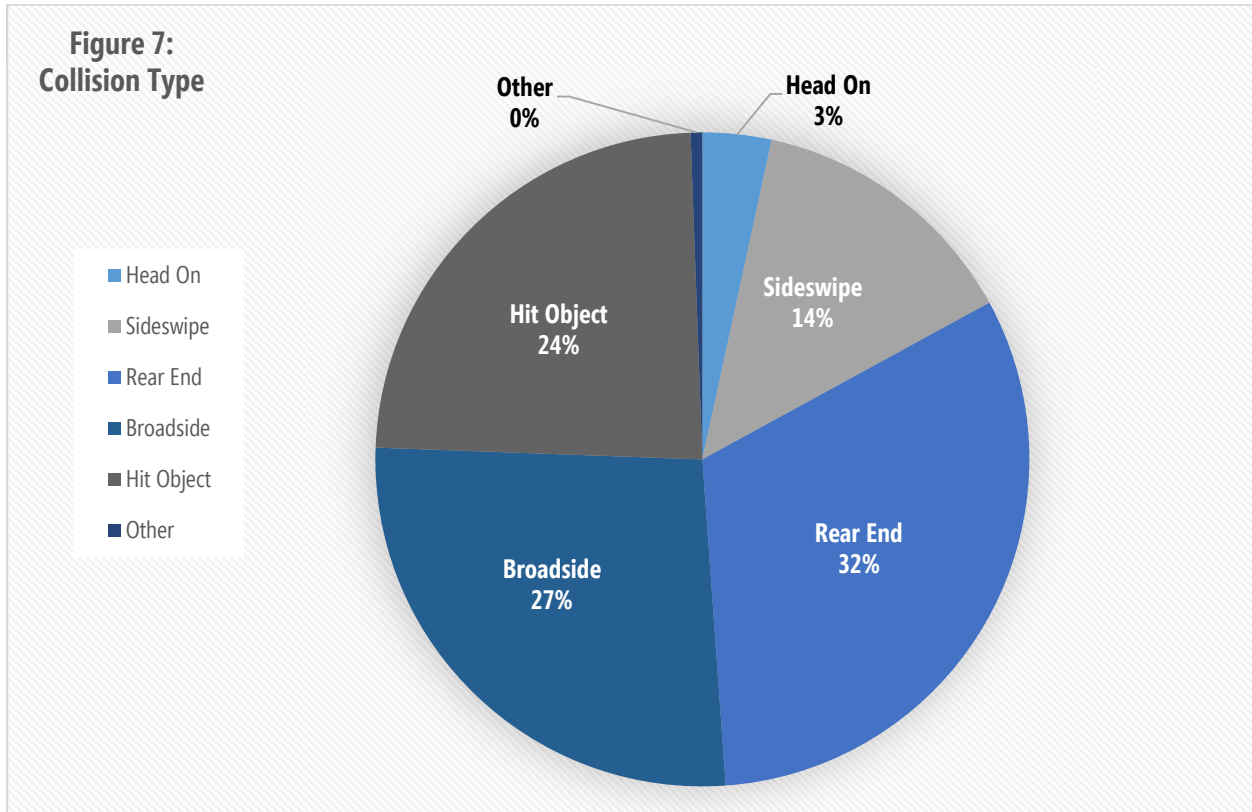
Of the 176 crashes reported, most were rear end (56 crashes), broadside (47 crashes) or hit object (42 crashes). As shown in **Figure 7**, these three collision types account for 83% of all crashes along the corridor. A breakdown of collision type by intersection is provided in **Table 5**.

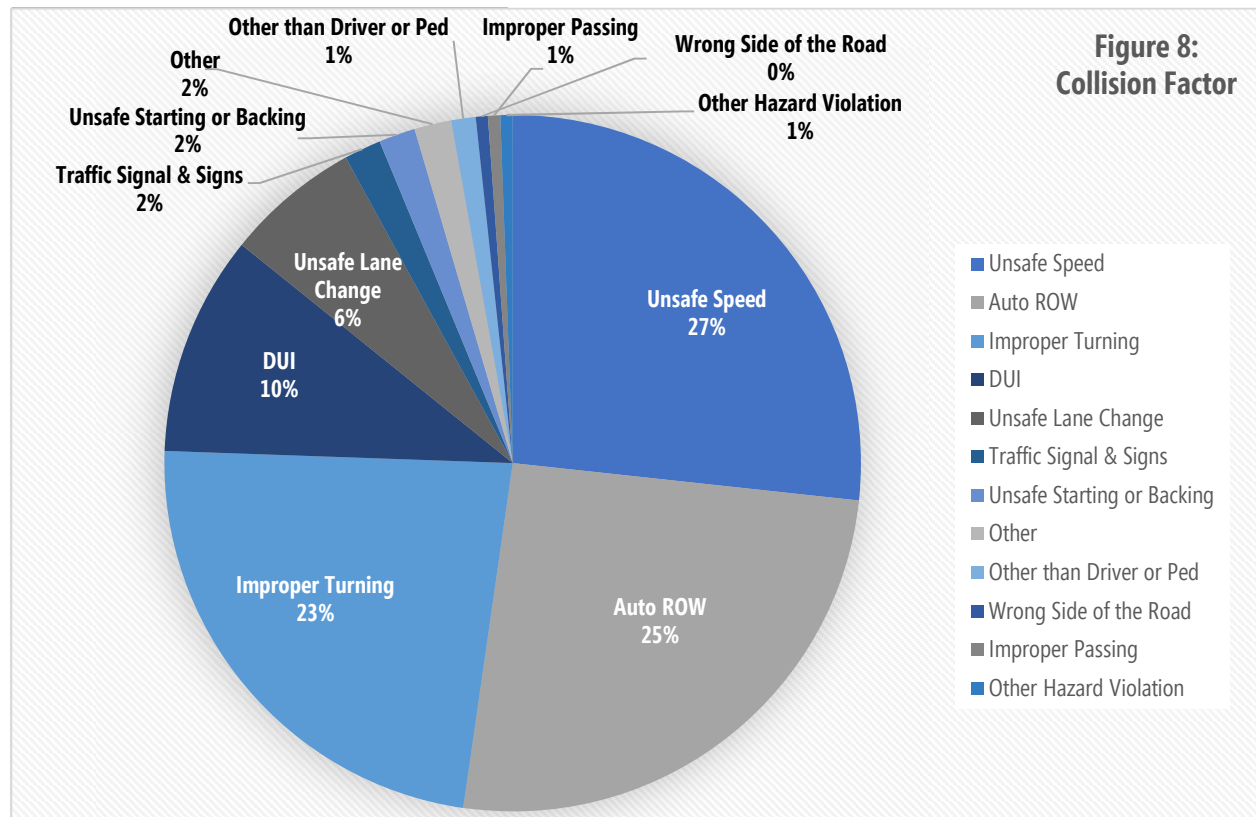
Of the 176 crashes reported, 76% of the crashes were attributed to unsafe speed (47 crashes), auto right-of-way violations (45 crashes) or improper turning (41 crashes). Driving under the influence (DUI) accounted for 18 of the 176 crashes reported along the corridor in the five-year period. **Figure 8** and **Table 6** summarize the collision factor data. Speed data provided with this report indicates that most drivers exceeded the posted speed limit. To reduce speed and reduce crashes associated with speed, traffic calming measures and/or geometric modifications to the road are necessary. Improper Turning and Auto ROW also correspond with the broadside collision type. Adding a raised median and consolidating the number of left turn and cross traffic locations will address the Improper Turning and and Auto ROW collision factor crashes.

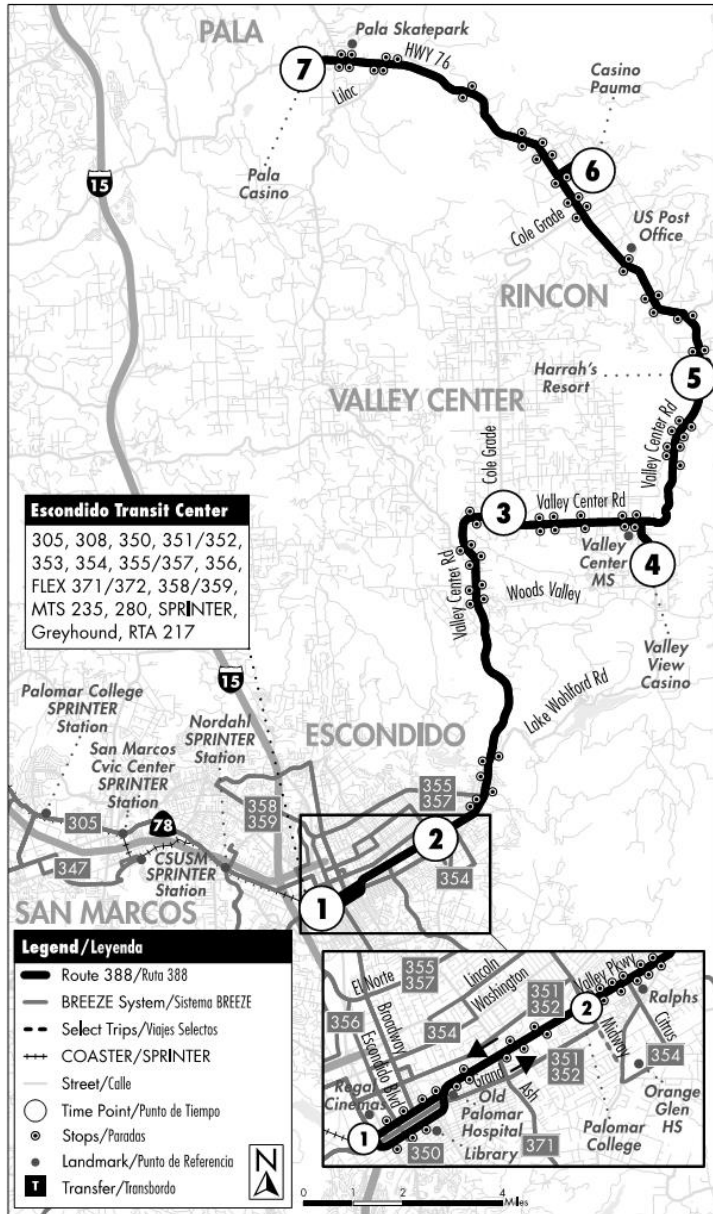
NCTD operates the local bus service along Valley Center Road. NCTD’s Route 388 travels along Valley Center Road as shown in **Figure 9**, connecting Pala, Rincon, Valley Center and Escondido. The route travels between the Pala Casino and the Escondido Transit Center. The Escondido Transit Center provides regional connections to ten other transit services, four FLEX routes, two MTS routes, SPRINTER, Greyhound and Riverside Transit Authority (RTA).

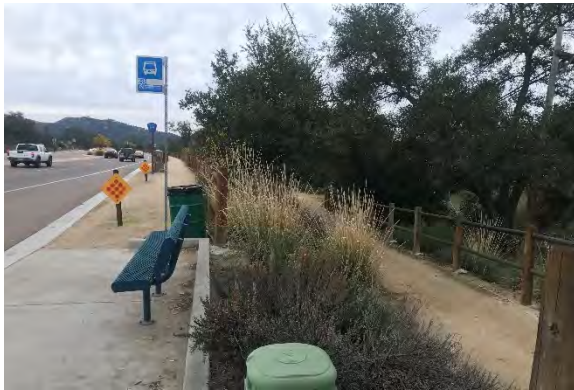
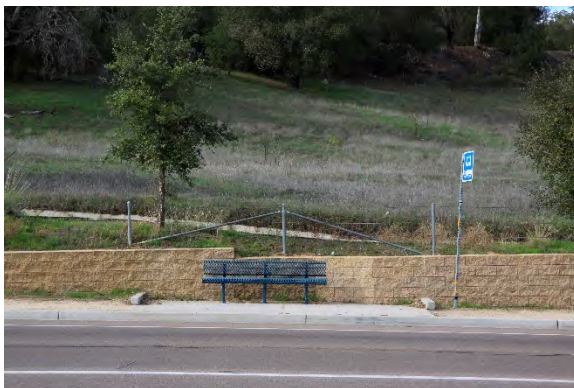
Figure 12: Typical Bus Stops with Bench and Sign

BREEZE buses provide public transportation along Valley Center Road via Route 388 and can carry up to 70 passengers per bus. Currently, most bus stops along the route contain minimal amenities such as a bench and route sign as shown in **Figure 12**. Some of the stops require maintenance such as the bus route map and schedule display shown in **Figure 13**.

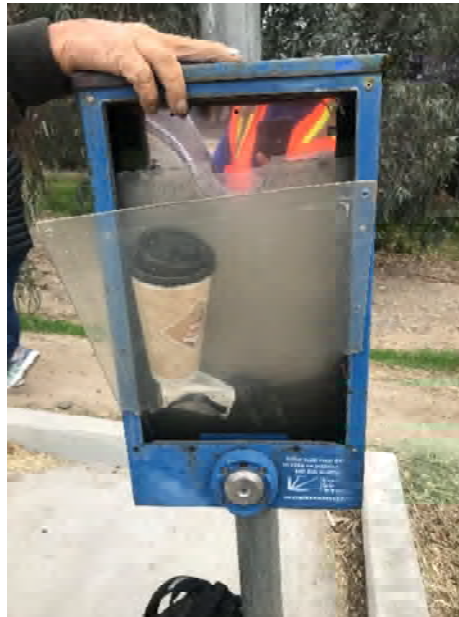
Figure 13: Bus route map/schedule display case

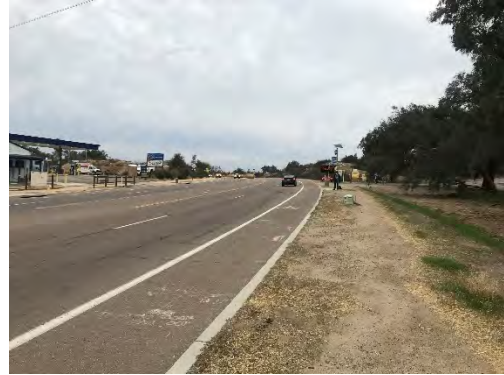
Figure 15: Example of Existing Goat Trail

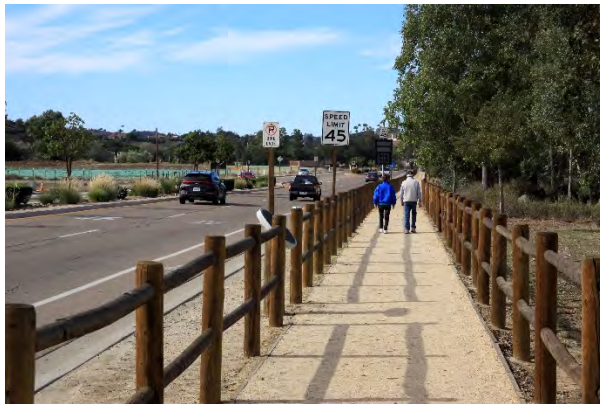
Figure 16: Heritage Trail with split rail fencing (looking westbound on Valley Center Rd.)

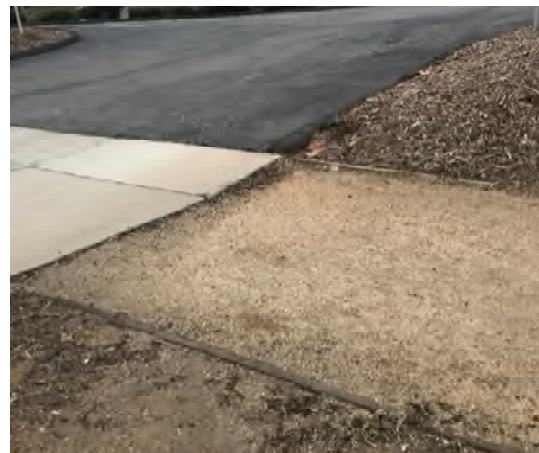
Figure 17: Example of trail erosion near concrete driveways.

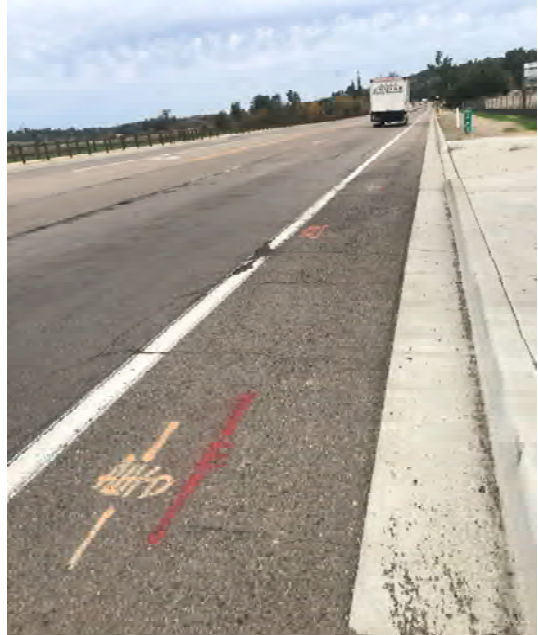
Figure 19: Class II bike lane with degraded surface.

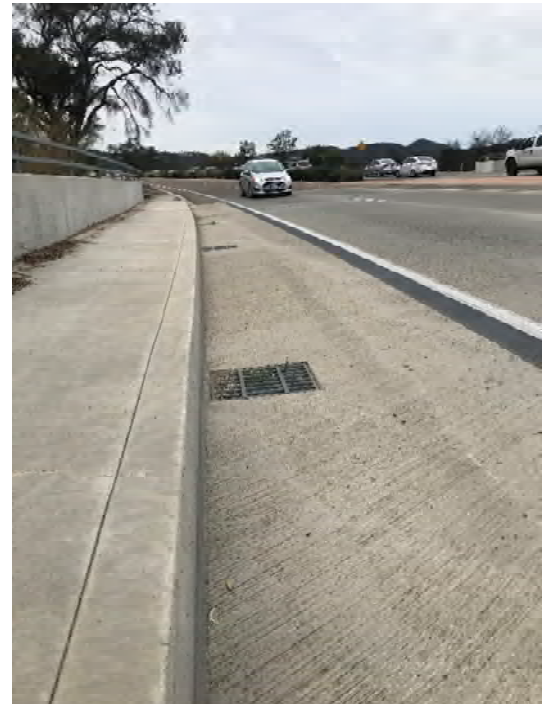
Figure 20: Class II bike lane with drainage inlet.

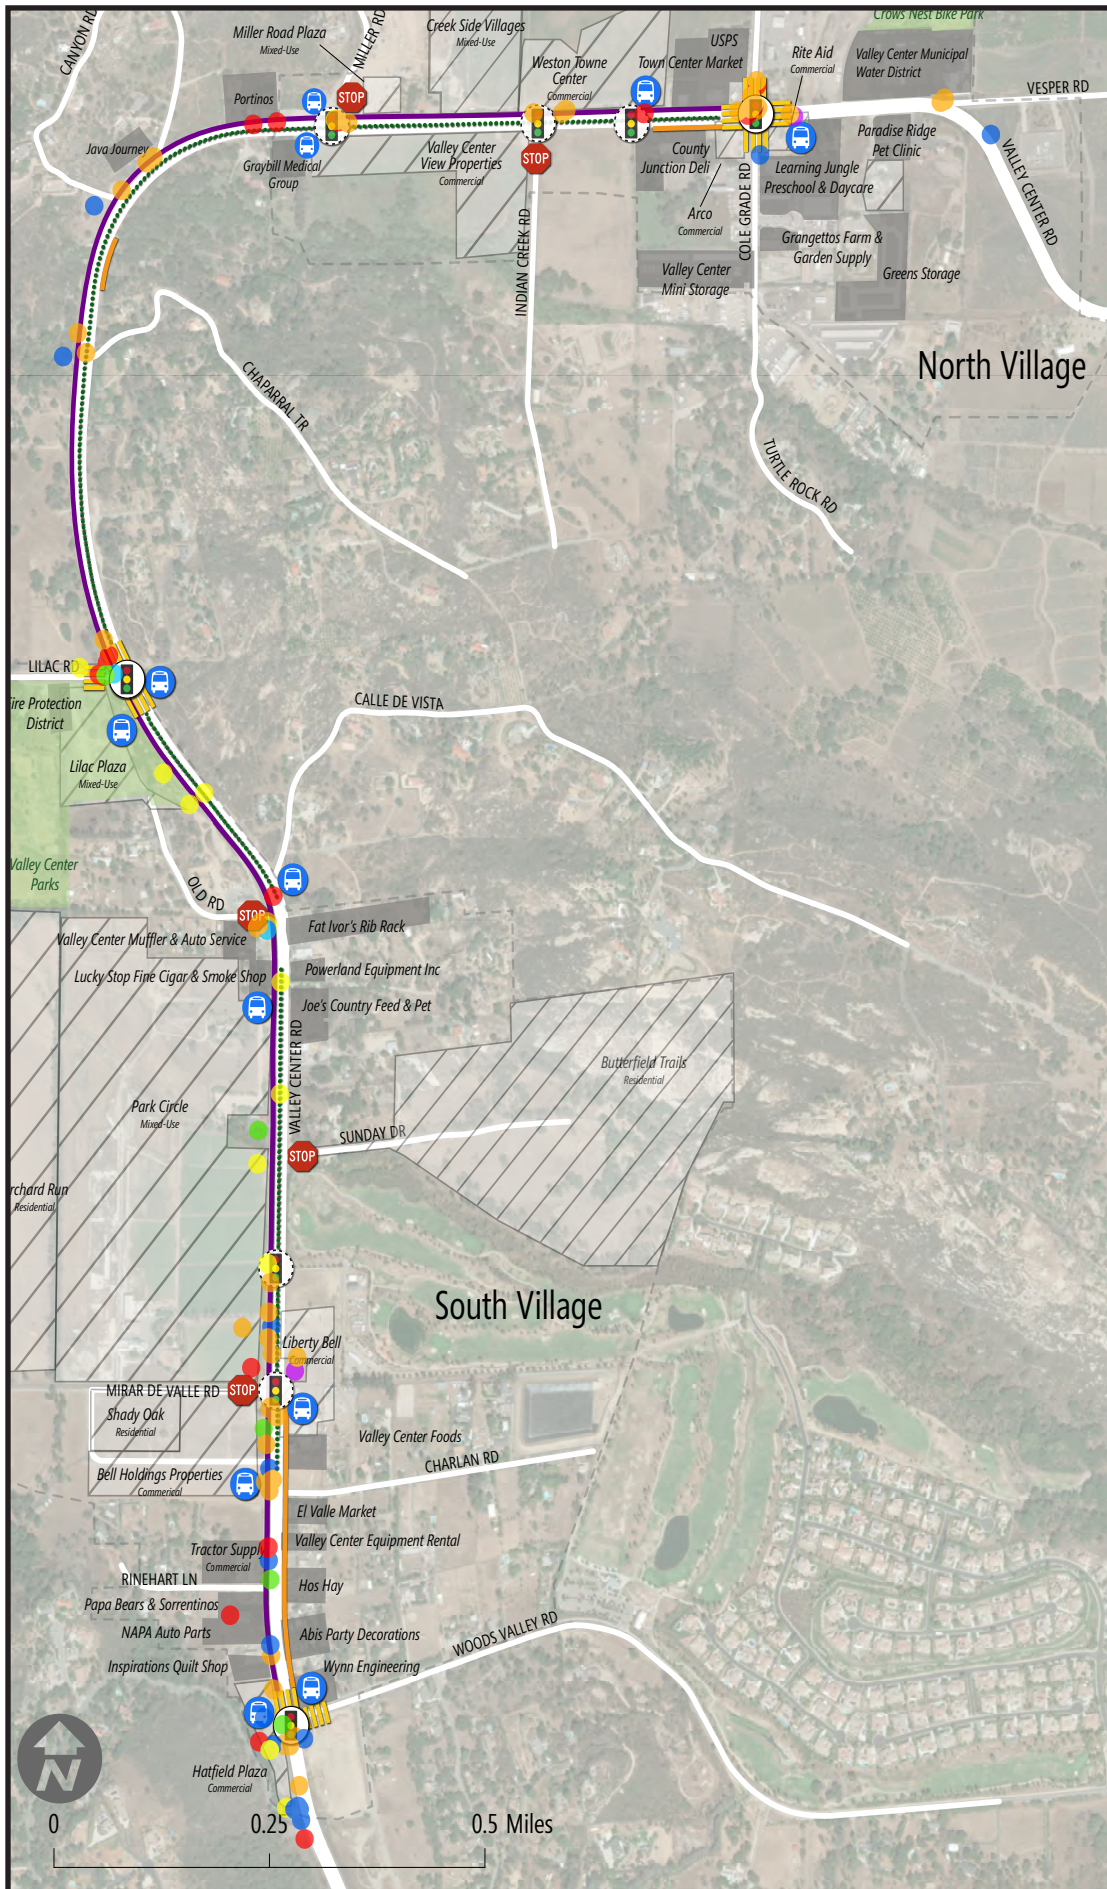
# What Did We Hear?

Workshop participants noted the Heritage Trail as a positive characteristic and ultimately would like to see more trails and walking paths along Valley Center Road. Most participants noted challenges throughout the study area. A map is provided on the following page displaying the common themes participants noted on each map. The map is then broken into four segments displaying the positive characteristics and corridor challenges along with common comments participants noted on each map.

- 48 Vehicle access comments
- 47 Overall safety comments
- 35 Streetscaping comments
- 22 Pedestrian access comments
- 6 Land use and surrounding development comments
- 5 Bicycle access comments
- 4 Equestrian use comments

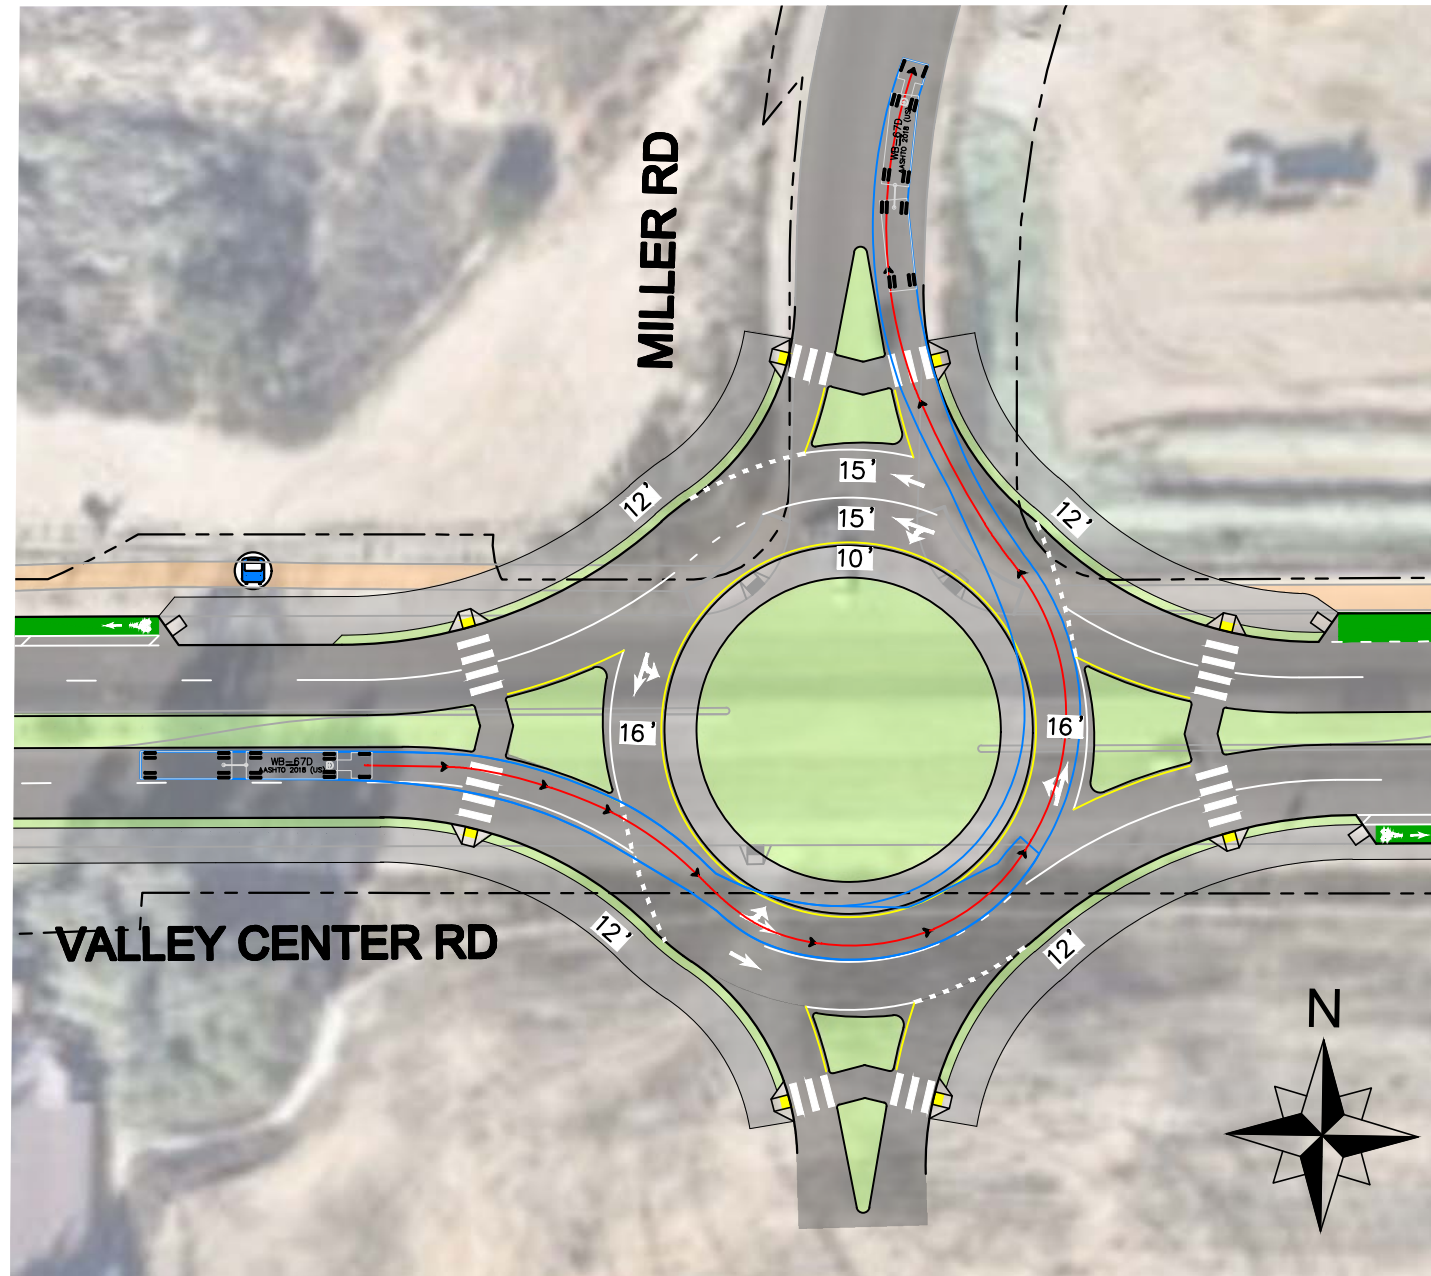
**WB-67D**

# VALLEY CENTER RD - MILLER RD TURN TEMPLATE
