Valley Center Road Corridor Concept Plan

# Appendix G: Themes Technical Memorandum

TO: Kevin Johnston, County of San Diego  
FROM: Dawn Wilson, PE TE  
DATE: June 10, 2020

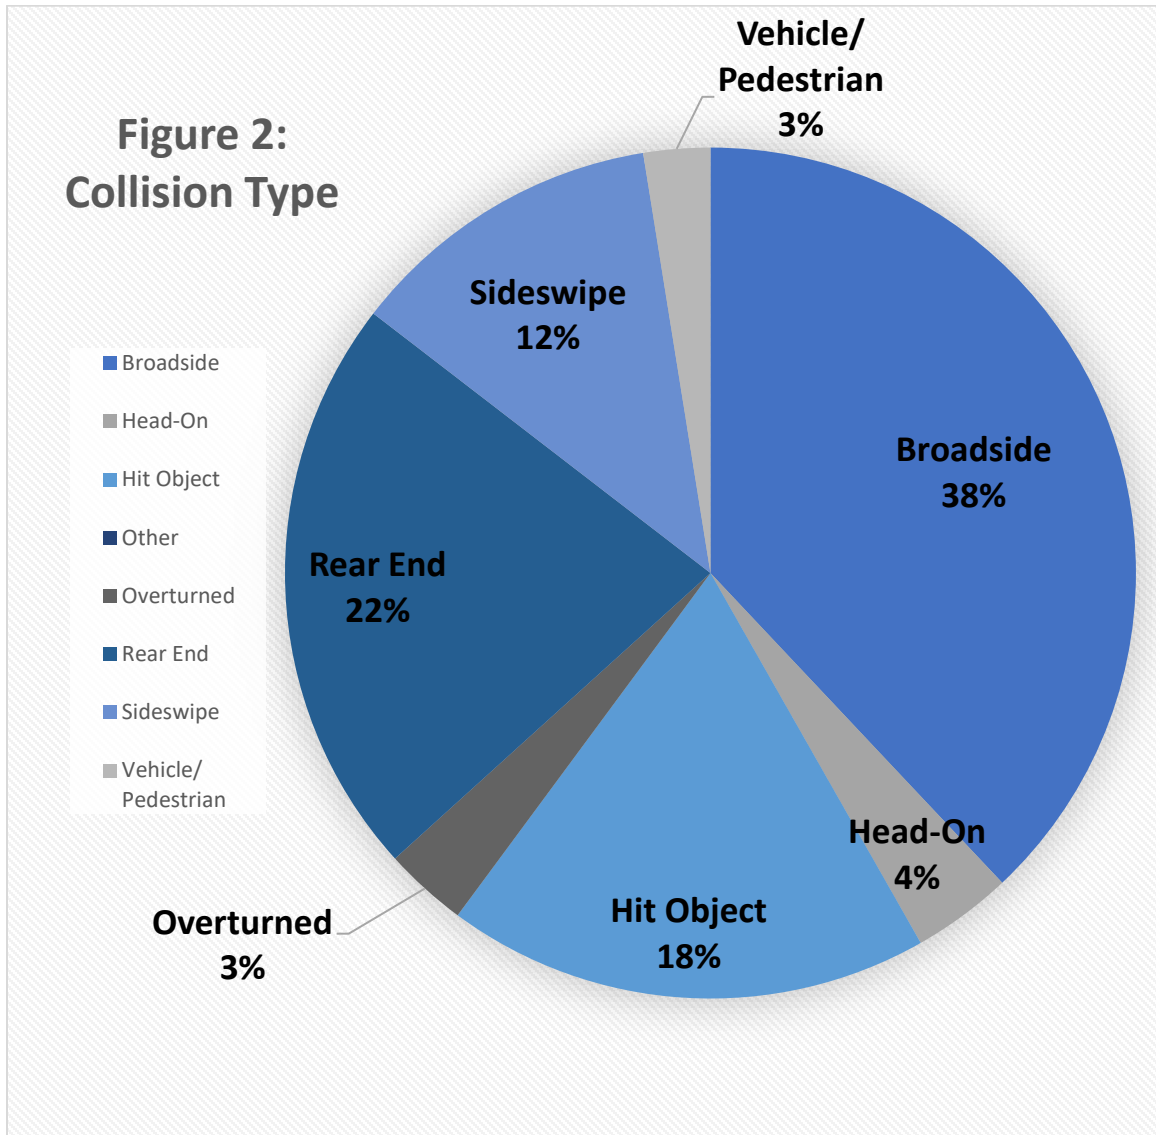
Of the 151 crashes reported, most were broadside (58 crashes), rear end (35 crashes), or hit object (27 crashes). As shown in **Figure 2**, these three collision types account for 78% of all crashes along the corridor. A breakdown of collision type by intersection is provided in **Table 2**.

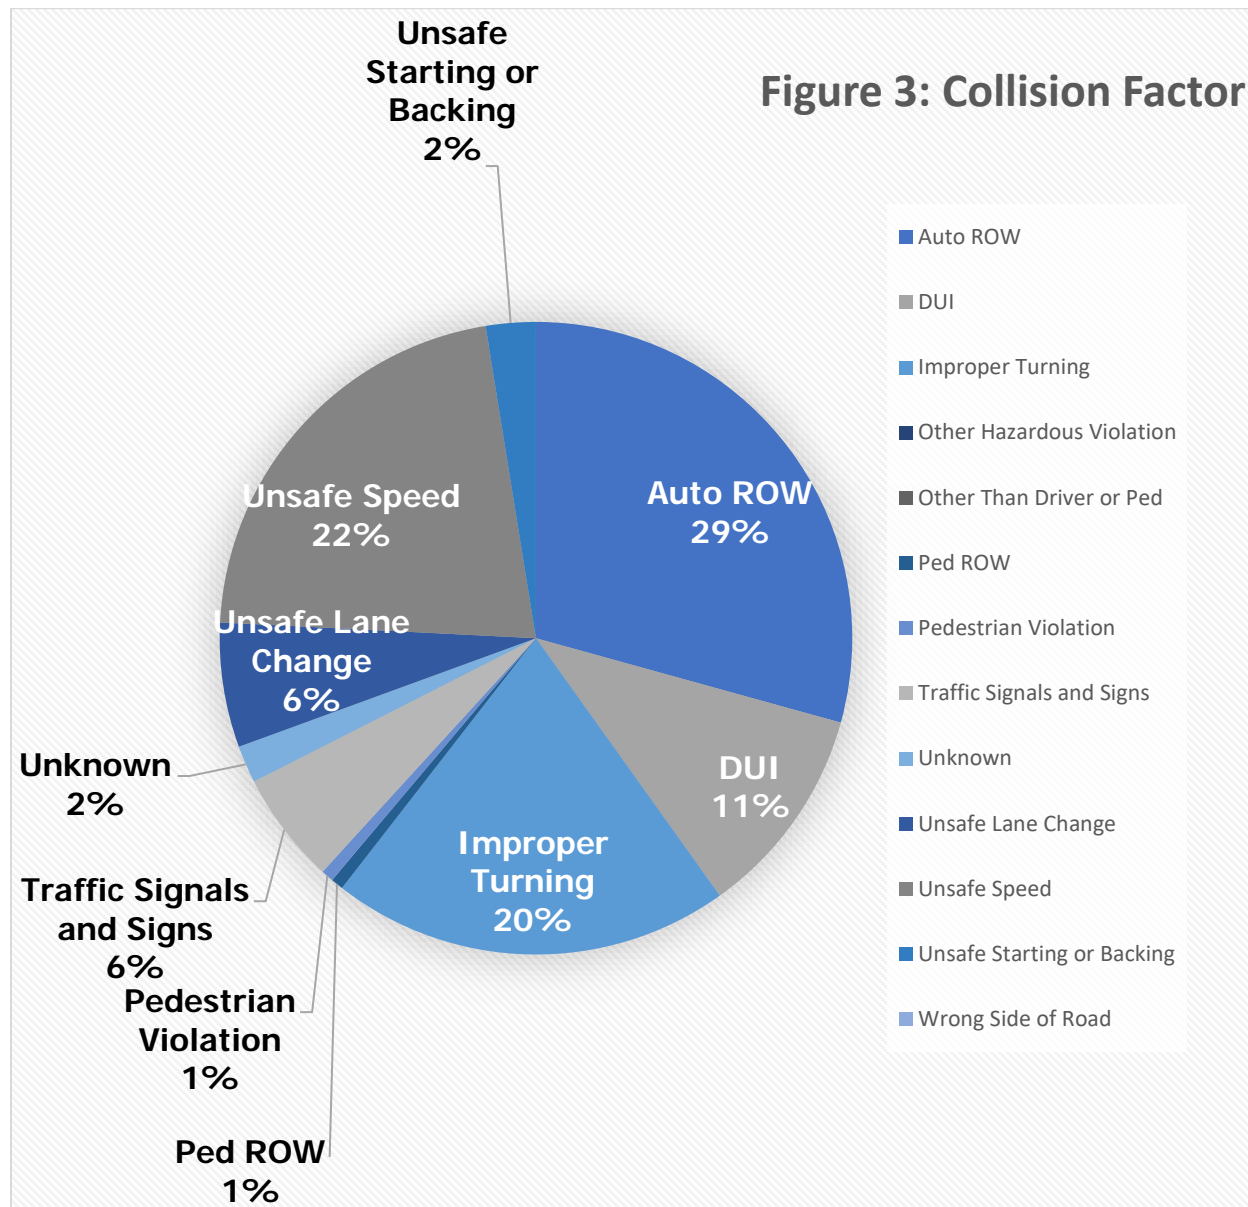
**Figure 3** and **Table 3** summarize the collision factor data. Speed data provided with the Existing Conditions memorandum for Valley Center Road indicates that most drivers exceed the posted speed limit. To reduce speed and reduce crashes associated with speed, traffic calming measures and/or geometric modifications to the road are necessary (i.e., installing a roundabout). Improper Turning and Auto ROW also correspond with the broadside collision type.
