**PHASE II ENVIRONMENTAL SITE ASSESSMENT  
PROPOSED RESIDENTIAL DEVELOPMENT  
2260 SAN PASQUAL VALLEY ROAD  
ESCONDIDO, CALIFORNIA**

**Project Information:** Proposed Residential Development, APN 234-261-23-00, 234-440-05-00 and 234-430-21-00, 2260 San Pasqual Valley Road, San Diego County, California

**SCST Project Number:** 180155N-2

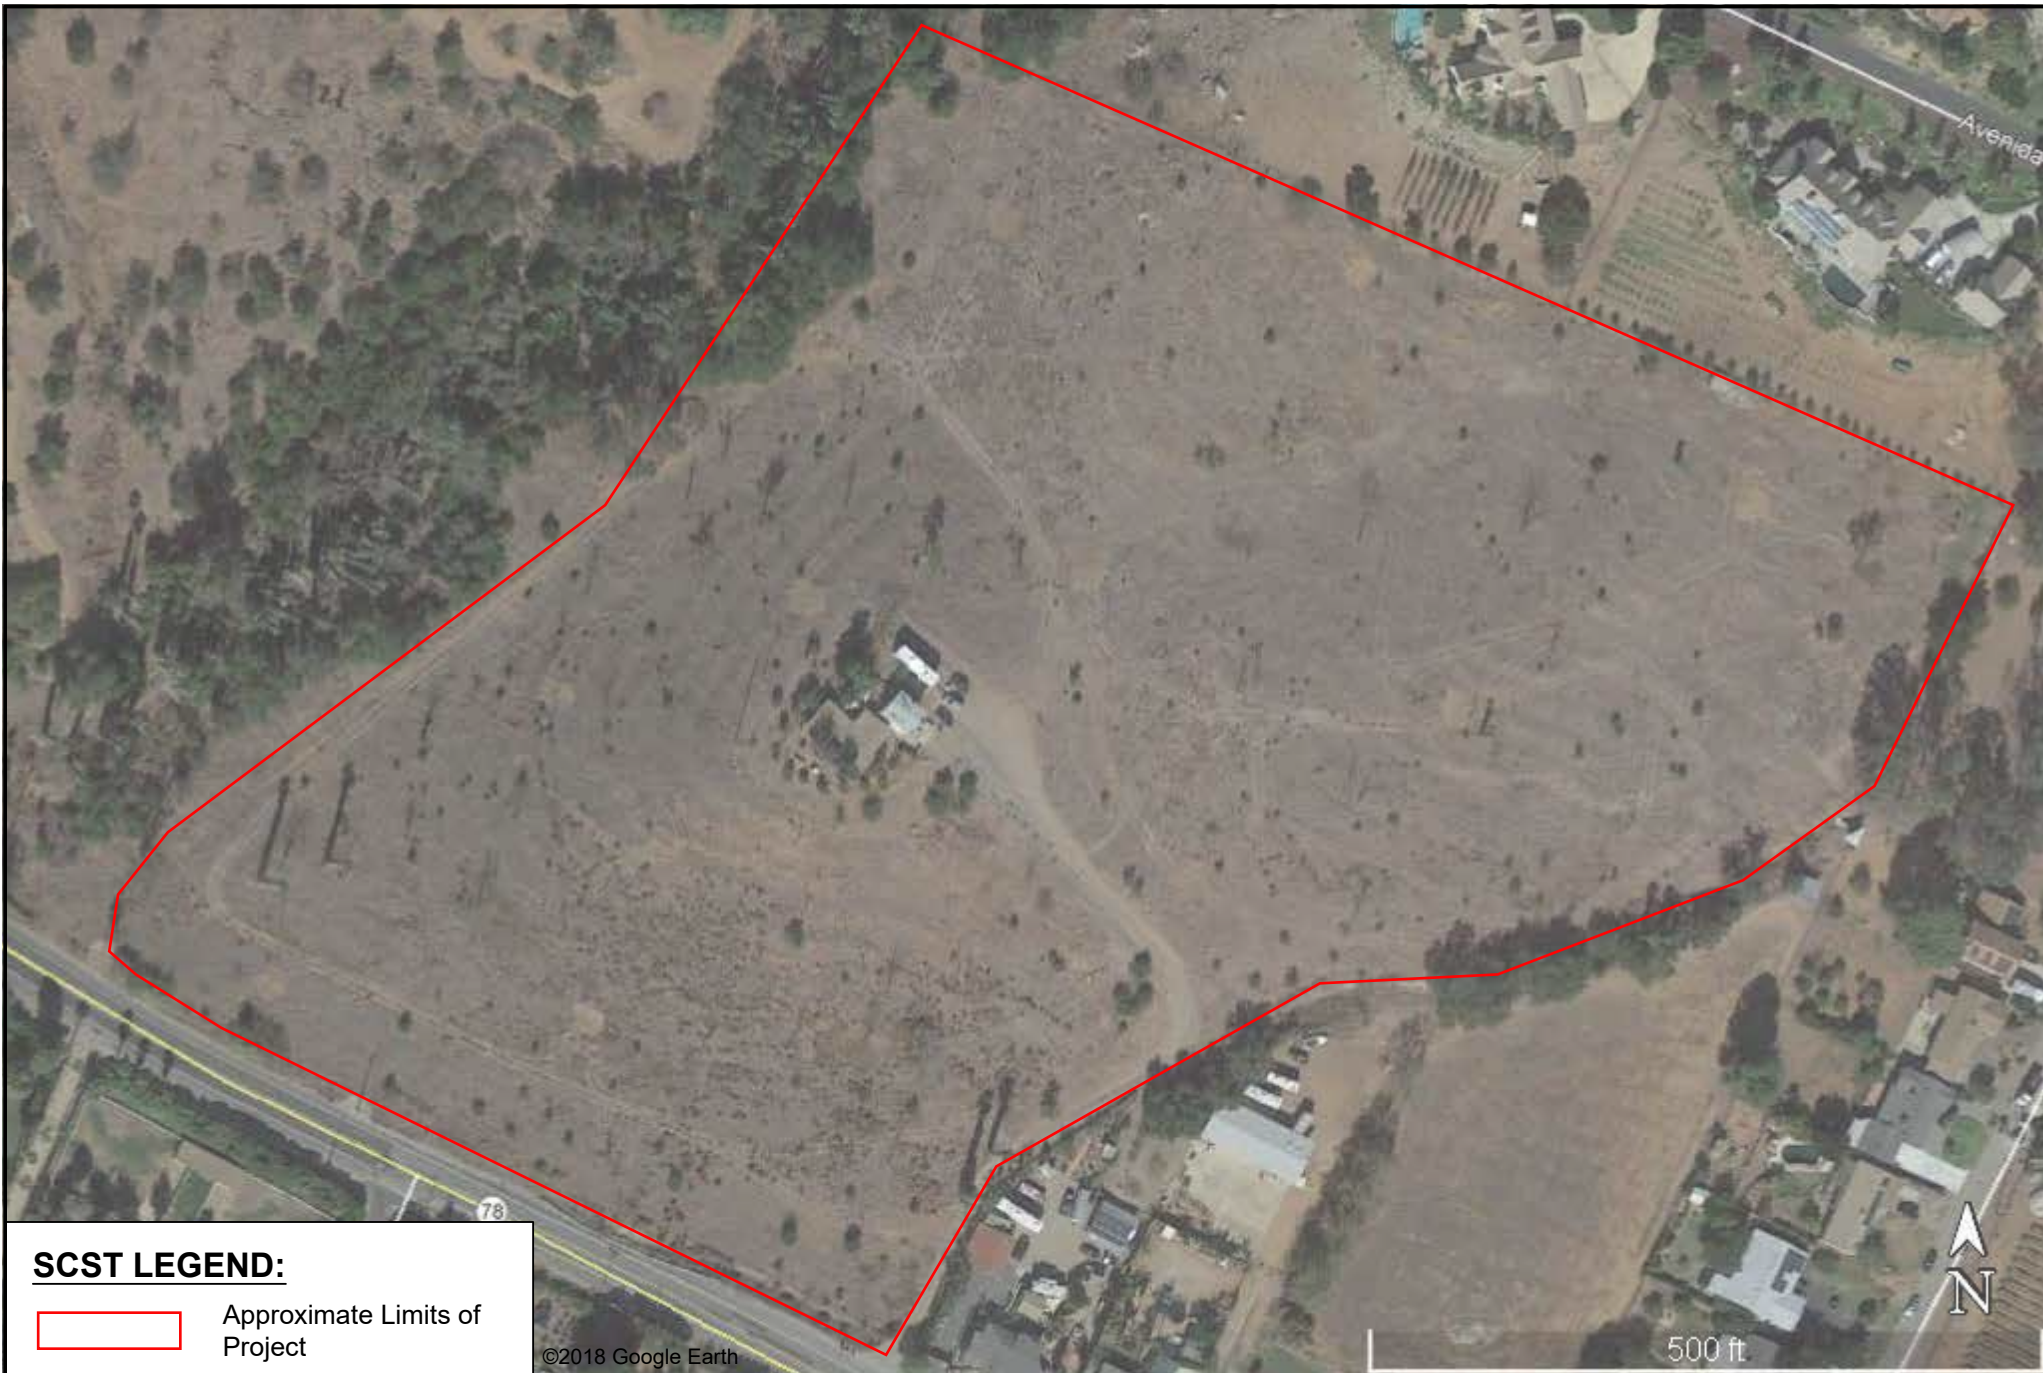
**2**

Approximate Limits of Project

**SITE PLAN**

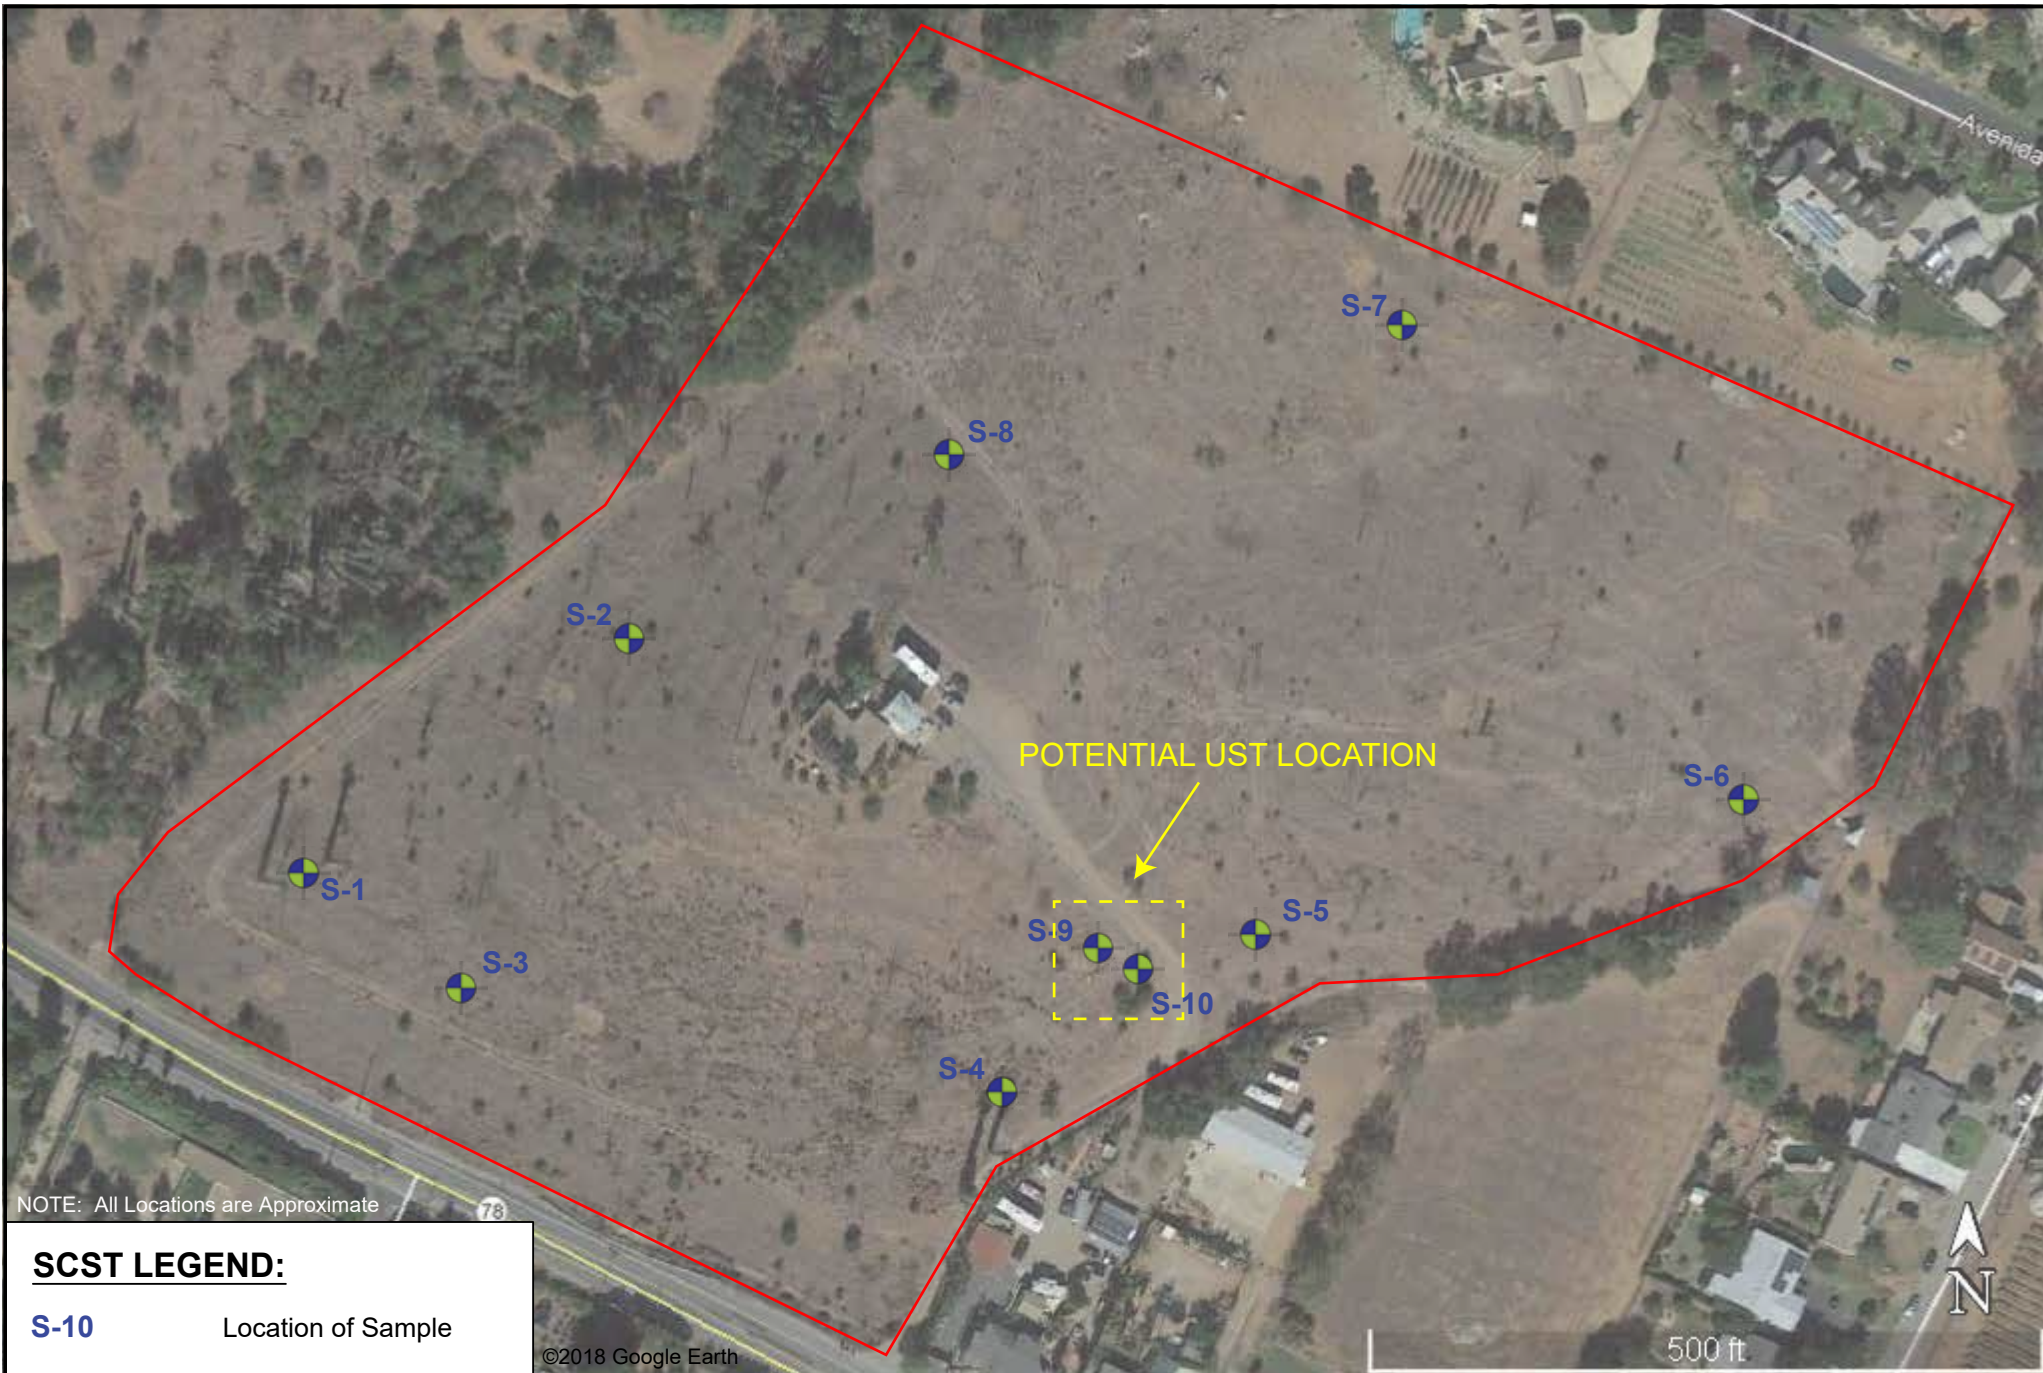
Figure:  
**3**

**S-10** Location of Sample

**SAMPLE LOCATION MAP**  
 2260 San Pasqual Valley Road  
 Escondido, California

On July 17, 2018, SCST personnel collected a total of 8 composite soil samples from 8 locations across the subject property for agricultural chemical residue analyses. The sample locations were selected to sufficiently characterize the site. In order to create each composite sample, SCST personnel collected a total of 3 discrete soil samples within a radius of 25 feet from each sample location at depths of 1 inch to 6 inches below existing grade. Each of the 3 discrete samples were thoroughly homogenized to produce a single composite sample. Sampling equipment was cleaned between each sample using a trisodium phosphate solution with two potable and one distilled water rinse. The composite soil samples were placed into certified-clean, four-ounce glass jars provided by the laboratory. The glass jars were immediately capped with Teflon coated lids, appropriately labeled, and placed in a chilled cooler pending delivery to a California State Certified Laboratory. Appropriate chain-of-custody procedures were followed. Figure 3 presents a site plan depicting the approximate sampling locations.

Research conducted by SCST did not reveal maps or other documents identifying the location or disposition of the UST reported at the site. In order to define an area of concern, SCST reviewed historic aerial imagery and maps to locate any evidence of chemical storage or equipment maintenance and repair. In aerial photographs taken of the site between 1936 and 1995, a shed/workshop is visible approximately 250 feet southeast of the residential structure adjacent to the driveway. In our opinion, this structure and the surrounding area is the most likely place a UST would have been located at the site. SCST personnel collected two discrete soil samples from two separate borings within this area for TPH residue analysis. The samples were collected at depths of 1 foot and 3 feet from each boring using hand tools. Sampling equipment was cleaned between each sample using a trisodium phosphate solution with two potable and one distilled water rinse. The composite soil samples were placed into certified-clean, four-ounce glass jars provided by the laboratory. The glass jars were immediately capped with Teflon coated lids, appropriately labeled, and placed in a chilled cooler pending delivery to a California State Certified Laboratory. Appropriate chain-of-custody procedures were followed. Figure 2 presents a site plan depicting the approximate sampling locations.
