Julian Sewer Service Area Sewer Master Plan

January 2013

County of San Diego
Wastewater and Water Engineering
5555 Overland Avenue
San Diego, CA 92123

ATKINS

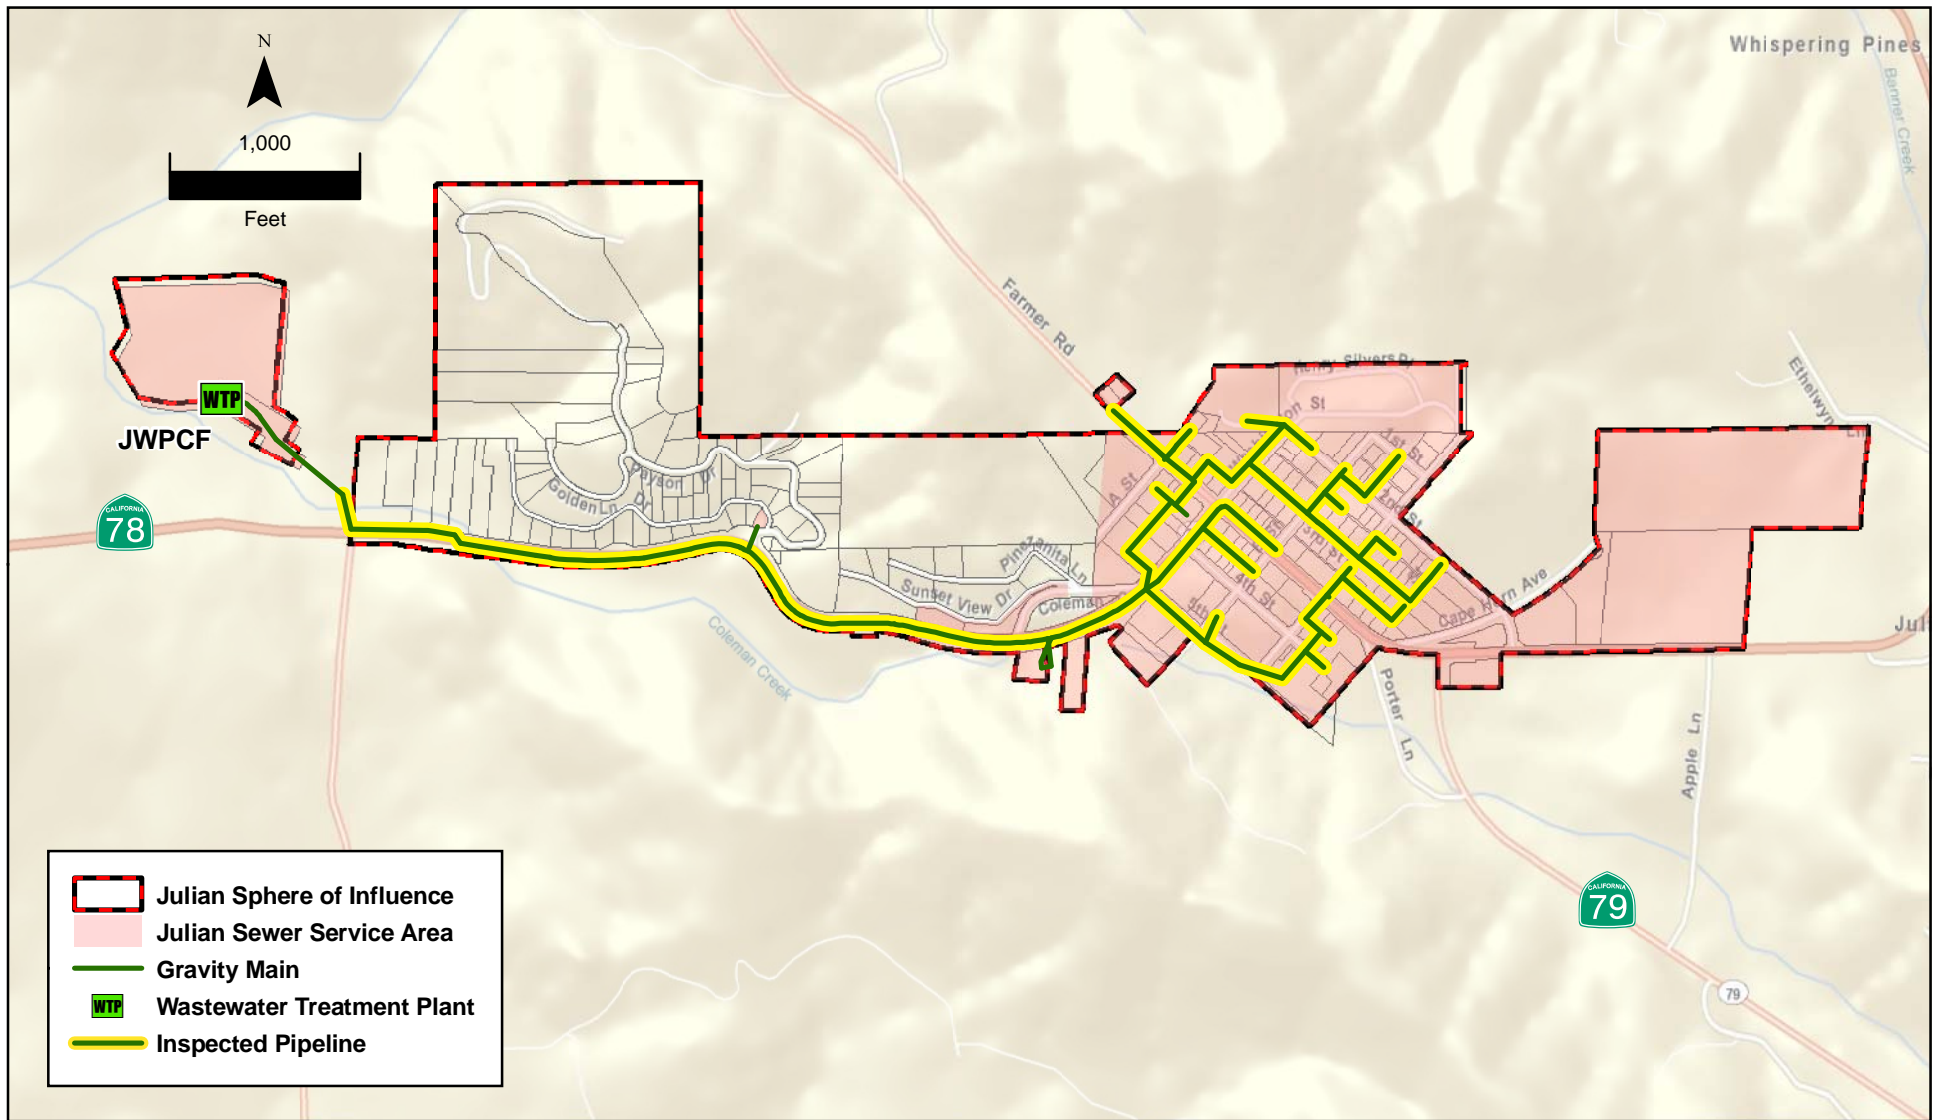
INSPECTED
AND ASSESSED PIPES
Figure 5-2

Closed circuit television cameras offer valuable insight to the structural and maintenance condition of underground infrastructure. Video inspection of sewer pipelines is used to identify and evaluate the existence and severity of defects including cracks, misaligned joints, accumulation of roots or silt, and potential sources of infiltration. Figure 5-2 shows the pipelines in the Julian SSA that were inspected and assessed.

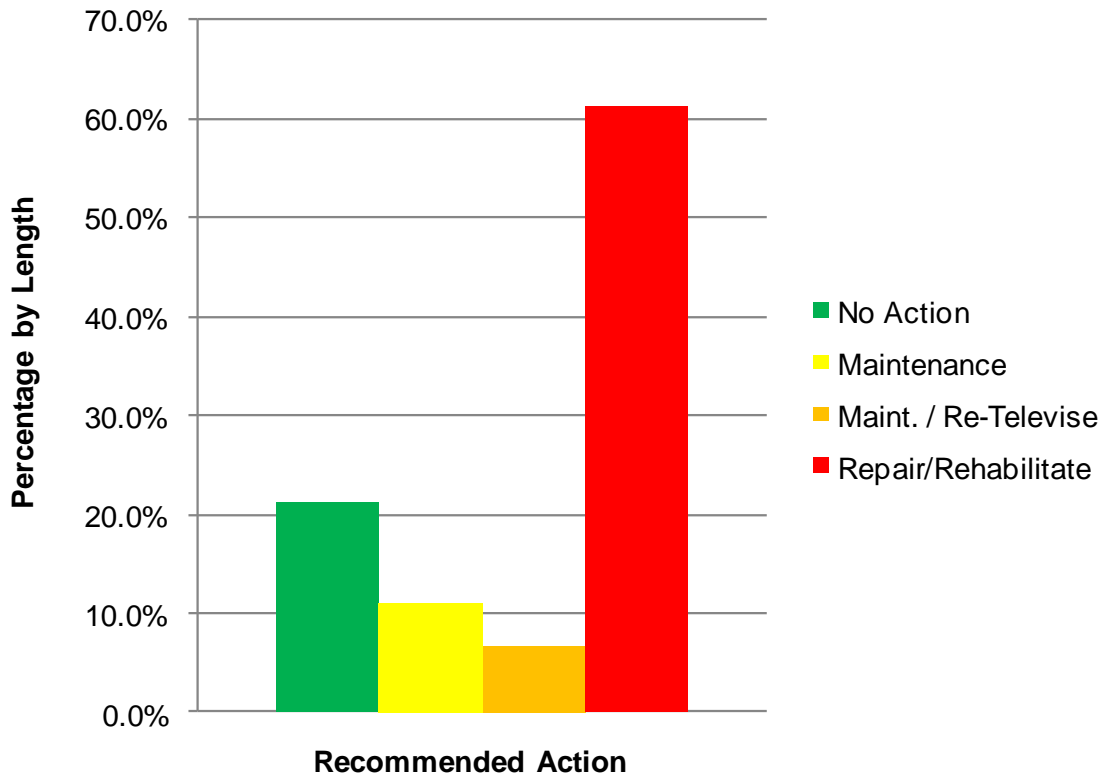
Figure 5-3 Pipeline Inspection and Assessment Findings by Percentage of Length

Overall, the pipe segments inspected are generally in fair condition. However, over 60 percent of the observed pipelines were identified as requiring some form of repair or rehabilitation while over 20 percent were identified as requiring No Action, and approximately 20 percent were identified as requiring maintenance. Table 5-5 includes a summary of the recommended actions based on the number of pipe segments and pipe length inspected and assessed while Table 5-6 includes a summary of the criticality rankings based on the number of pipe segments and pipe length inspected and assessed. Figure 5-3 graphically presents the pipeline inspection and assessment findings by length.

Description	Criticality					Total
	A	B	C	D	E	
No of Pipeline Segments	15	17	14	11	4	61
Length (feet)	2,936	3,683	3,675	2,324	1,297	13,915
Percentage by Length	21.1%	26.5%	26.4%	16.7%	9.3%	100.0%

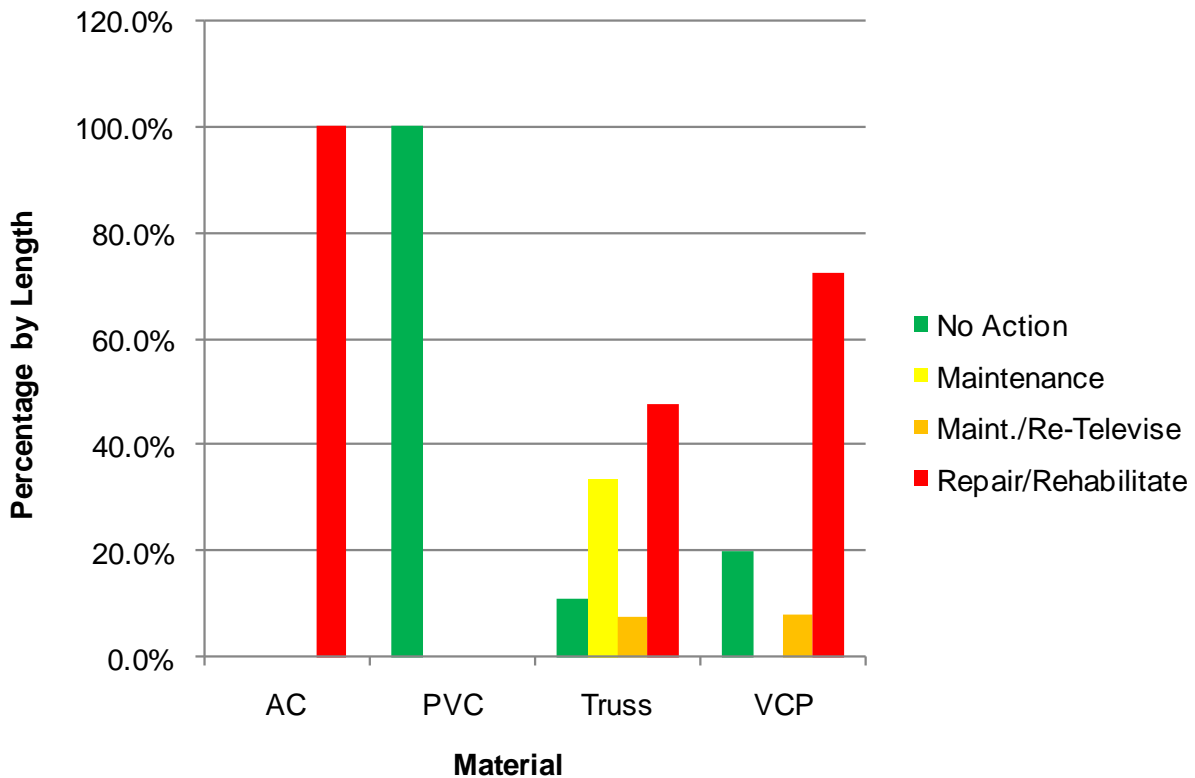
Figure 5-4 Pipeline Inspection and Assessment Findings by Material

Table 5-7 summarizes the number of pipe segments and length of pipe inspected and assessed by material type while Figure 5-4 illustrates the recommendations for the pipelines within the SSA based on material. It should be noted that based on information obtained from the City’s GIS and mapbooks several of the pipelines inspected were classified as having “unknown” material type. However, based on information obtained from the CCTV inspection videos, the material type was updated to reflect the assessment findings. Specifically, the pipelines located along State Route 78, appear to be of truss type pipe material which consists of a semi-rigid walls with concentric inner and outer walls braced by a truss-type structure.

Description	Material				Total
	AC	PVC	Truss	VCP	
Number of Segments	3	3	11	44	61
Length (feet)	691	877	4,555	7,792	13,915
Percentage by Length	5.0%	6.3%	32.7%	56.0%	100.0%

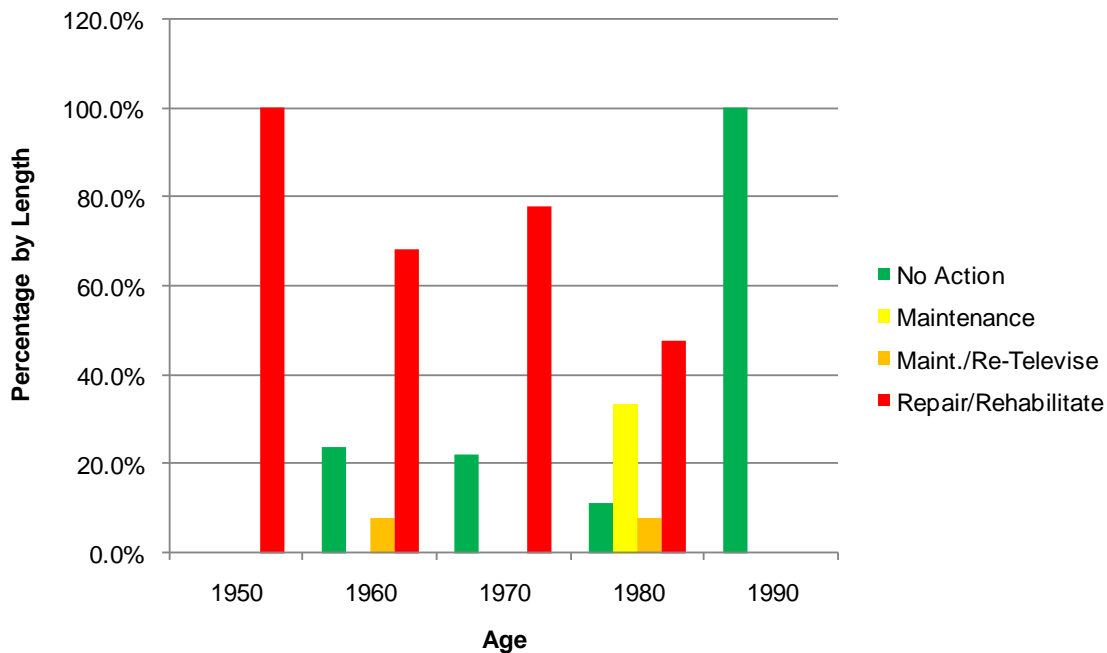
Figure 5-6 Pipeline Inspection and Assessment Findings by Age

Figures 5-6 illustrates the recommendations for the pipelines within the SSA that were inspected and assessed based on age.

Based on the results of the inspection and assessment of nearly the entire wastewater collection system within the Julian SSA, it is estimated that approximately 8,500 linear feet (1.60 miles) requires some form of repair, rehabilitation or replacement over the next 10 to 15 years.

The wastewater collection system in the Julian SSA includes approximately 6,800 feet of 6-inch diameter pipeline. Approximately 4,600 linear feet of the 6-inch pipelines were identified as requiring a form of rehabilitation and/or replacement. Of the 4,600 linear feet, approximately 50% (2,300 feet) is recommended for lining, over 30% (approx. 1,600 feet) is recommended for complete replacement and four (4) pipelines were identified as requiring partial lining to address the types of defects identified.
