EXISTING CONDITIONS TRAFFIC ANALYSIS AND PARKING ASSESSMENT

Casa de Oro Specific Plan

Prepared for:
County of San Diego
Planning & Development Services
5510 Overland Avenue
San Diego, CA 92123

February 28, 2020

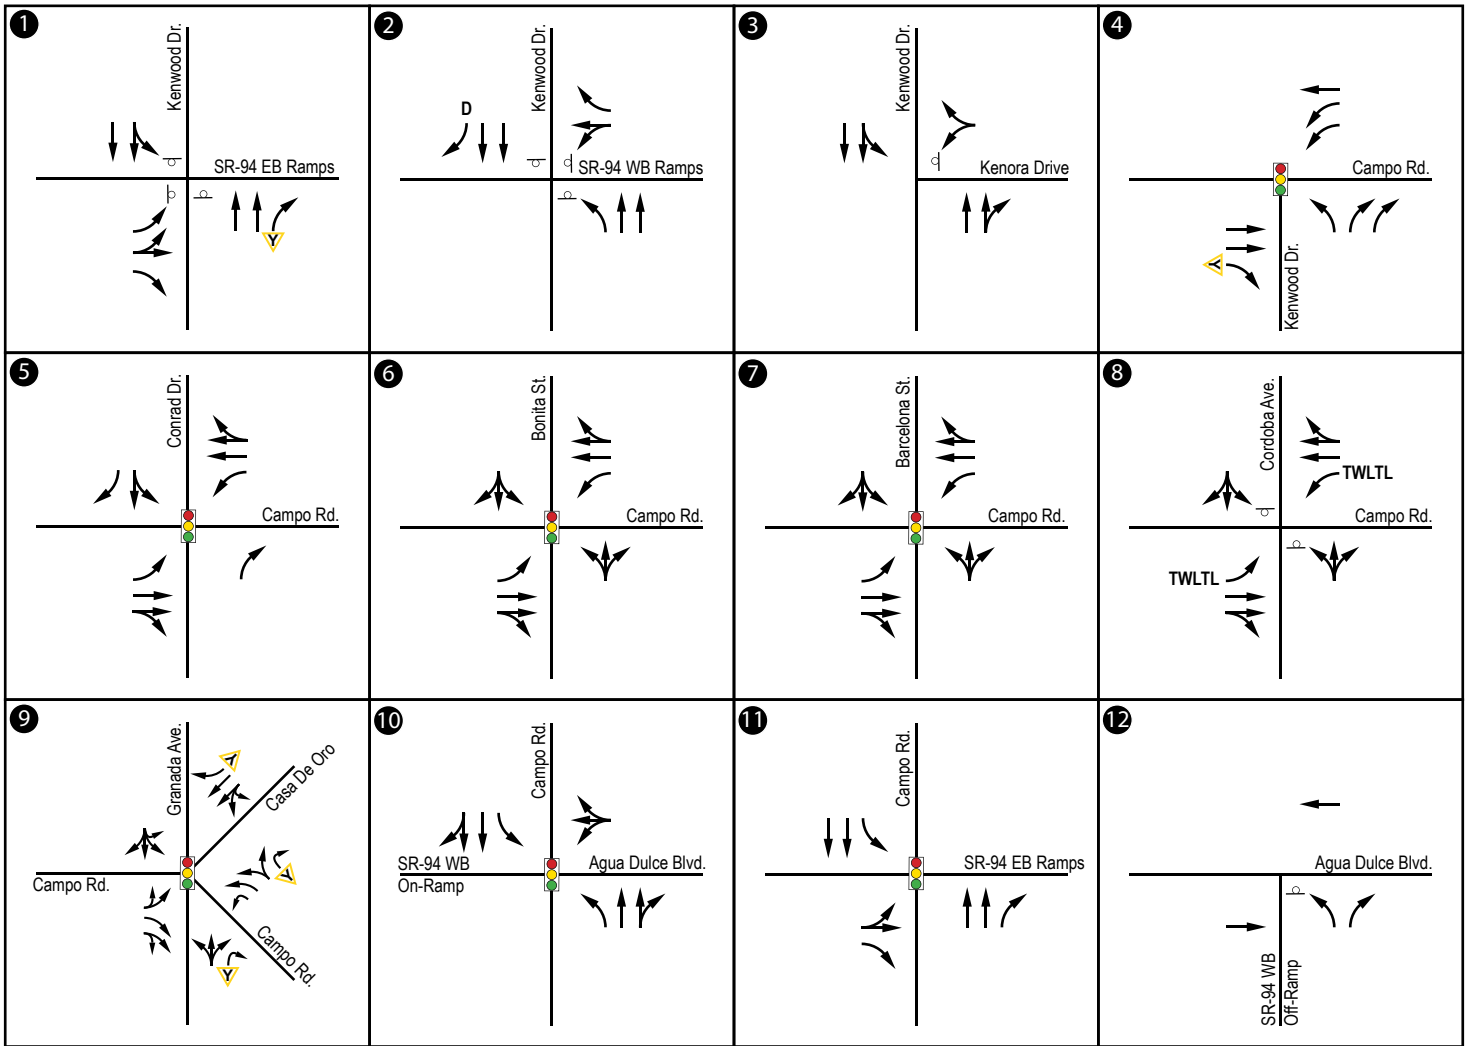
Legend

- = Signal Control Intersection
- = Stop Control Intersection
- = Yield Control Movement
- TWLTL = Two-Way-Left-Turn-Lane
- D = Defacto Turn-Lane

Lastly, the intersection of Campo Road at Granada Avenue / Casa de Oro Boulevard is a signalized 5-legged intersection. The through movement is prioritized for Campo Road (north-westbound to westbound and westbound to south-eastbound) movements. Granada Avenue and Casa de Oro Boulevard are considered minor streets and the signal is split-phased for these approaches; that is each individual minor street approach is given a protected green signal indication for all movements at that approach. While traffic flows well through the intersection, the amount of time needed to serve all movements requires a long cycle-length and this causes vehicles at the intersection to experience long average delays and a deficient level of service during the AM peak hour.

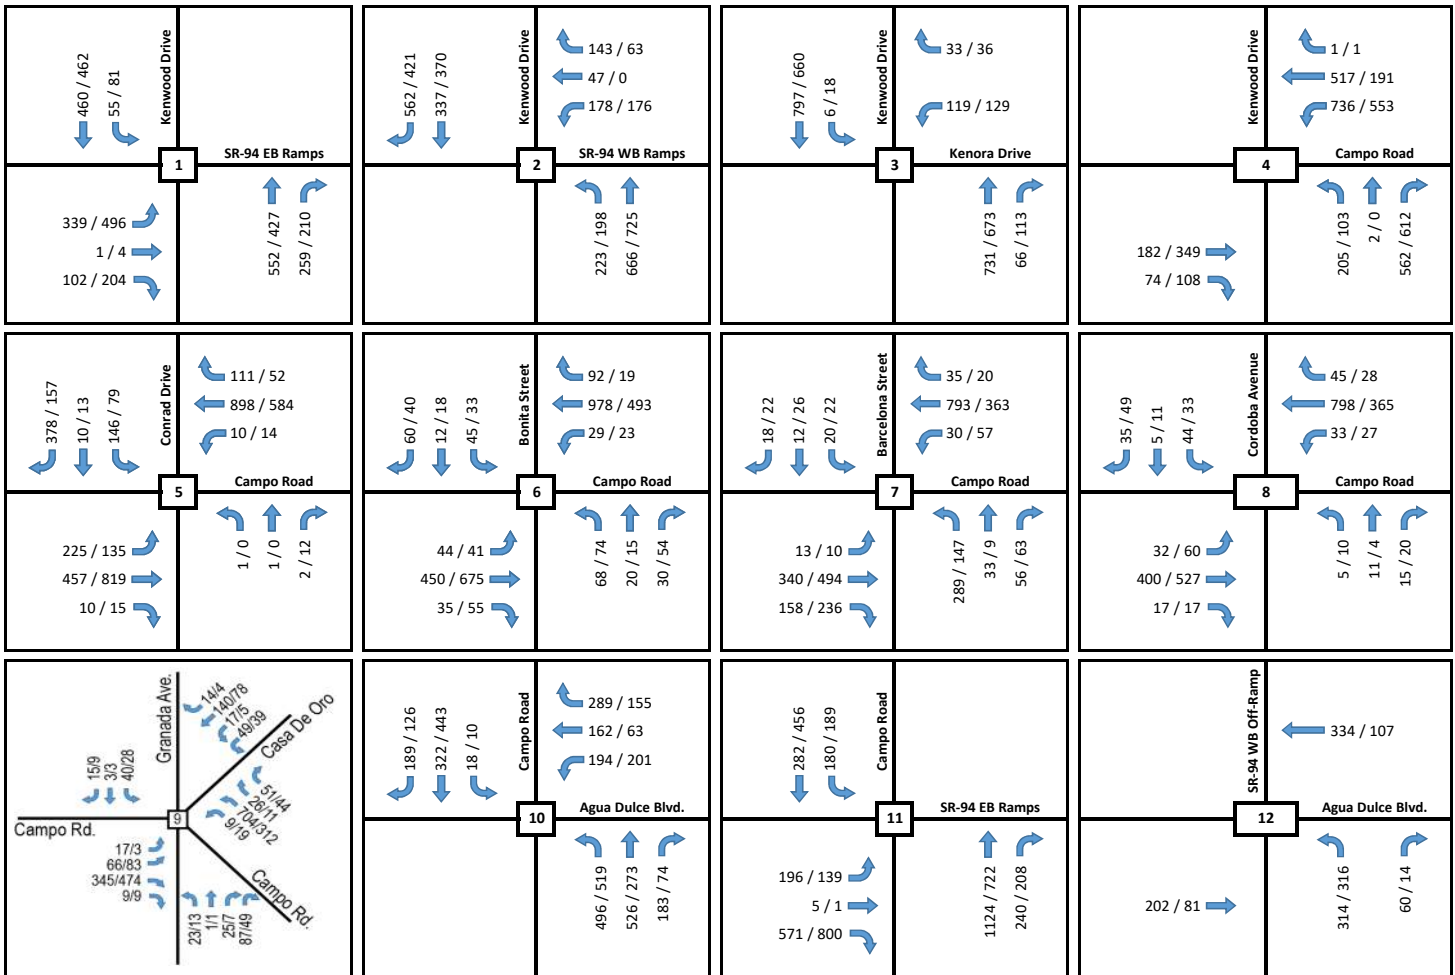
Notes: XX / XX = AM / PM Peak Hour Volumes

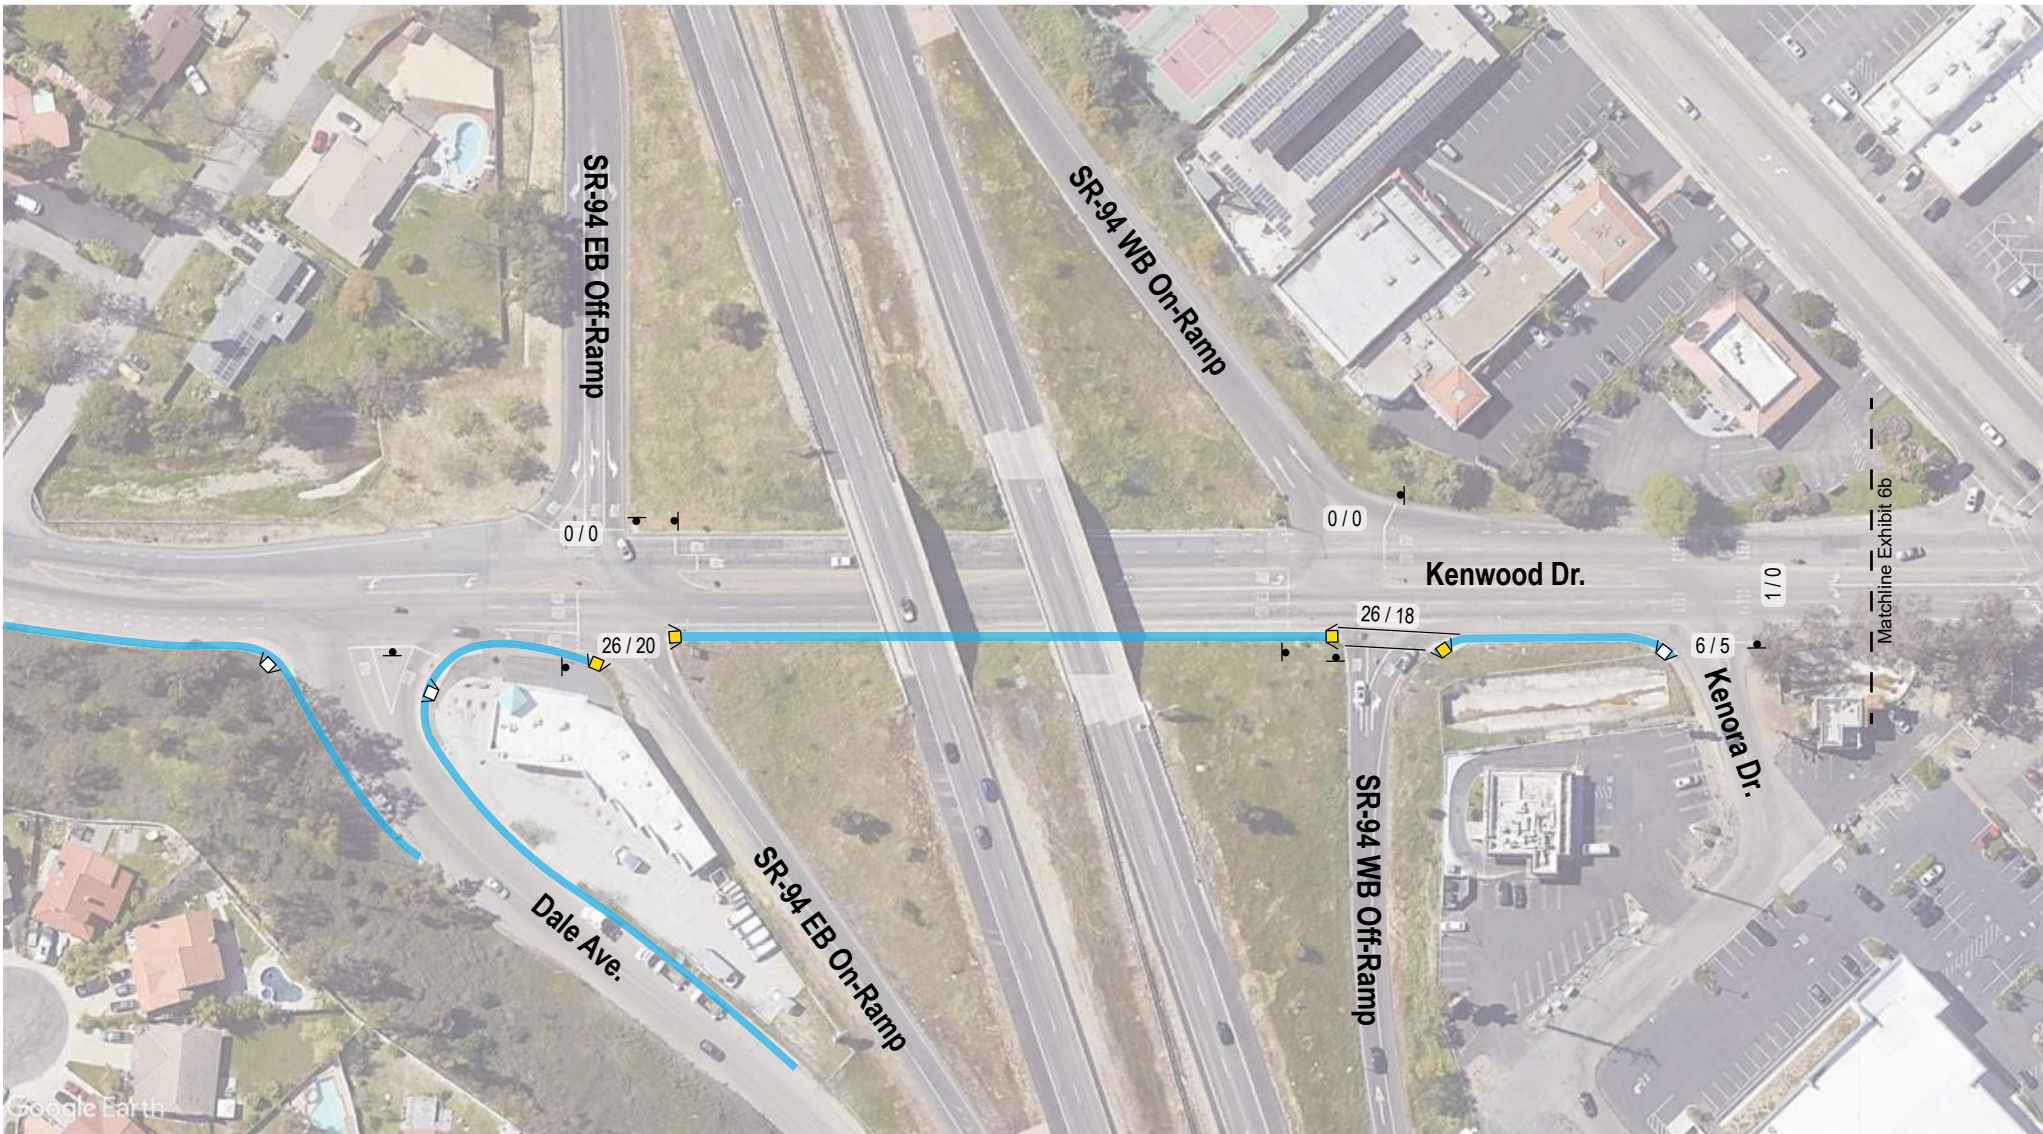
Legend

- = Existing Sidewalk
- = Ped. Ramp
- = Ped. Ramp with Truncated Domes
- = Marked Crosswalk
- = Signal Controlled Intersection
- = Stop Controlled Intersection
- = Ped. Push Button (non-ADA)
- = Ped. Push Button (ADA)
- = Ped. Signal Head
- = Ped. Signal Head with Countdown
- = AM / PM Peak Hour Ped. Volumes
- = Bus Stop

Existing peak hour pedestrian activity was recorded on Tuesday, November 12, 2019. Based on the existing counts, pedestrian activity on Campo Road during the AM peak hour peaks at the Conrad Drive westside crosswalk with 84 pedestrians crossing Campo Road. During the PM Peak hour, pedestrian activity peaks at the Kenwood Drive/ SR-94 Eastbound Ramp intersection where 20 pedestrians cross the on-ramp.

Near Spring Valley Middle School, there are two mid-block, controlled crossings with flashing beacon warnings on Conrad Drive at the north and south limits of the school. These locations are striped as continental crosswalks with pedestrian push buttons that control the overhead flashing beacons as well as ADA compliant ramps with truncated domes.

At the easterly end of the study area, there are continental crosswalks across Casa de Oro at San Juan Street as well as across Ramona Drive at Casa de Oro. These locations, however, do not have any ramps and pedestrians must step off of the curb into the street.

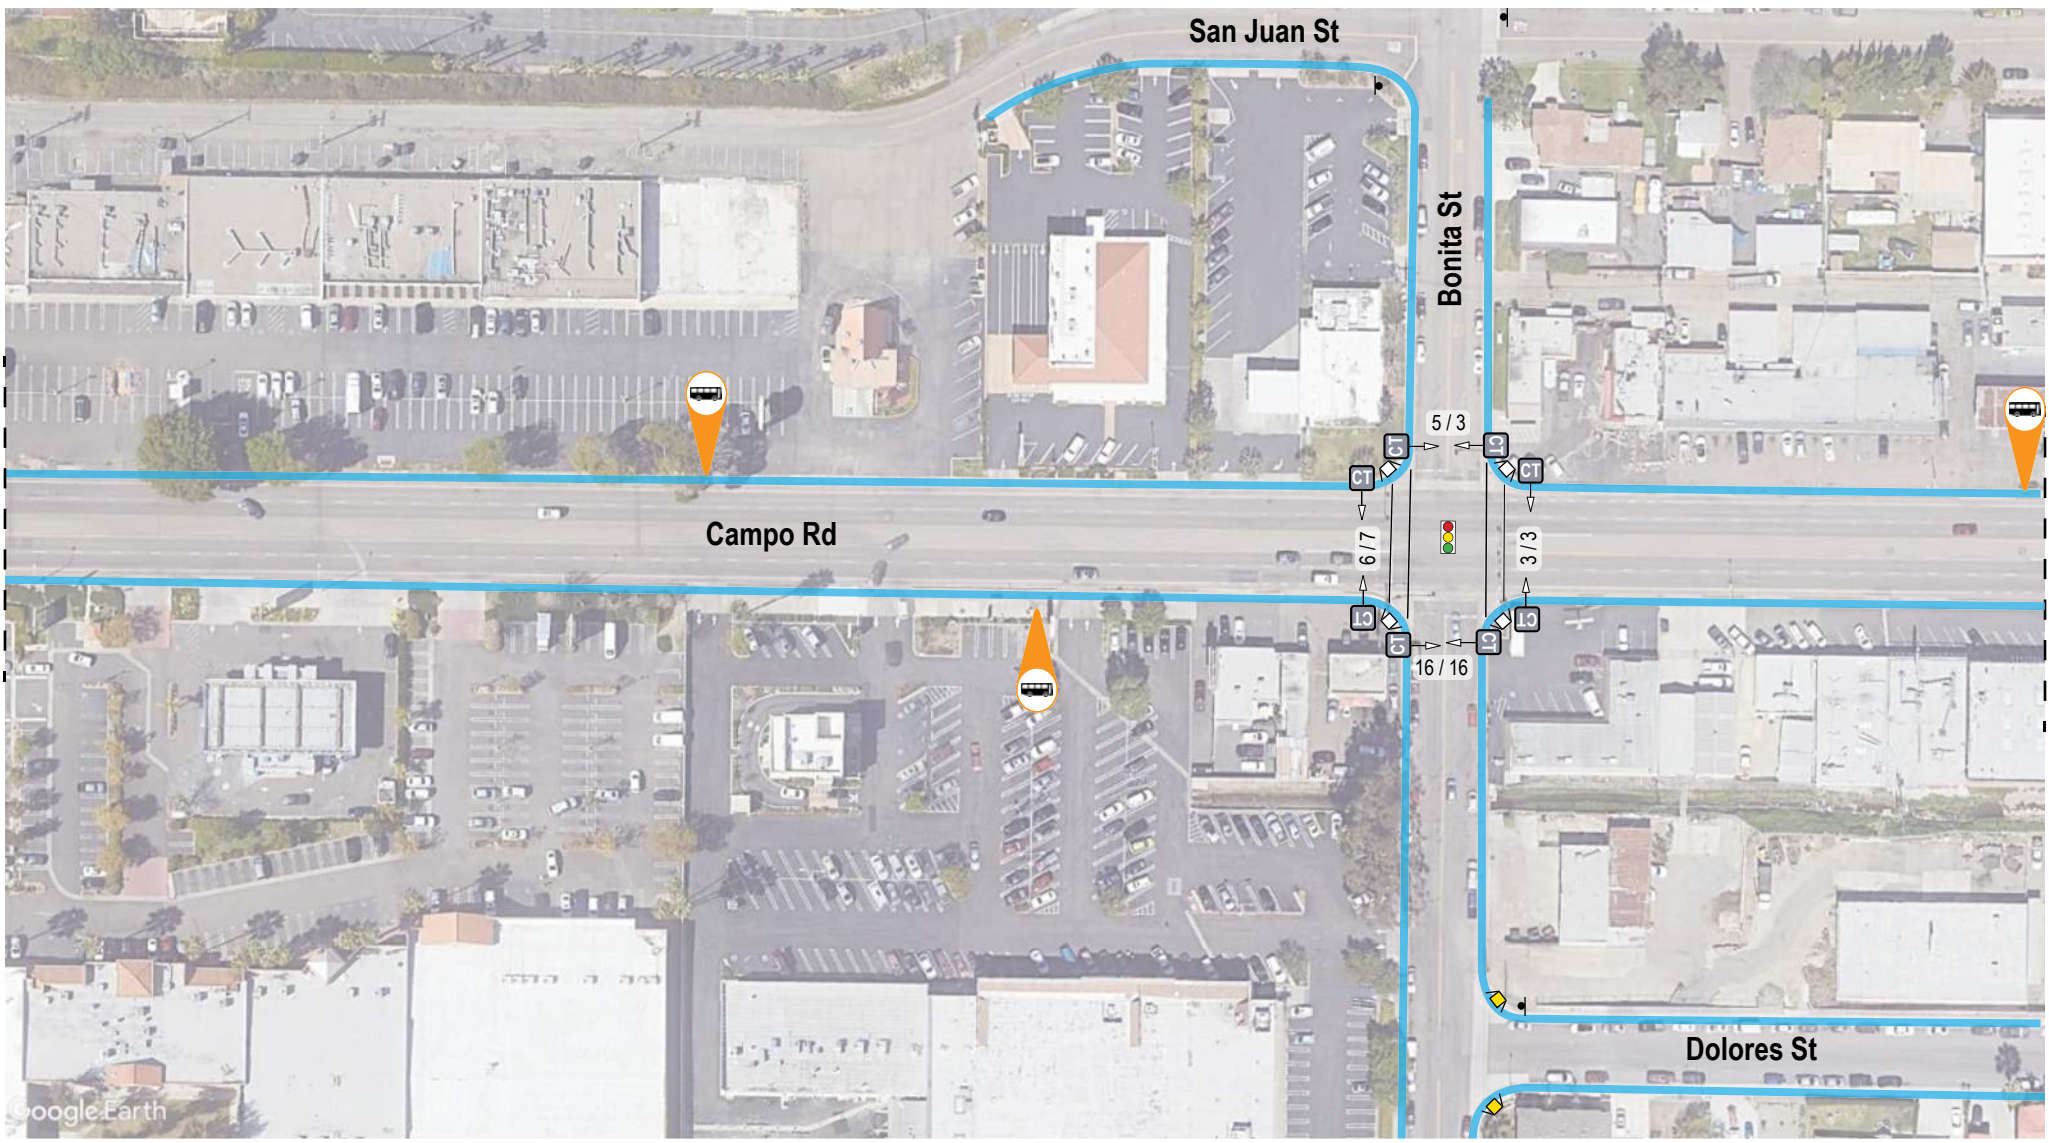
- = Existing Sidewalk
- = Ped. Ramp
- = Ped. Ramp with Truncated Domes
- = Marked Crosswalk
- = Signal Controlled Intersection
- = Stop Controlled Intersection
- = Ped. Push Button (non-ADA)
- = Ped. Push Button (ADA)
- = Ped. Signal Head
- = Ped. Signal Head with Countdown
- = AM / PM Peak Hour Ped. Volumes
- = Bus Stop

**Existing Pedestrian Facilities
& AM/PM Peak Hour Pedestrian Volumes**

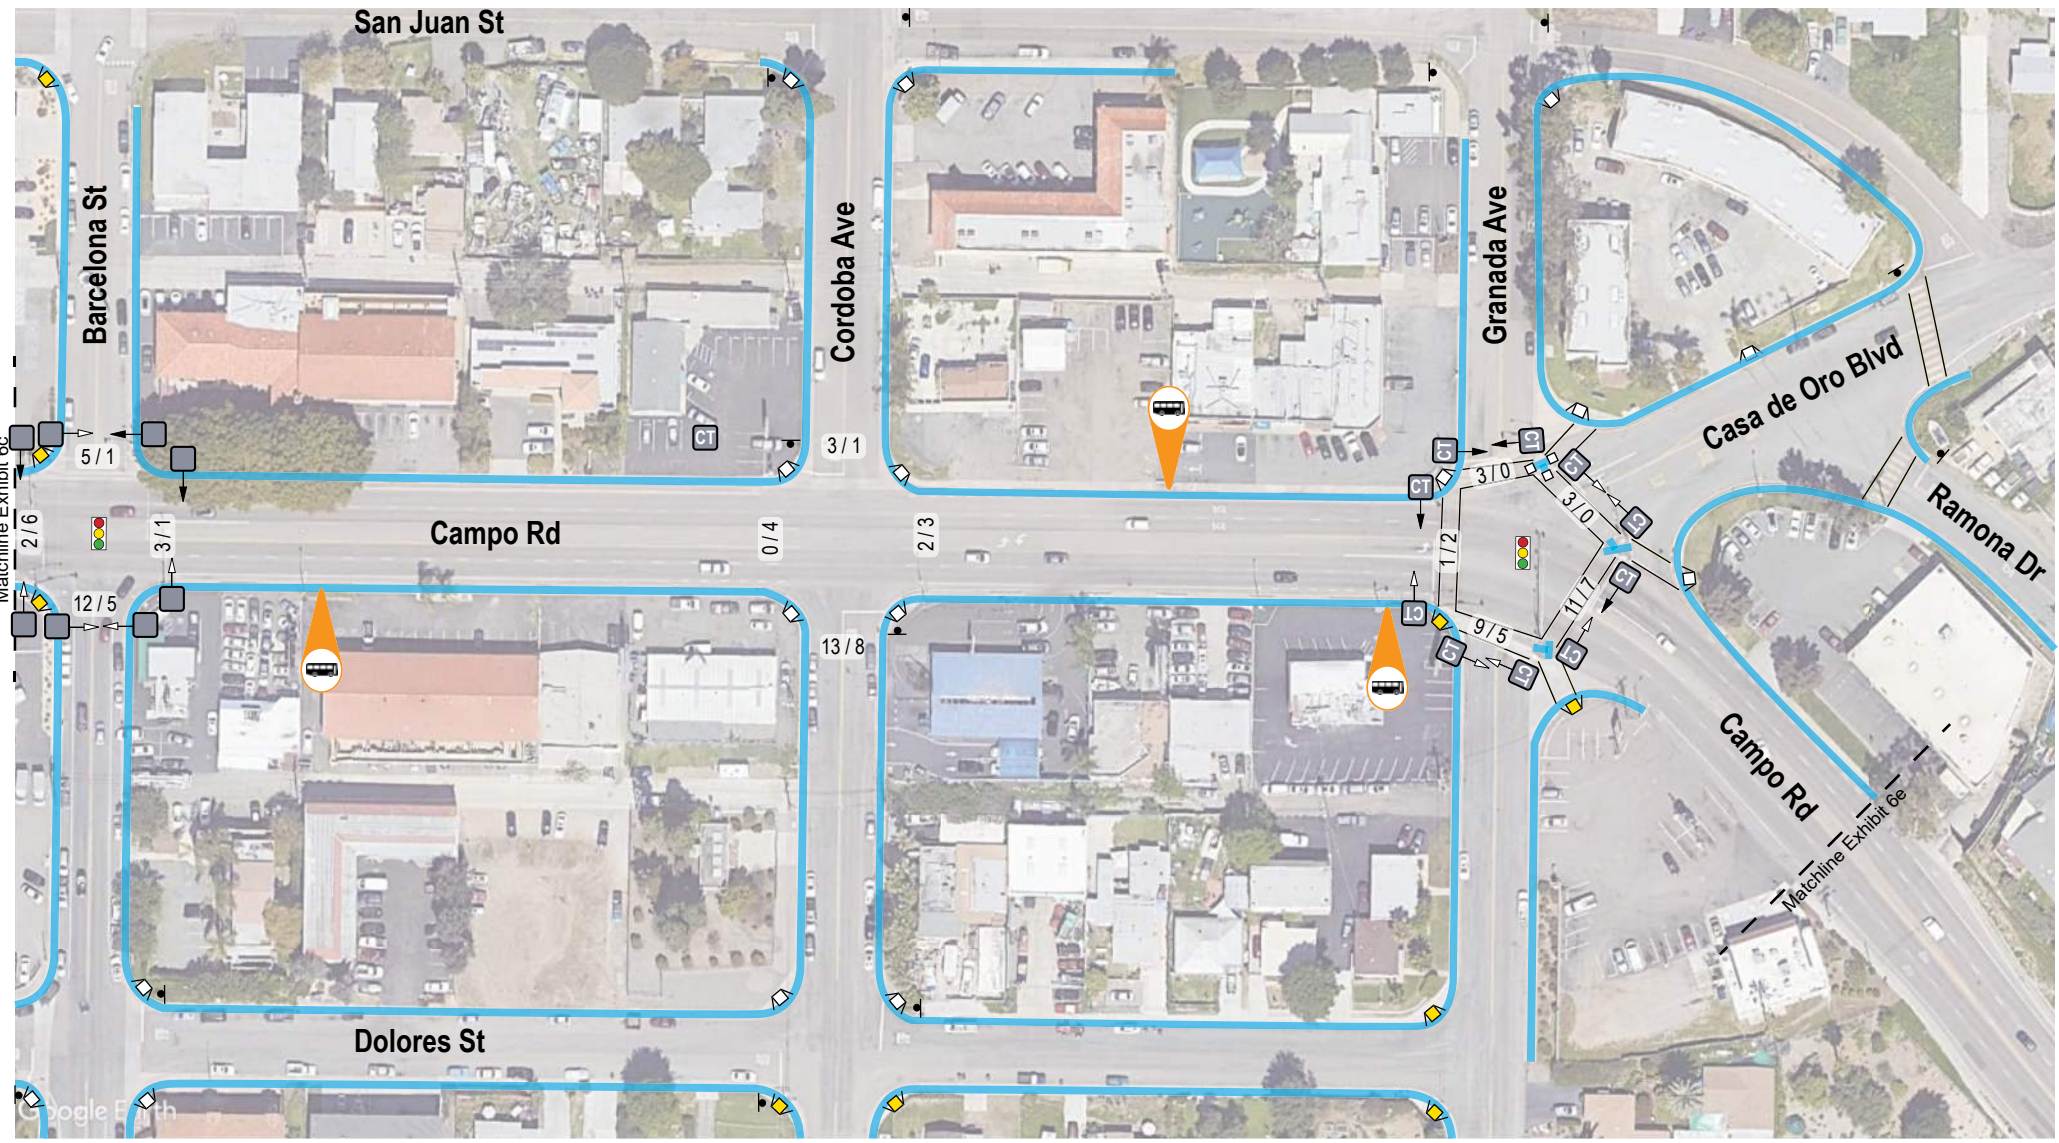
- = Existing Sidewalk
- = Ped. Ramp
- = Ped. Ramp with Truncated Domes
- = Marked Crosswalk
- = Signal Controlled Intersection
- = Stop Controlled Intersection
- = Ped. Push Button (non-ADA)
- = Ped. Push Button (ADA)
- = Ped. Signal Head
- = Ped. Signal Head with Countdown
- = AM / PM Peak Hour Ped. Volumes
- = Bus Stop

**Existing Pedestrian Facilities
& AM/PM Peak Hour Pedestrian Volumes**

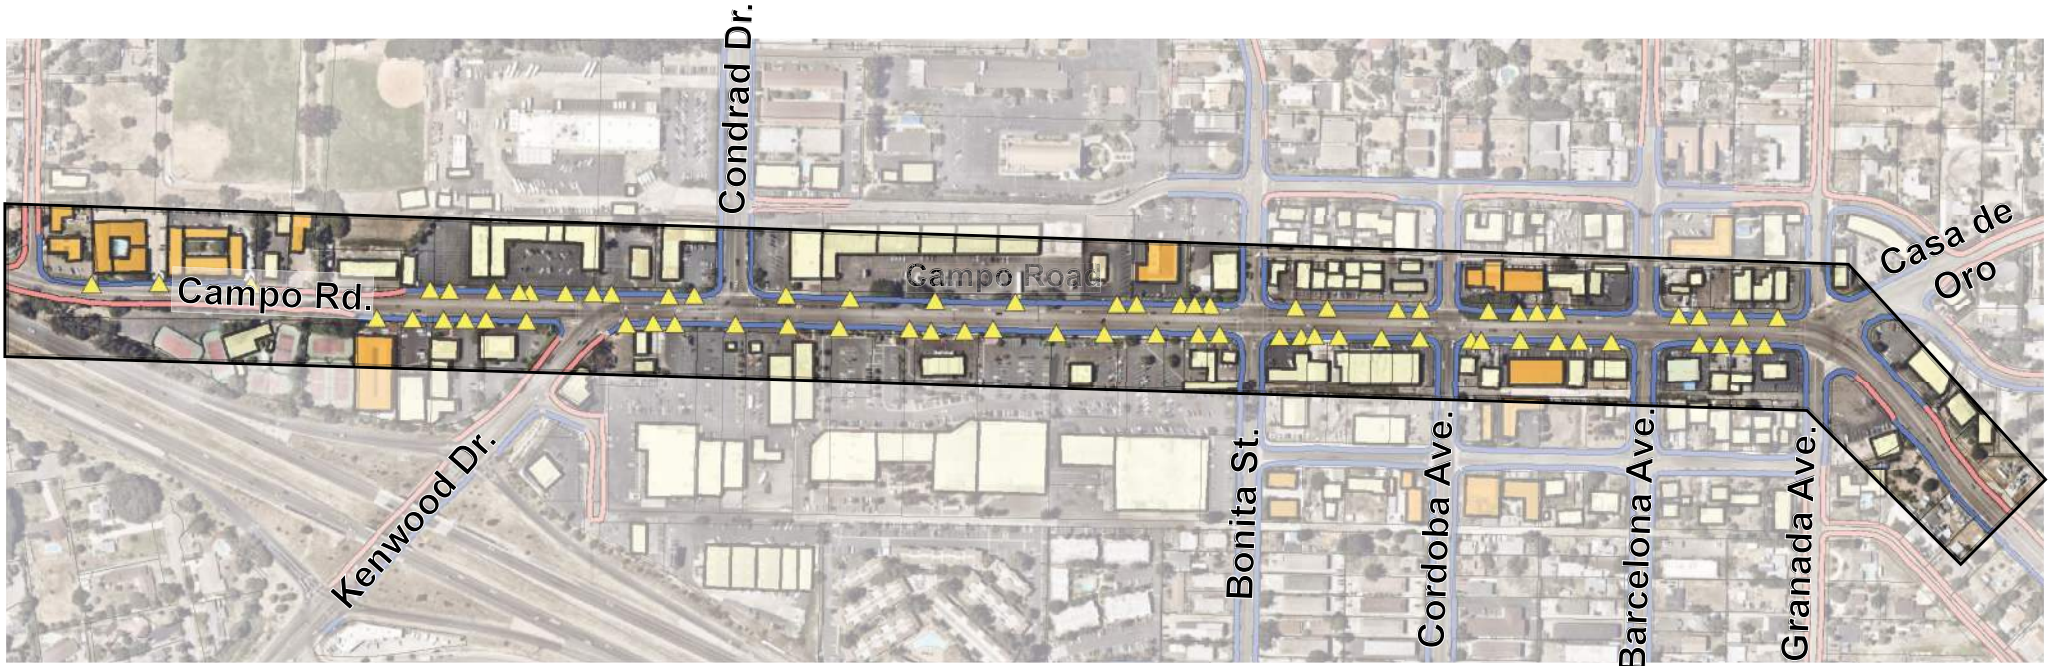
Legend

- = Existing Sidewalk
- = No Sidewalk
- ▲ = Existing Driveways

In addition to the conflict points caused by the driveways, the existing retaining walls within the shopping centers prevent pedestrian and vehicular connectivity between adjacent properties. These barriers impede access, complicate circulation, and generate additional traffic from the increased turn movements to and from Campo Road.

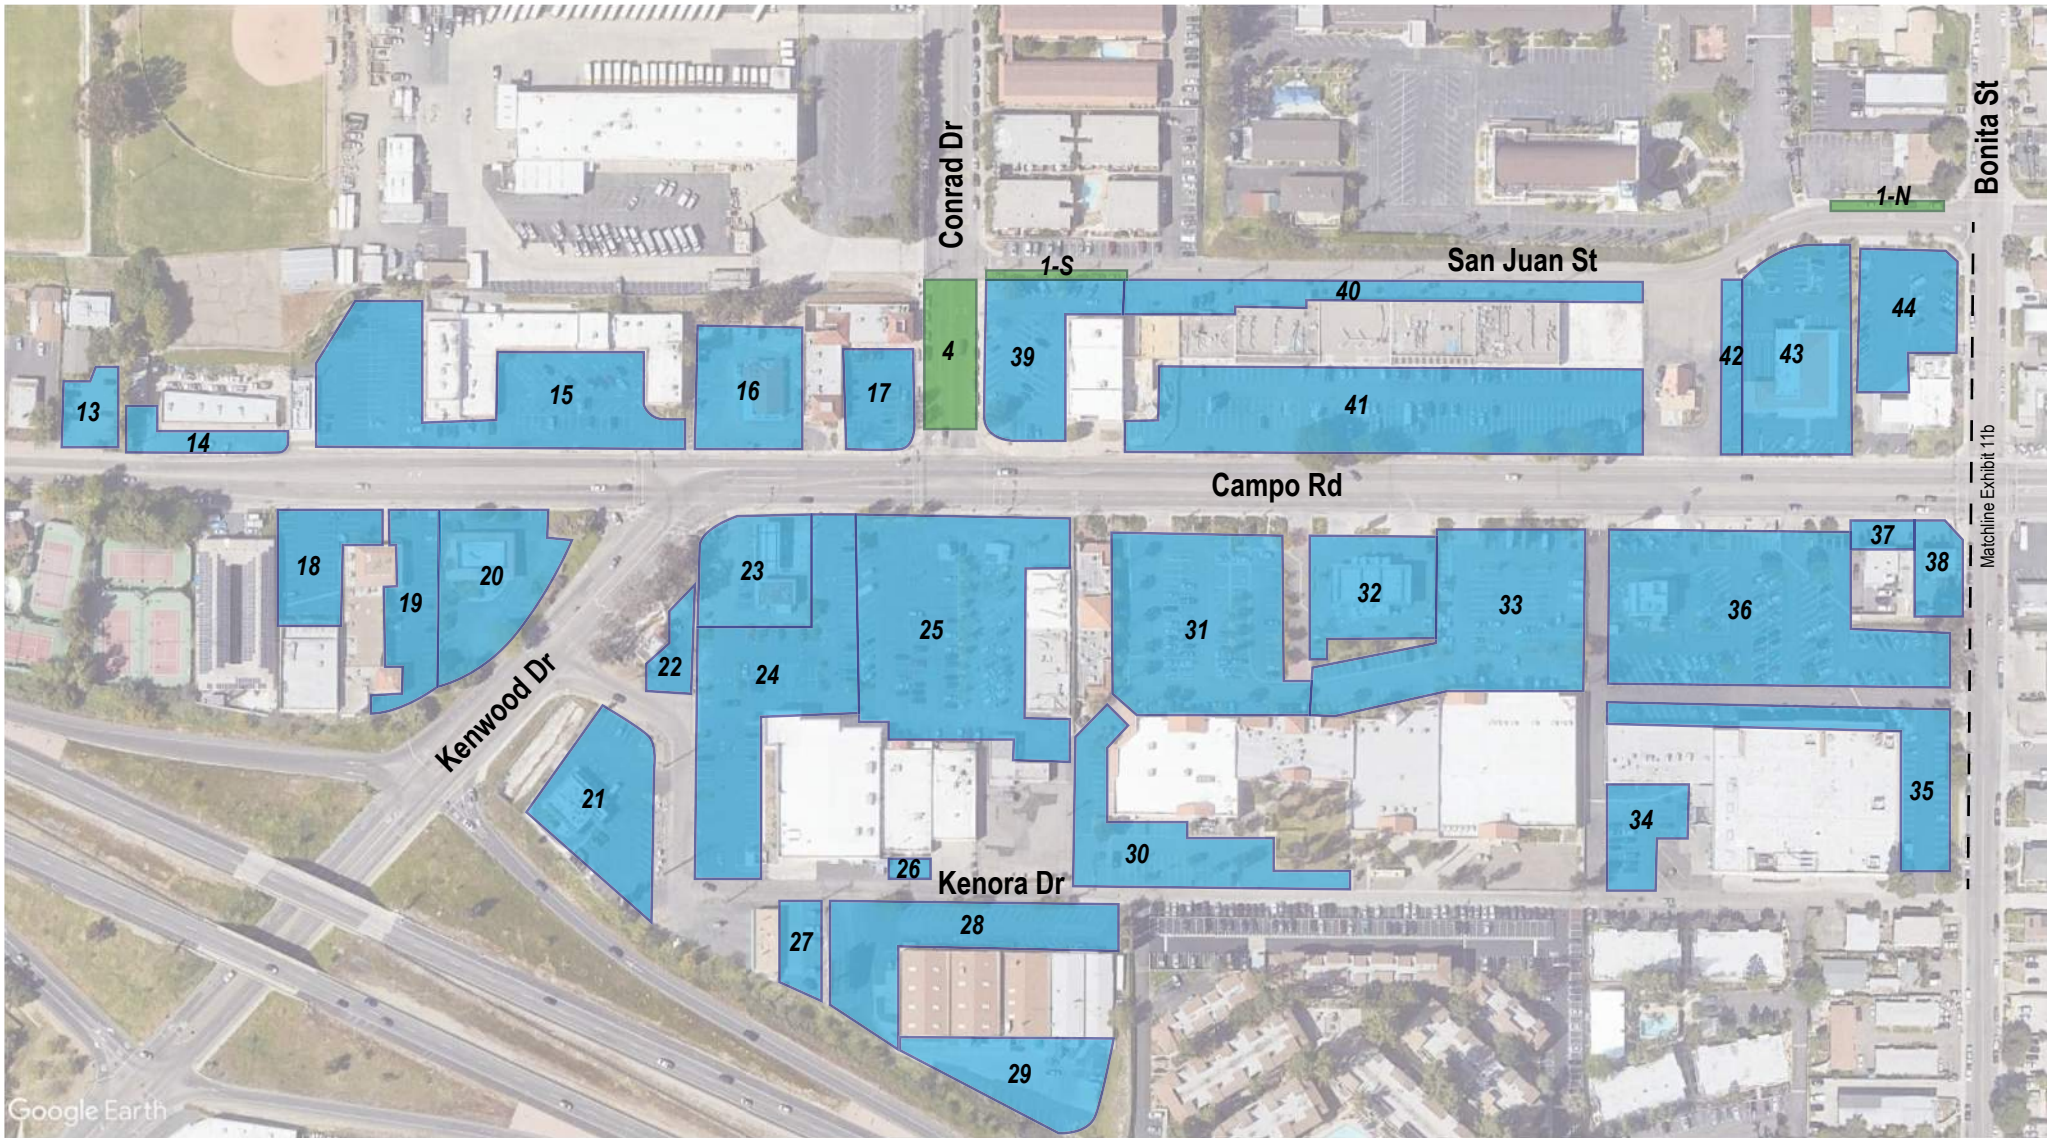
Exhibit 11a

- = On-Street Parking
- = Off-Street Parking
- ##** = Parking Zone ID

**Parking Survey Zones
Area 1**

Exhibits 11a and **11b** show the parking survey zones included in the survey. For the purposes of this study, the study area was broken up into a total of 72 parking survey zones. The general extents of the survey included 60 off-street parking lots on non-residential parcels along Campo Road between Rodgers Road and Granada Avenue / Casa de Oro Boulevard. In addition, 12 road segments with on-street parking block faces were included along both sides of the following minor streets:

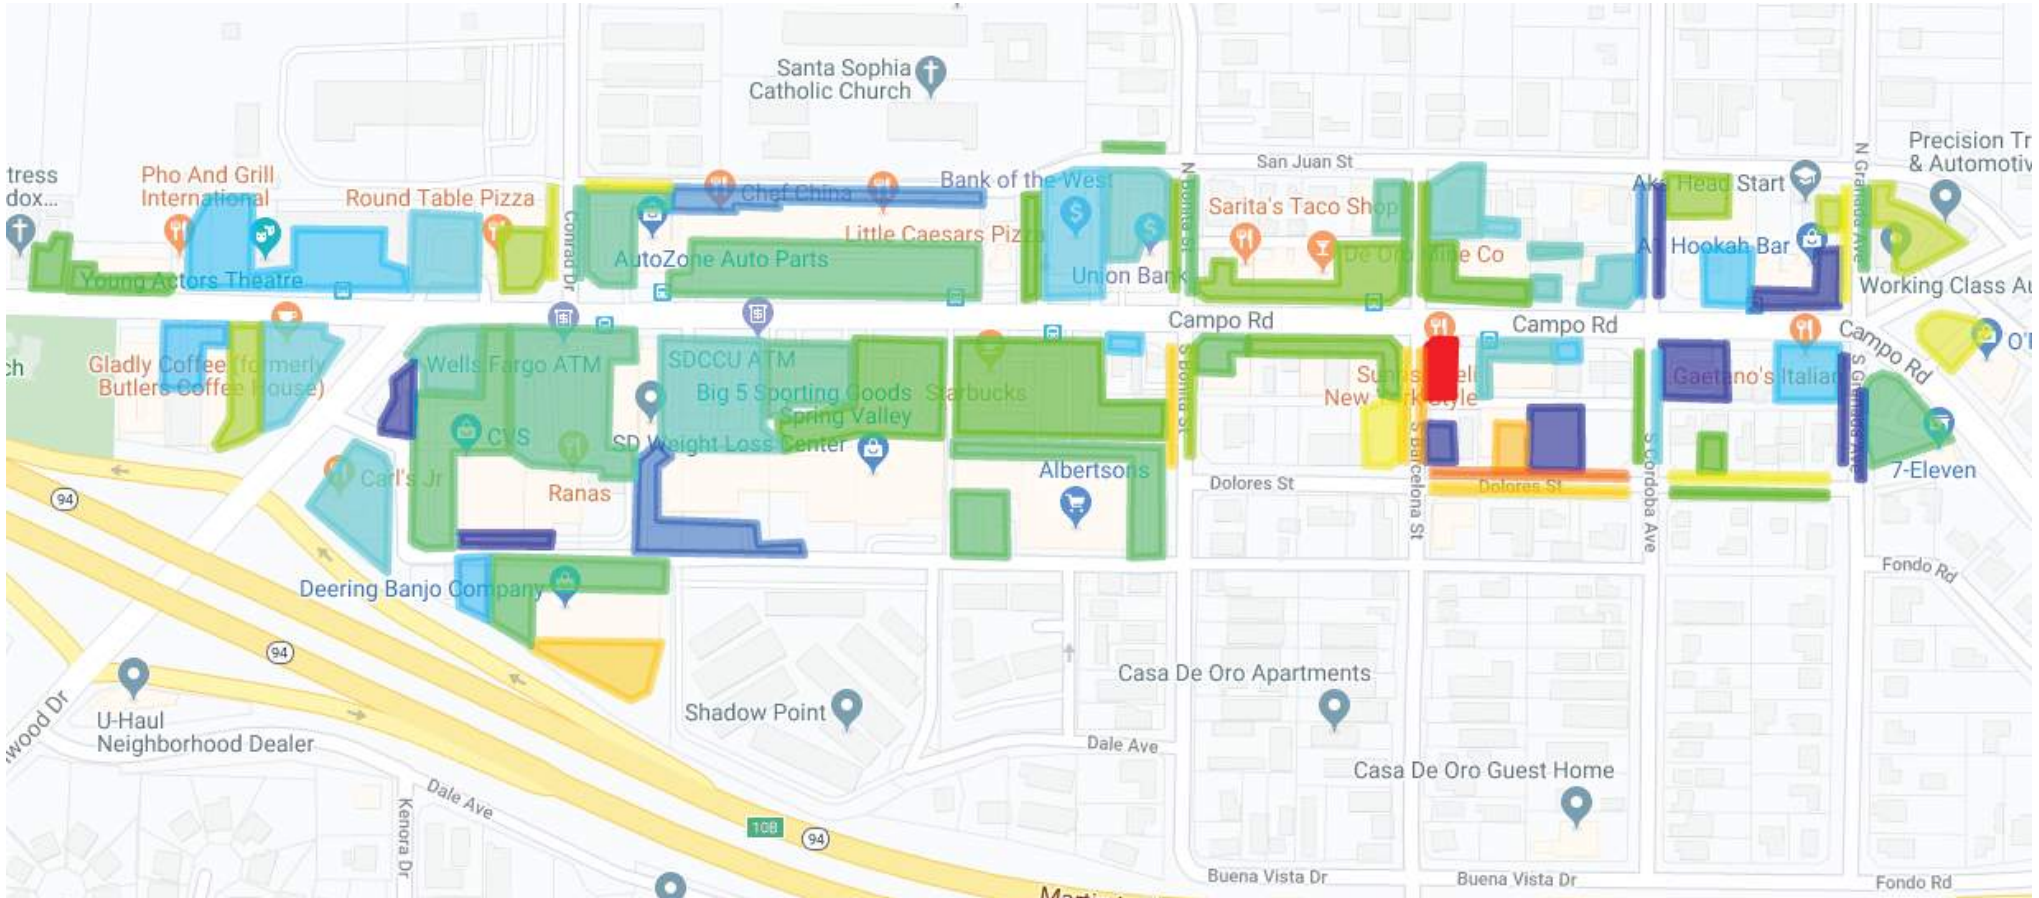
Source: National Data & Surveying Services

Based on the parking survey, the lowest combined parking demand for the study area is during the 10:00 AM hour when 35.2% of the total available spaces were utilized. The peak parking demand for the study area occurred at 2:00 PM when 102 on-street parking spaces and 798 off-street parking spaces were occupied for a total of 900 occupied spaces. This represents a combined parking utilization of 45.7%. This shows that during the peak period, less than half of the available parking spaces are occupied within the study area. The survey found that on-street parking utilization (58.3%) was higher than off-street parking utilization (44.5%)

It should be noted that the land uses which experience the highest level of occupancy are automotive repair related. That is, a high number of vehicles are temporarily stored on-site while being worked on or awaiting pick-up. In many of these areas, the utilization exceeds 100% because the vehicles are being parked in unmarked spaces.

Additionally, other parking survey zones had vehicles parked in unmarked spaces, including two car-washes. These unmarked spaces were not included in the inventory, but they were counted towards the utilization. Even so, only 7 of the 72 survey zones experienced parking utilization rate greater than 85%.
