TECHNICAL MEMORANDUM

RE: Project Management Action (PMA) No. 7: Initial Surface Water Recharge Evaluation,

Task 6: Possible Benefits to Potential Groundwater Dependent Ecosystems

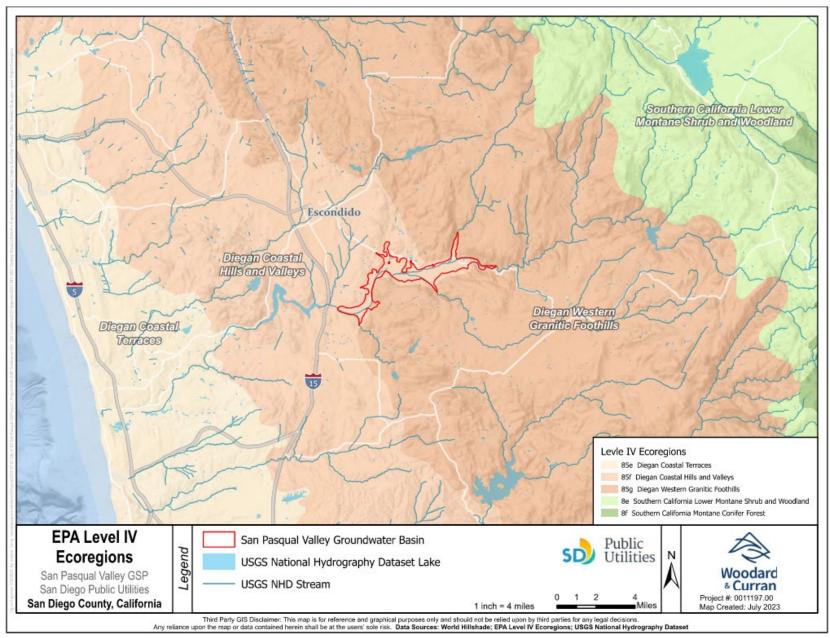
Figure 1: Basin Location in EPA Level IV Ecoregion

Much of the Basin is within the Diegan Coastal Valleys and Hills (85f) EPA Level IV ecoregion, as shown in **Figure 1**. This ecoregion is characterized by terraces and steep foothills. Numerous canyons exist along with a few wide valleys and the geology primarily consists of sedimentary and granitic rocks. Oceanic influence drives and changes the climate in this ecoregion. Soils are typically hot and dry, and the native vegetative communities include coastal scrub, chaparral, grasslands and meadows, and some small areas of coastal oak woodland. The westernmost portions of the Basin are located within the Diegan Western Granitic Foothills (85g) Level IV ecoregion. This ecoregion consists of low, somewhat steep, foothills that are part of the lower Peninsular Ranges. Valleys in the ecoregion vary in width. Marine air does not affect the climate as much as in the neighboring ecoregions to the west, however, soil temperature and moisture regimes and vegetative communities are similar.

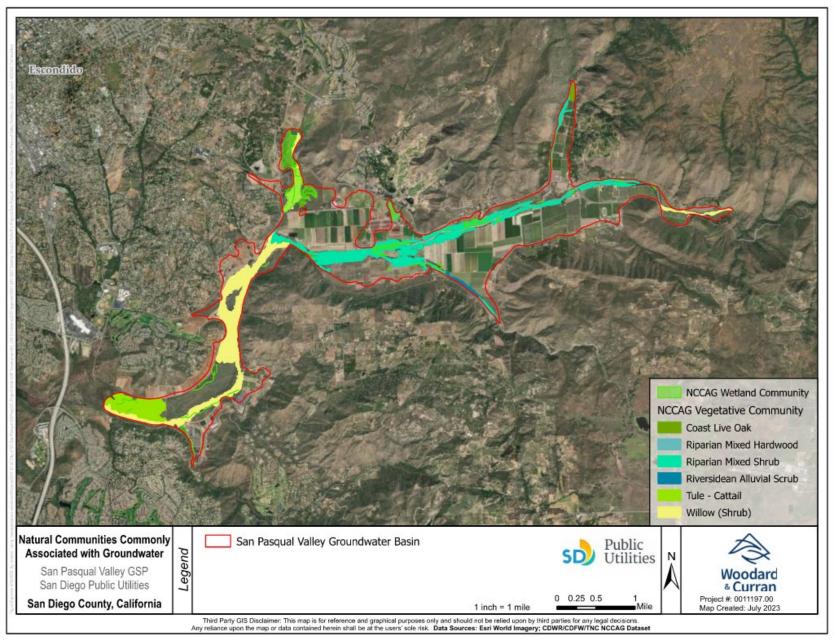
Figure 2: Potential GDEs and Potential Non-GDEs in the San Pasqual Valley Groundwater Basin

are described in **Table 1**. Potential GDEs identified in this TM are defined as mapped NCCAG community polygons with average maximum rooting depths that intersect groundwater. Potential non-GDEs identified in this TM are defined as being mapped NCCAG polygons with average maximum rooting depths that do not intersect groundwater. The average maximum rooting depths for each NCCAG-mapped community type were then compared against 10 years (2013-2022) of measured average groundwater level data for the Basin. If the average maximum rooting depth was at or below the average annual groundwater level, then the polygon was classified as a potential GDE. If the maximum rooting depth of a NCCAG community polygon was above the average annual groundwater level and did not intersect groundwater, the polygon was considered a potential non-GDE (**Figure 3**). Out of the 72 NCCAG-mapped polygons, only 14 polygons had average maximum rooting depths that intersected with the groundwater level contours, meaning groundwater depth was within the rooting zone's depth, and were therefore classified as potential GDEs. The remaining 58 NCCAG-mapped polygons with average maximum rooting depths that did not intersect groundwater were classified as potential non-GDEs.

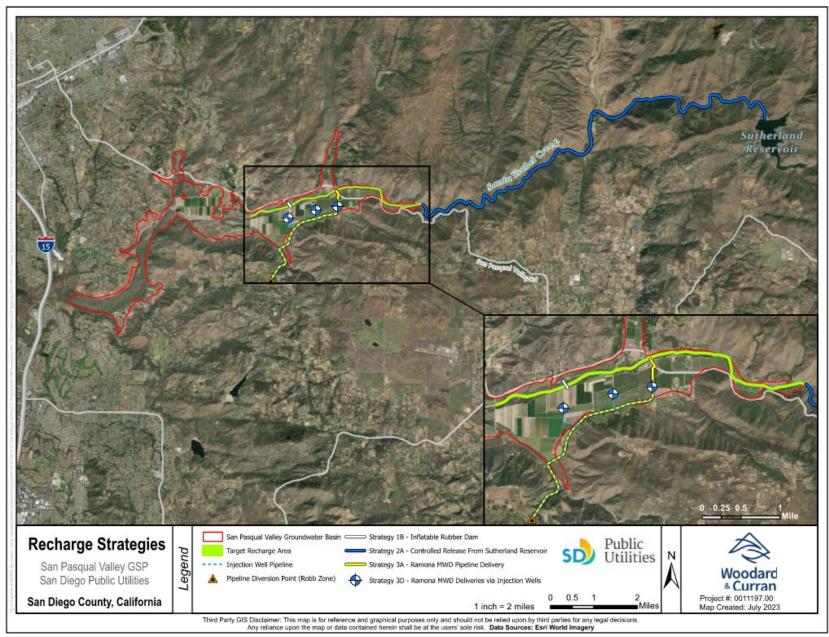
Figure 4: Location of Proposed Recharge Strategies

Strategy 1B: Enhance Streamflow Infiltration with In-stream Modifications; A permanent, channel-spanning, inflatable rubber dam across Santa Ysabel Creek will be installed. The rubber dam would be inflated during selected periods to detain stormwater and increase the opportunity for additional infiltration and groundwater recharge behind the dam and deflated when Santa Ysabel Creek is dry or during higher-streamflow periods to allow stormwater in the creek to flow past the dam. The conditions under which the dam was inflated when modeling this strategy are described in TM 5 (City, 2023c).

Strategy 2A: Augment Santa Ysabel Creek Streamflow with Sutherland Controlled Releases; Streamflow in Santa Ysabel Creek would be augmented with controlled releases from Sutherland Reservoir. The timing of recharge strategy implementation would occur based on certain conditions established in the GSP related to current groundwater levels in the target area, future predicted water availability due to precipitation and weather events, availability of water in Sutherland Reservoir, and current streamflow with Santa Ysabel Creek.

Strategy 3A: Augment Santa Ysabel Creek Streamflow with Ramona MWD Deliveries; Santa Ysabel Creek streamflow would be augmented with deliveries of raw water from Ramona MWD. Deliveries of raw water would occur upstream of River Mile 3 near the San Pasqual Valley Road bridge. This location was ultimately determined to maximize the potential for streambed infiltration by conveying water along a realistic hypothetical pipeline route from Ramona MWD's existing untreated water conveyance system to Santa Ysabel Creek and delivering the water in the eastern portion of the Basin.

Strategy 3D: Injection Wells with Ramona MWD Deliveries; Recharge water from Ramona MWD would be injected directly into the Basin aquifer through three injection wells. During the modeled Strategy 3D implementation periods, the monthly volume of water available from Ramona MWD would be conveyed to and evenly distributed across each of the three injection wells.

The updated SPV GSP Model v2.0 was used to evaluate the four recharge strategies retained from the Task 4 assessment of potential recharge strategies. The intent of the evaluation is to better understand potential benefits of the recharge strategies, should they require implementation as part of adaptive management to avoid undesirable results. Additional discussion on the four recharge strategies and considerations for implementation can be found in TM 5 (City, 2023c). The recharge strategies are shown in **Figure 4** and include:

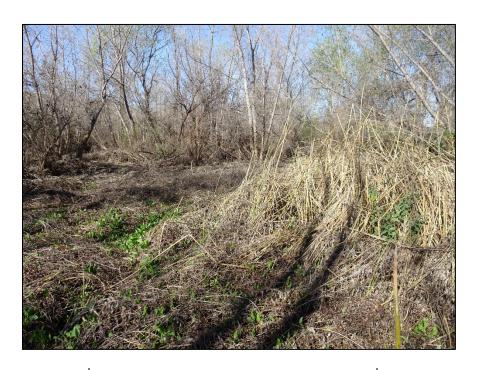
Photo Number: 1 View Direction: West Date: March 2, 2020 Description: Representative photograph taken of confirmed probable groundwater dependent ecosystem (NCCAG 2020).

Photo taken at GDE field assessment site 2.

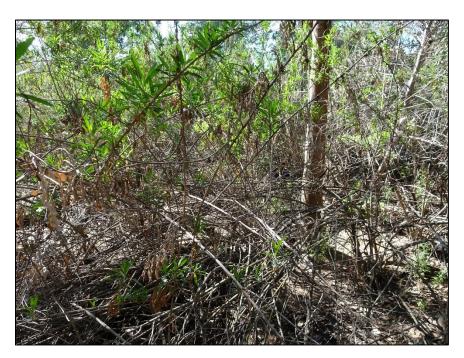
Photo Number: 2 | View Direction: South | Date: March 2, 2020 |
Description: Representative photograph taken of confirmed probable groundwater dependent ecosystem (NCCAG 2020). Photo taken at GDE field assessment site 3.

3	33.046929 N 117.042083 W	Yes	Wetland—Palustrine, scrub- shrub, forested, seasonally flooded	 Eucalyptus globulus Baccharis salicifolia Salix laevigata Eriogonum sp. Conium maculatum Carex sp. 	Site is a forested drainage with a small intermittent/ephemeral stream channel; sediment is deposited throughout the floodplain; soils are low-chroma. Multiple songbirds were observed/heard at this site. This location appears to be a GDE.		
4	33.053996 N/ 117.039712 W	Yes	Wetland - Palustrine, emergent, persistent, seasonally flooded	Salix laevigataBaccharis salicifoliaRumex crispus	Site is a dense willow thicket with little herbaceous vegetation; soils are low-chroma with some organic content. This location appears to be a GDE.		
5	33.069208N/ 117.031547W	Yes	Vegetation—Willow (Shrub)	 Salix lasiolepis Salix laevigata Urtica dioica Typha domingensis Schoenoplectus californicus 	Site is a riparian willow thicket. Soils are saturated at the surface by what appears to be groundwater; high organic content observed. Surface water, drainage patterns, drift deposits, and iron-oxidizing bacteria observed. This location appears to be a GDE.

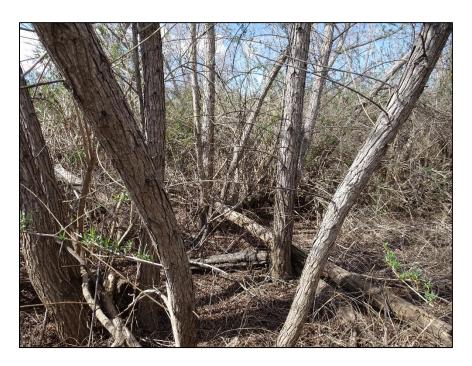
Photo Number: 3 View Direction: West Date: October 23, 2018

Description: Representative photograph taken of confirmed probable groundwater dependent ecosystem (NCCAG 2020).

Photo taken at GDE field assessment site 4.

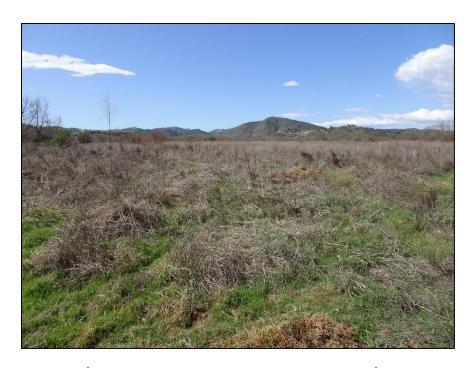
Photo Number: 4 View Direction: West Date: March 2, 2020 Description: Representative photograph taken of potential incorrectly mapped groundwater dependent ecosystem (NCCAG 2020). Photo taken GDE field assessment site 1.

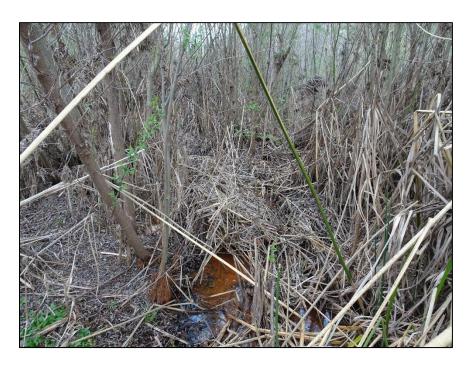
Photo Number: 5 View Direction: North Date: March 2, 2020 Description: Representative photograph taken of confirmed probable groundwater dependent ecosystem (NCCAG 2020).

Photo taken GDE field assessment site 5.

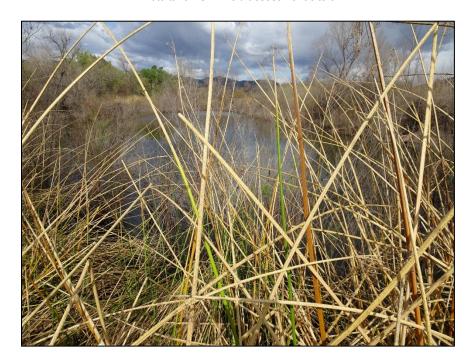
Photo Number: 6 View Direction: North Date: March 2, 2020 Description: Representative photograph taken of unmapped potential groundwater dependent ecosystem (NCCAG 2020). Photo taken at GDE field assessment site 6.

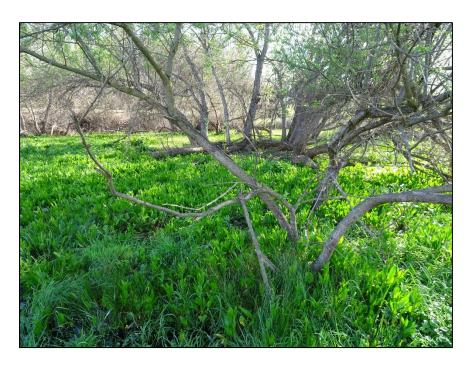
Photo Number: 7 View Direction: South Date: March 2, 2020 Description: Representative photograph taken of confirmed probable groundwater dependent ecosystem (NCCAG 2020).

Photo taken at GDE field assessment site 10.

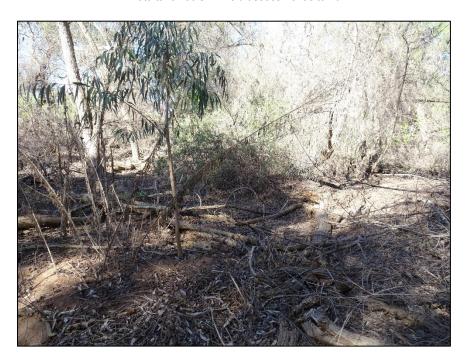
Photo Number: 8 View Direction: West Date: March 3, 2020

Description: Representative photograph taken of confirmed wetland and riparian vegetation .

Photo taken at GDE field assessment site 11.

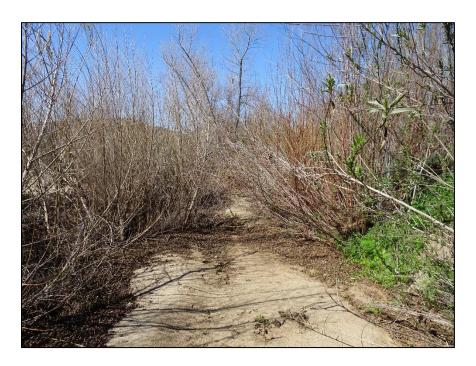
Photo Number: 9 View Direction: West Date: March 3, 2020

Description: Representative photograph taken of confirmed wetland and riparian vegetation.

Photo taken at GDE field assessment site 12.

12	33.083919 N/ 116.995362 W	Yes	Vegetation—Riparian mixed shrub Wetland—Palustrine, emergent, persistent, seasonally flooded	 Tamarisk ramosissima Salix lasiolepis Baccharis salicifolia Arundo donax Xanthium strumarium Conium maculatum Madia exigua 	Site is a dry creek bed and adjacent riparian zone. Some vegetated mid-channel bars are present. No evidence of recent flow. Soils are very dry, friable sands. Butterflies and a lizard were observed. This location appears to be a wetland/riparian community, but not a GDE.

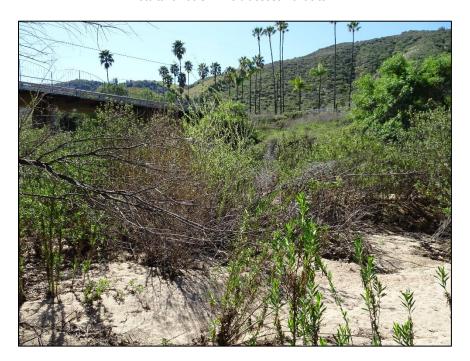
Photo Number: 10 View Direction: South Date: March 3, 2020

Description: Representative photograph taken of confirmed wetland and riparian vegetation.

Photo taken at GDE field assessment site 13.

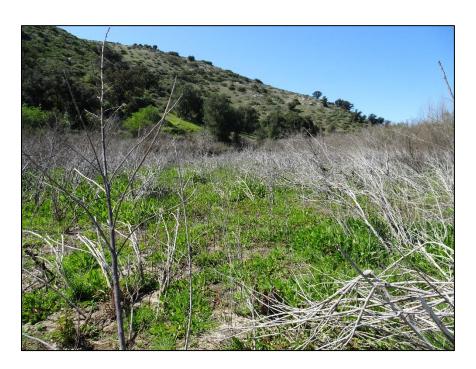
Photo Number: 11 View Direction: West Date: March 3, 2020 Description: Representative photograph taken of confirmed probable groundwater dependent ecosystem (NCCAG 2020).

Photo taken at GDE field assessment site 7.

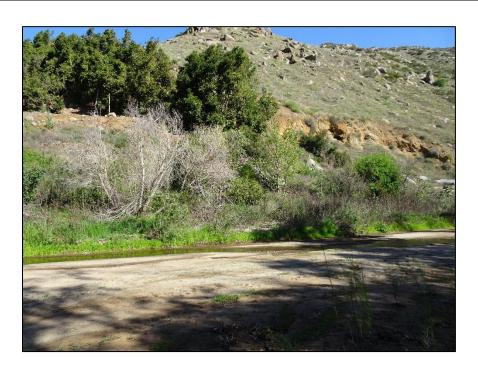
Photo Number: 13 View Direction: North Date: March 4, 2020

Description: Representative photograph taken of confirmed wetland and riparian vegetation.

Photo taken at GDE field assessment site 16.

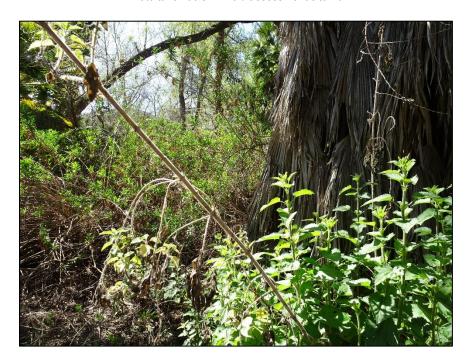
Photo Number: 14 | View Direction: South | Date: March 4, 2020 |
Description: Representative photograph taken of confirmed probable groundwater dependent ecosystem (NCCAG 2020). |
Photo taken at GDE field assessment site 8.

8	33.091726 N 117.019165 W	Yes	Vegetation—Willow (shrub) Wetland—Palustrine, forested, seasonally flooded	 Washingtonia filifera Salix laevigata Baccharis salicifolia Urtica dioica Anemopsis californica 	Site is a forested floodplain with a dense understory. Soils are low-chroma through the profile with some organic content. Multiple songbirds heard/observed as well as small mammal. This location appears to be a GDE.		
9	33.093791 N/ 117.016029 W	Yes	Wetland—Palustrine, forested, seasonally flooded	 Salix laevigata Baccharis salicifolia Urtica dioica Schoenoplectus californicus 	Site is an inundated pond/basin with thick scrub-shrub wetland vegetation surrounding and extending into deeper, open water areas. Significant waterfowl and other songbirds heard/observed. This location appears to be a GDE.

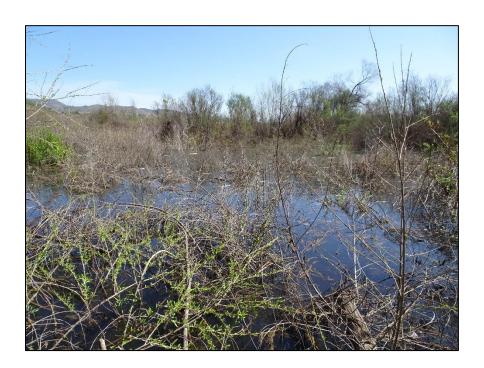
Photo Number: 15 View Direction: West Date: March 4, 2020 Description: Representative photograph taken of confirmed probable groundwater dependent ecosystem (NCCAG 2020).

Photo taken at GDE field assessment site 9.
