**PHASE I ENVIRONMENTAL SITE ASSESSMENT  
PROPOSED BRADLEY COURT SKILLED CARE NURSING FACILITY  
675 EAST BRADLEY AVENUE  
EL CAJON, SAN DIEGO COUNTY, CALIFORNIA 92021  
APN 165-430-30-00**

**W.O. E8096-SC      JUNE 9, 2021**

Subject: Phase I Environmental Site Assessment Proposed Bradley Court Skilled Care Nursing Facility, 675 East Bradley Avenue, El Cajon, San Diego County, California 92021 APN 165-430-30-00

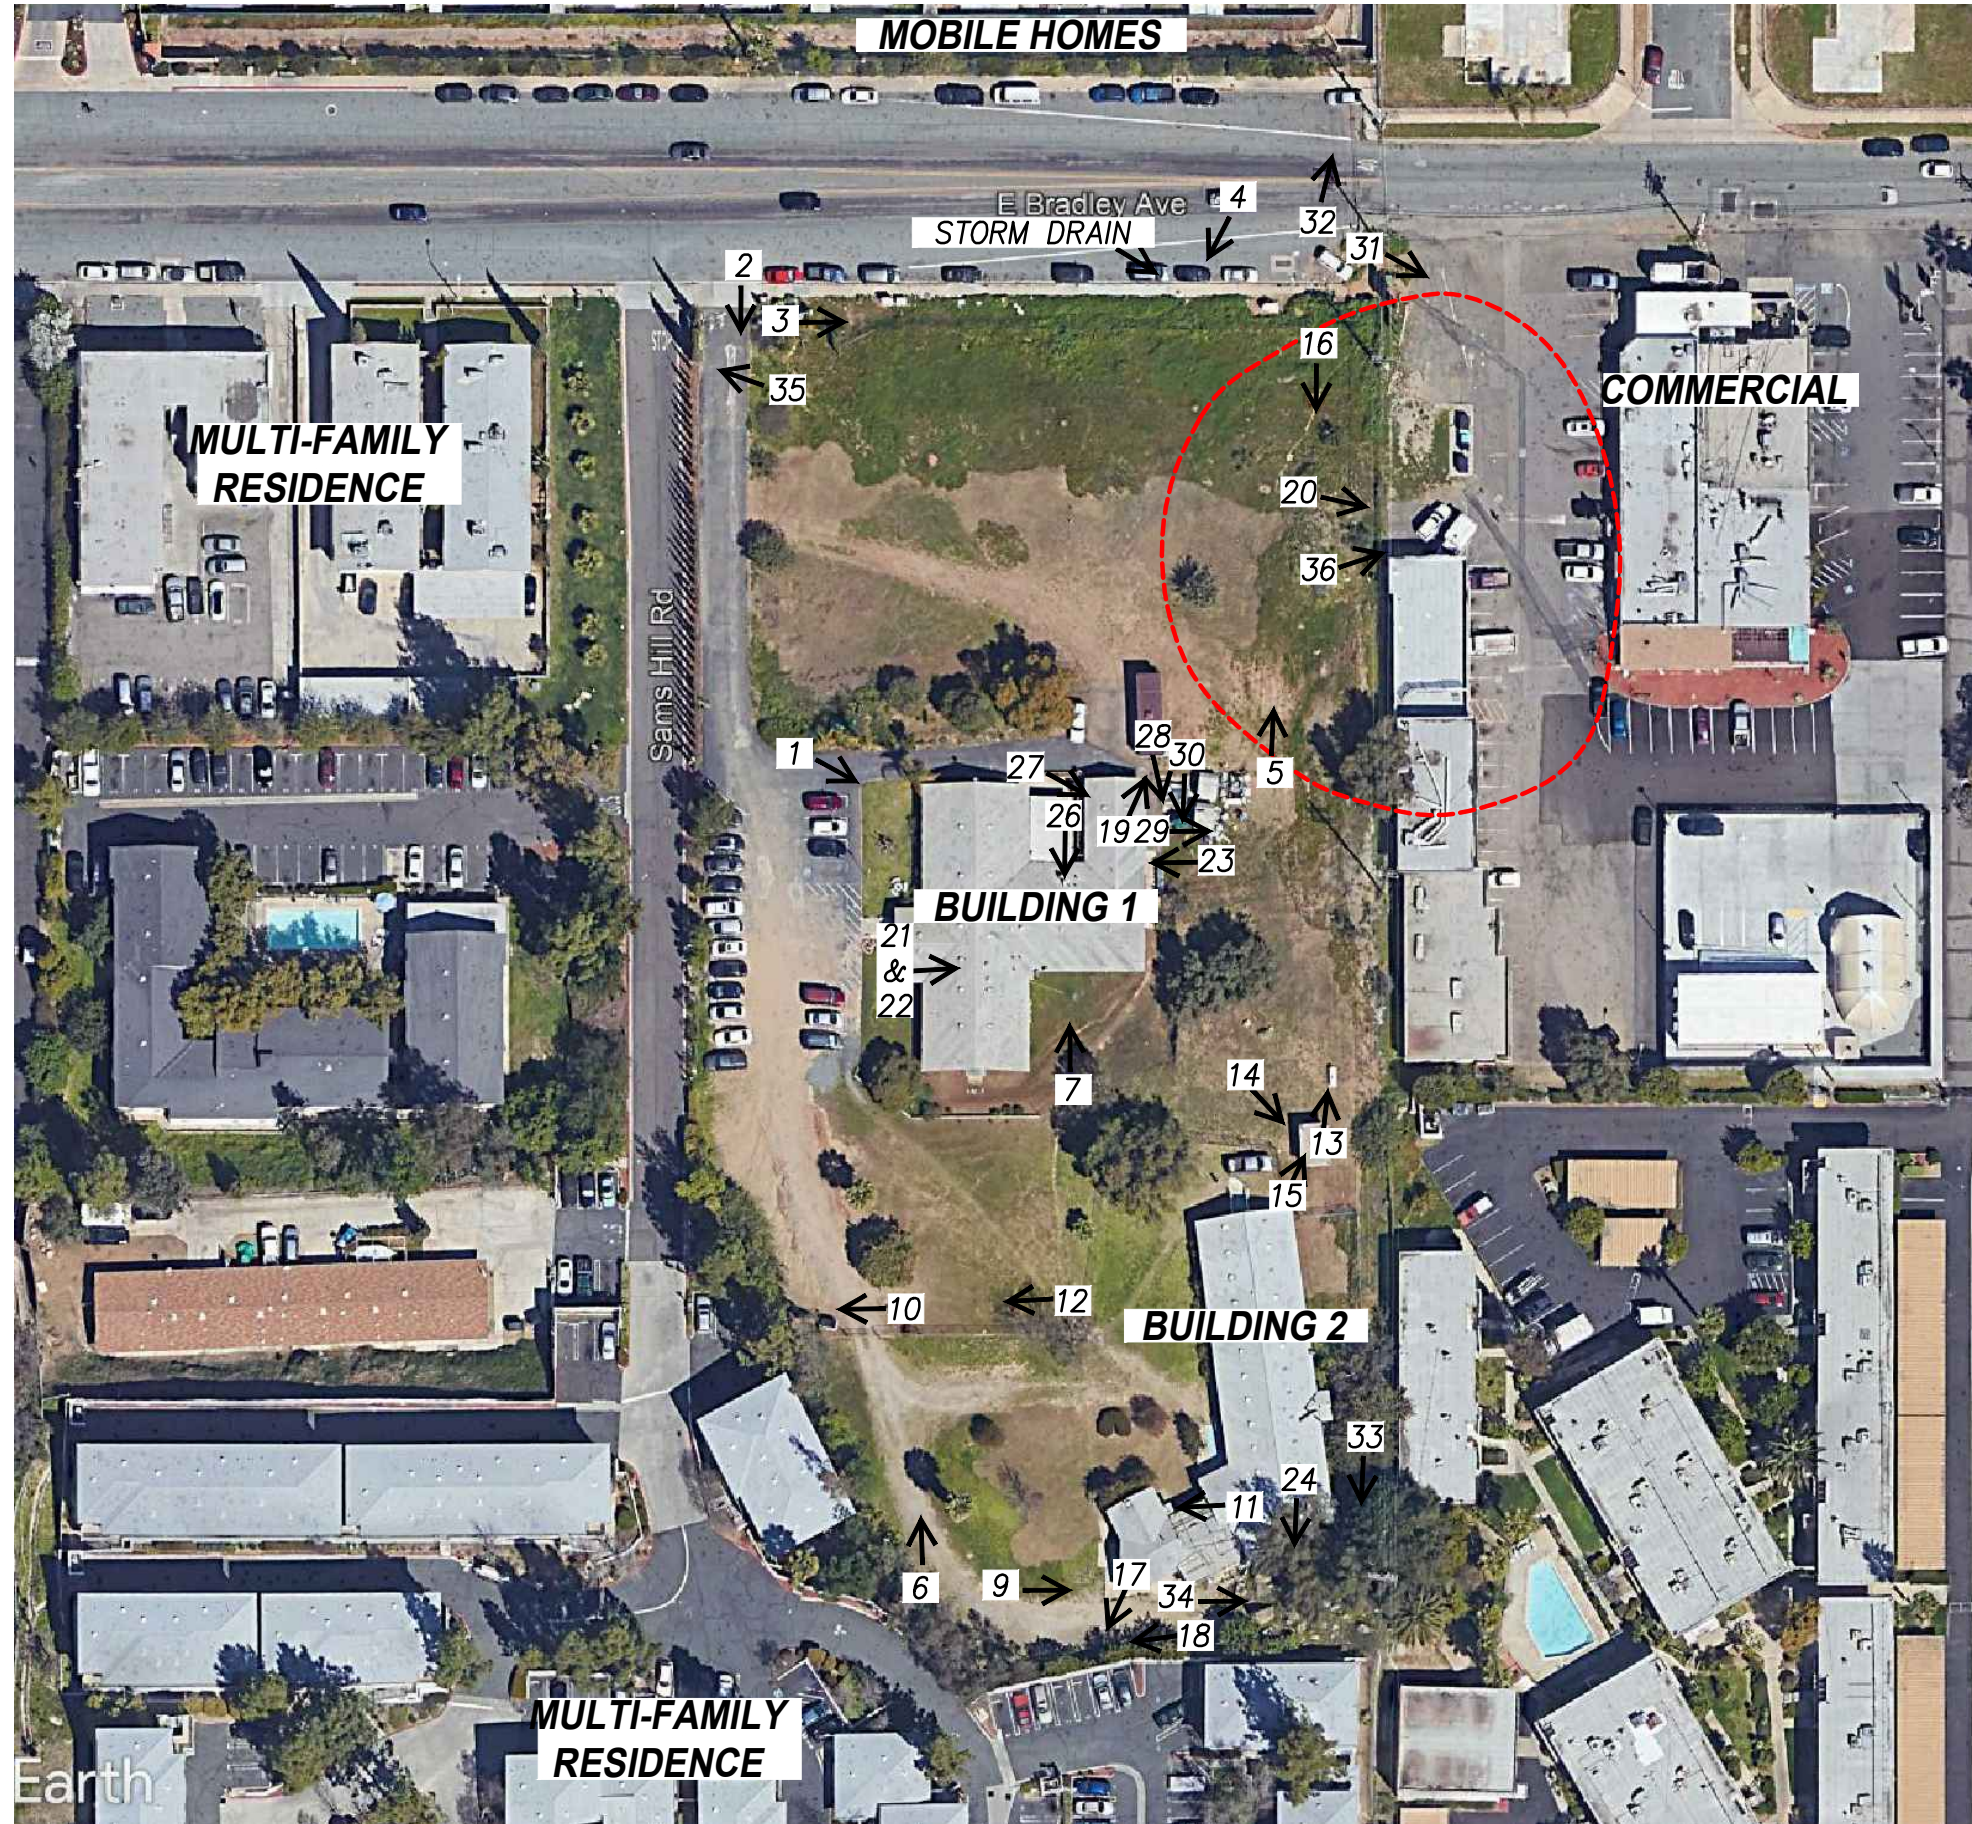
On April 28, 2021, a GSI representative visited the subject site to assess current utilization and observe for signs of possible contamination, which included walking the site and remote sensing the surrounding properties from the subject site and public thoroughfares. Features observed during the site reconnaissance are described below and illustrated on the Site Map (see Figure 2) which uses a Google Earth image as a base. Photographs of the subject site are presented in Appendix B, and on the CD data disc. The photograph locations and viewpoints are also indicated on Figure 2 (Site Map).

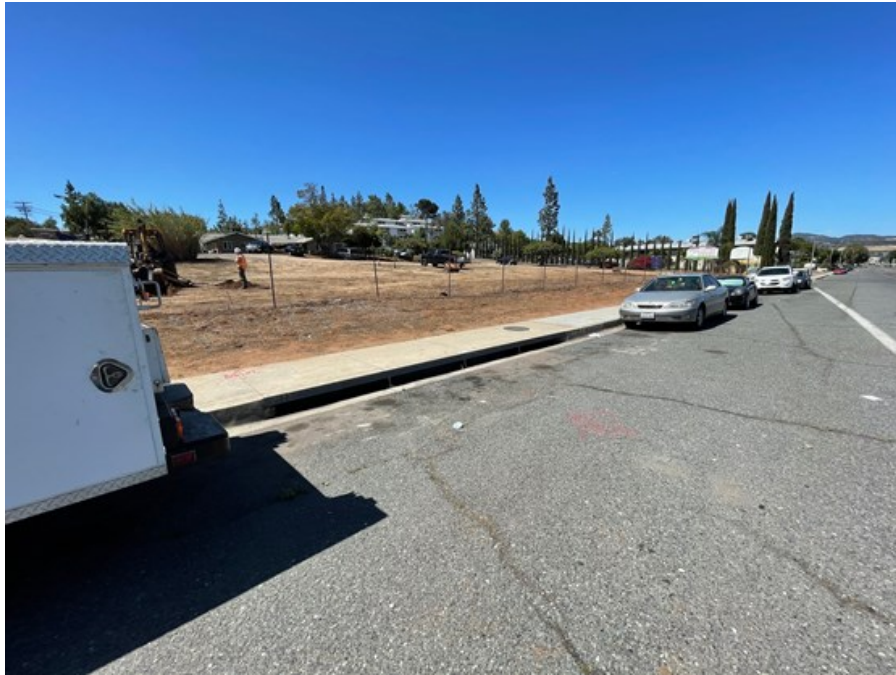
4. Looking southwest from street, near northeast side of subject site. Note storm drain.

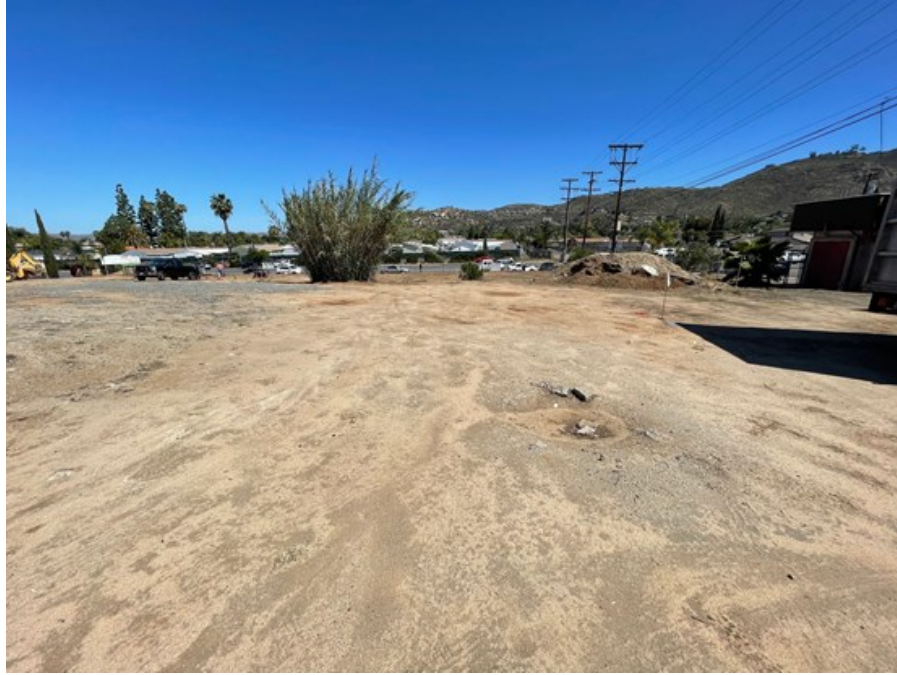
- **Solid Waste Landfills (SWLF)** – The subject site is not a SWLF. Therefore, SWLFs are not considered an REC.
- **Water Wells** – What appeared to be a former groundwater monitoring well location was observed near the northeast corner of Building 1. Mr. de Santiago indicated that, although he did not know what the well was used for, he observed something being put into the well, and water being removed. He noted that several wells had been located onsite, but had been filled with concrete. The wells are discussed further in the Results of Government Agency/Documents Review section below.

5. Looking north along east side of subject site. Note possible former monitoring well in foreground and soil stockpile in background.

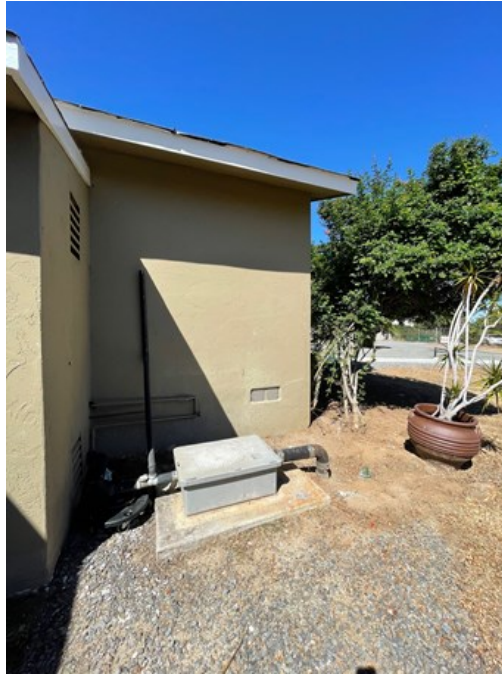
11. Grease trap near north side of western portion of Building 2.

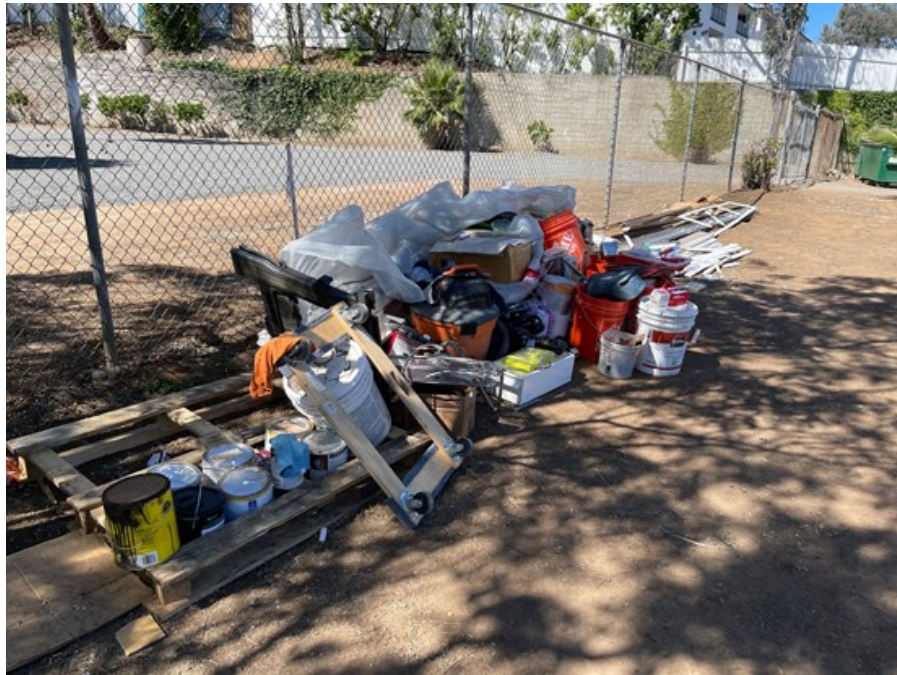
12. Trash on west side of subject site, north of fence near Building 2.

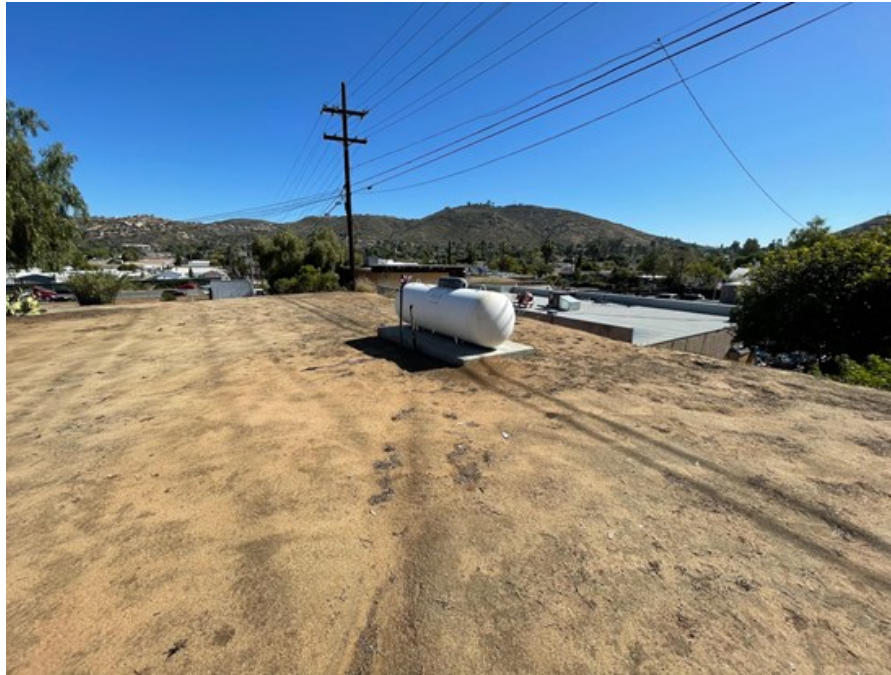
13. Propane tank for emergency generator, east side of subject site.

- **Storage Tanks** – GSI observed one propane tank located on the west side of the subject site, north of the generator building. According to the site contact, the generator is fueled by propane, with piping from the tank located in the subsurface. The tank is 250 gallons in volume, according to Mr. de Santiago. Based on the nature of the propane fuel, the storage tank is not considered an REC.

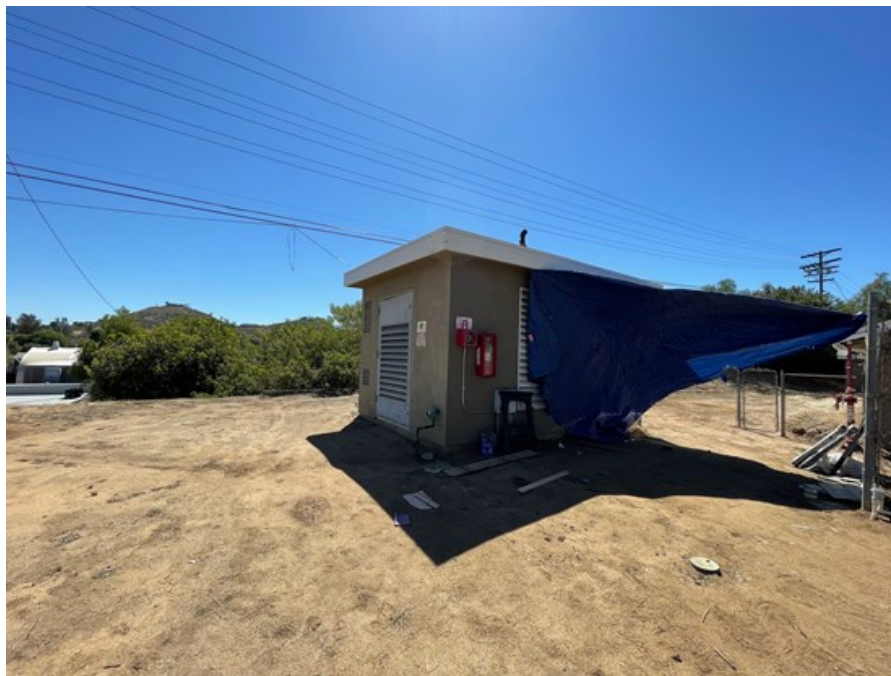
14. Emergency generator building, east side of subject site.

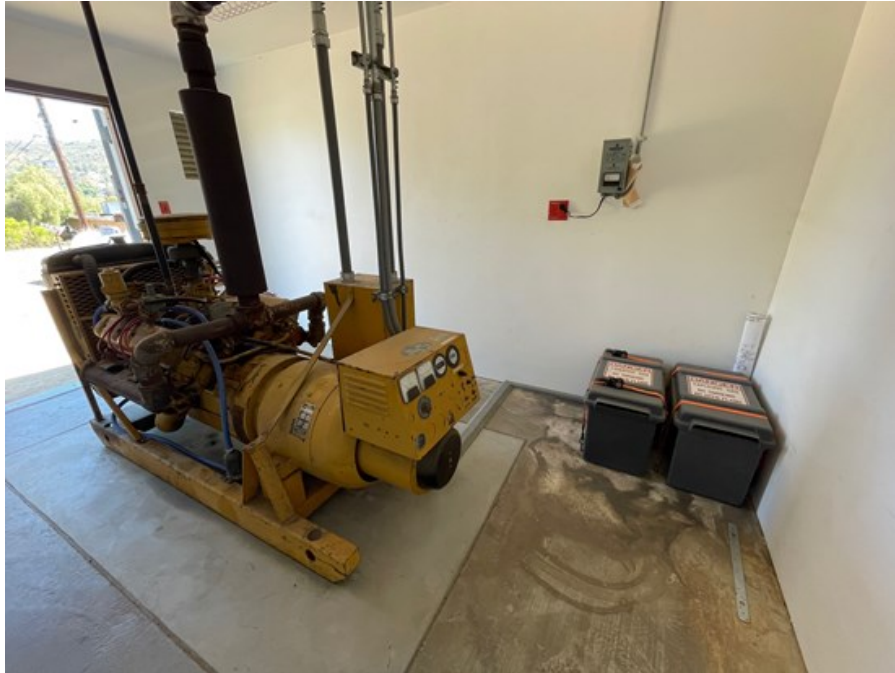
15. Emergency generator and lead-acid batteries.

- **Hazardous Chemical/Material Use, Storage, and Disposal** – GSI observed two large lead-acid batteries in the generator building. The batteries are presumed to be part of the emergency electricity system. Minor staining was observed in the vicinity of the batteries; however, it was limited in nature and did not appear to penetrate to the subsurface. Therefore, the staining is considered de minimis.

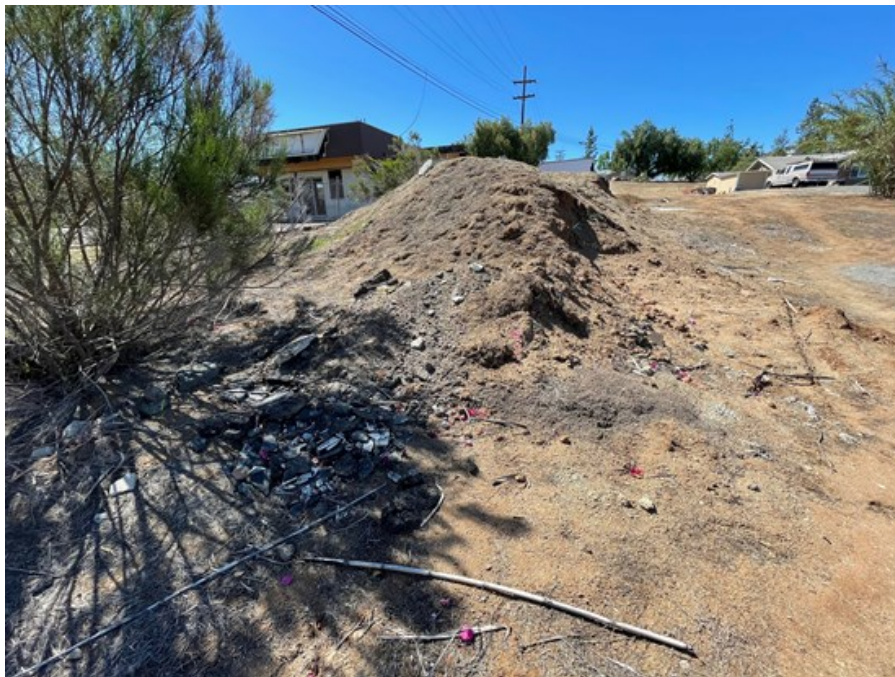
16. Soil stockpile on east side of subject site.

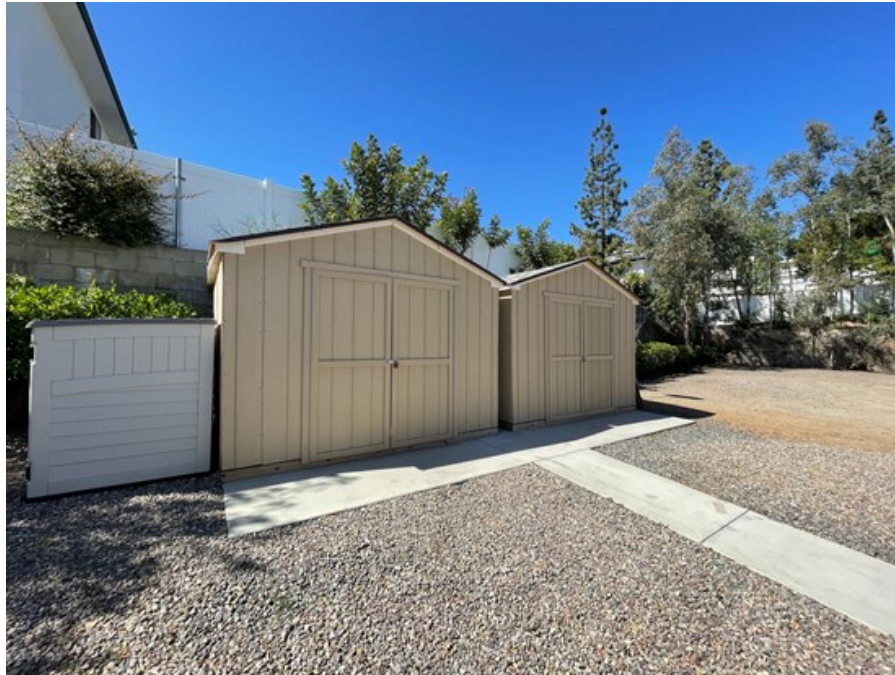
17. Storage sheds on north side of subject site (not accessed). Note biohazard container to the east of the sheds.

GSI observed a locked storage container on the south side of the subject site labeled Biohazard. According to Mr. de Santiago, the biohazard waste is picked up monthly by Logic Environmental Services. No obvious signs of mishandling of biohazard waste was observed. Based on these observations, hazardous chemical/material use, storage, or disposal is not considered an REC.

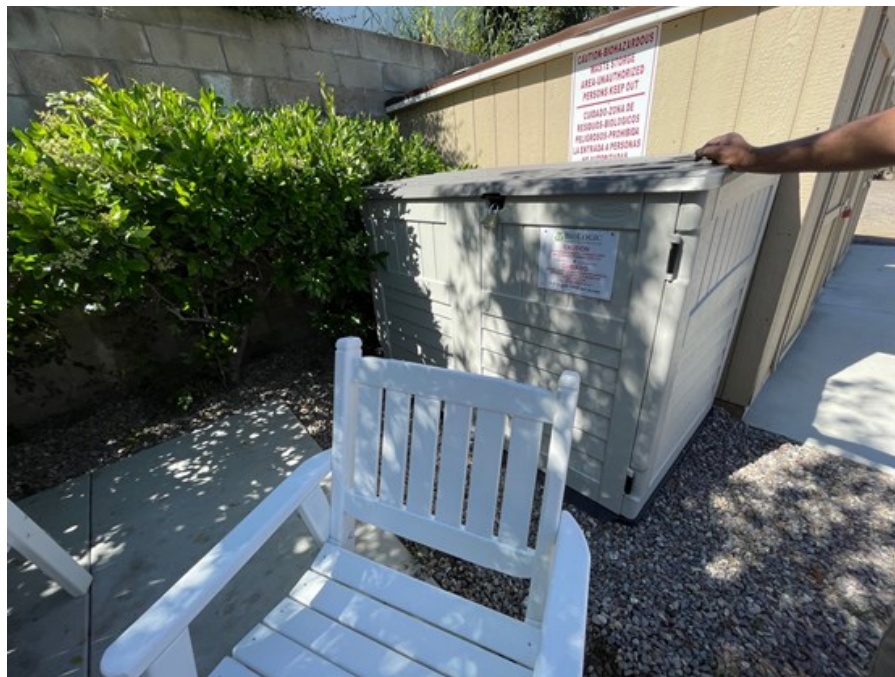
18. Biohazard container on north side of subject site.

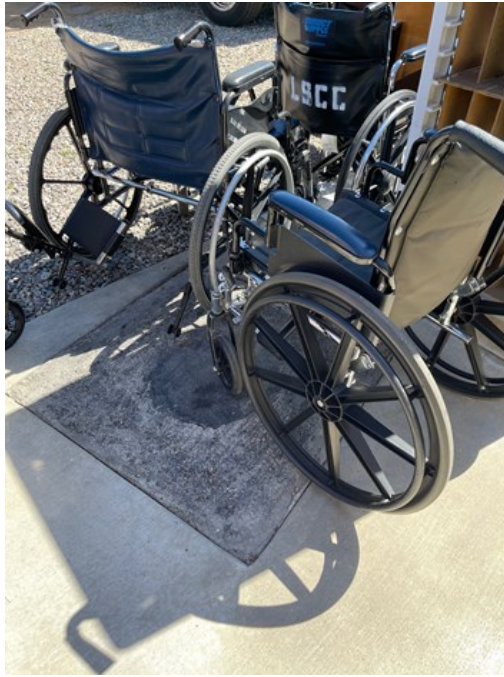
19. Former groundwater monitoring well, northeast corner of Building 1.

- The adjoining property to the east, Price Management, had a release of gasoline which migrated onto the subject site, as discussed herein. Although the case received regulatory closure, some residual contamination remains in the subsurface at the subject site and regulatory limitations and requirements may exist for site redevelopment in that area. In addition, two rusted drums that formerly contained purged groundwater with petroleum product, still exist onsite.

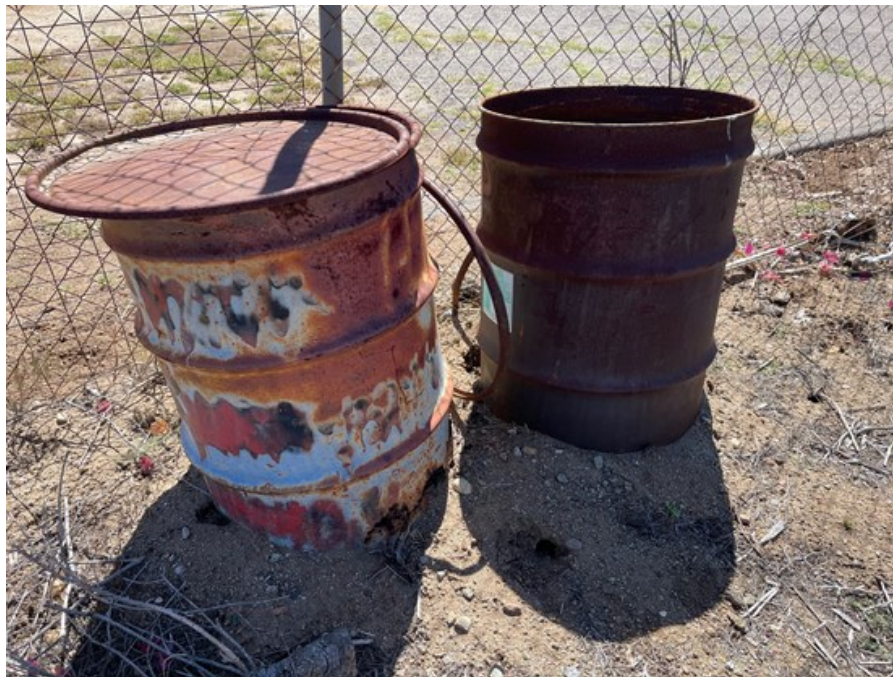
20. Unidentified drums with holes on east side of subject property.

- **Drum Storage** – Two old, rusted drums with holes were observed on the northern portion of the site, along the eastern property boundary. Green “non-hazardous” waste stickers were observed on each drum; however, site information had faded. Based on information provided on the GeoTracker website, as well as information provided during an interview with the maintenance supervisor, Mr. Tony de Santiago, groundwater monitoring had been conducted at the property in connection with a Leaking Underground Storage Tank (LUST) case located on the adjoining property to the east. The labels were typical of those which are used on purge water drums for groundwater generated during monitoring activities. Therefore, given the potential for the drums to have held purged groundwater impacted with petroleum hydrocarbons, these drums represent an REC.

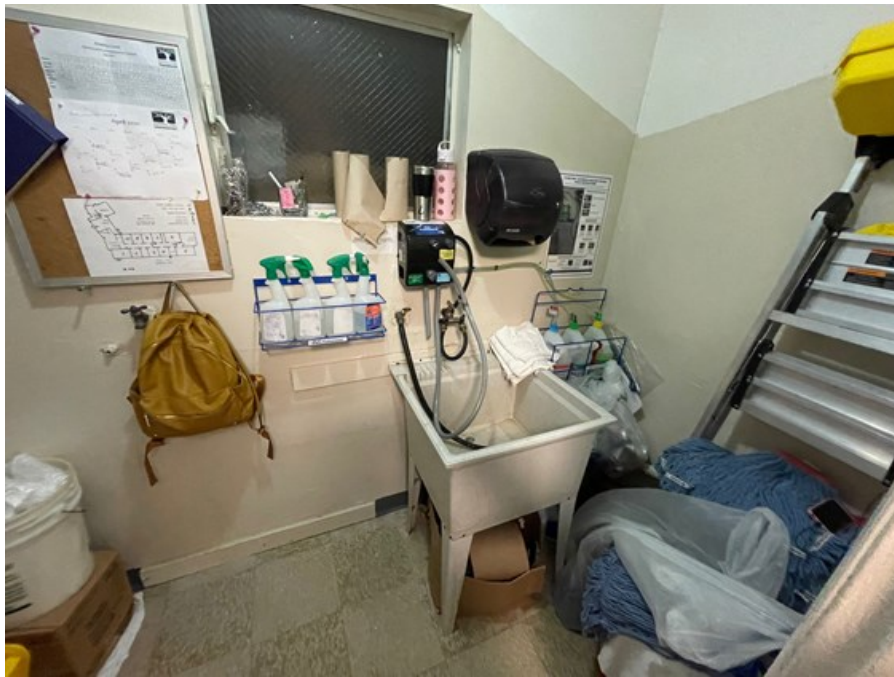
Chemicals and materials typical of routine maintenance at a convalescent facility, including laundry detergent, fabric softener, dishwashing soap, disinfectant, bleach, drain cleaner, as well as paint, floor wax, and floor stripper, were observed in a storage shed located to the east of Building 1. Additional supplies were observed in the laundry room on the east side of Building 1, a storage closet within the courtyard of Building 1, kitchen, and janitor's closets in each building. The materials were stored in containers 5-gallons or less in volume and appeared to be in good condition with no evidence of significant spills or releases.

24. Janitor's closet in Building 2.

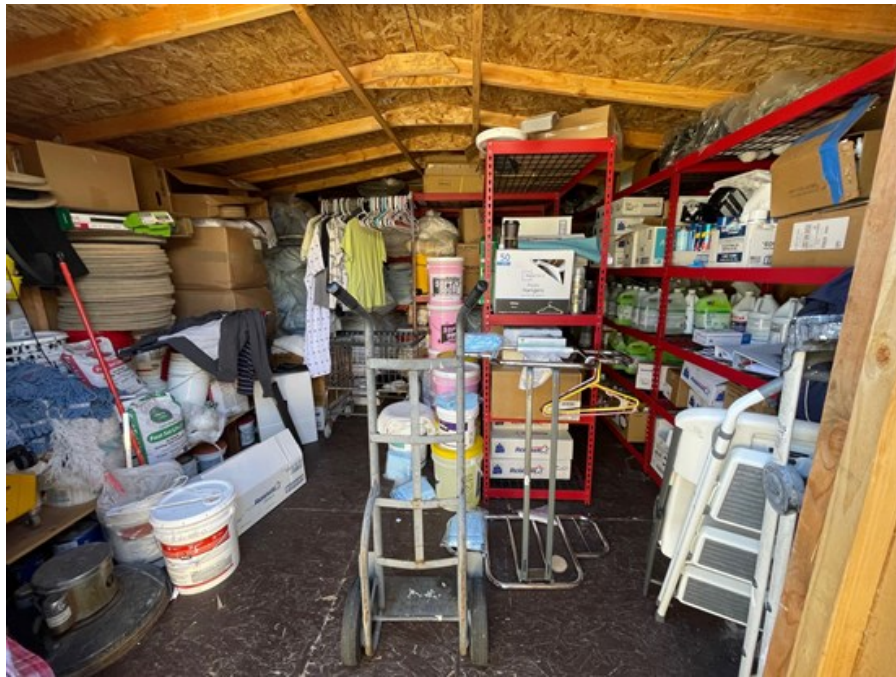
29. Cleaning supply storage on east side of Building 1.

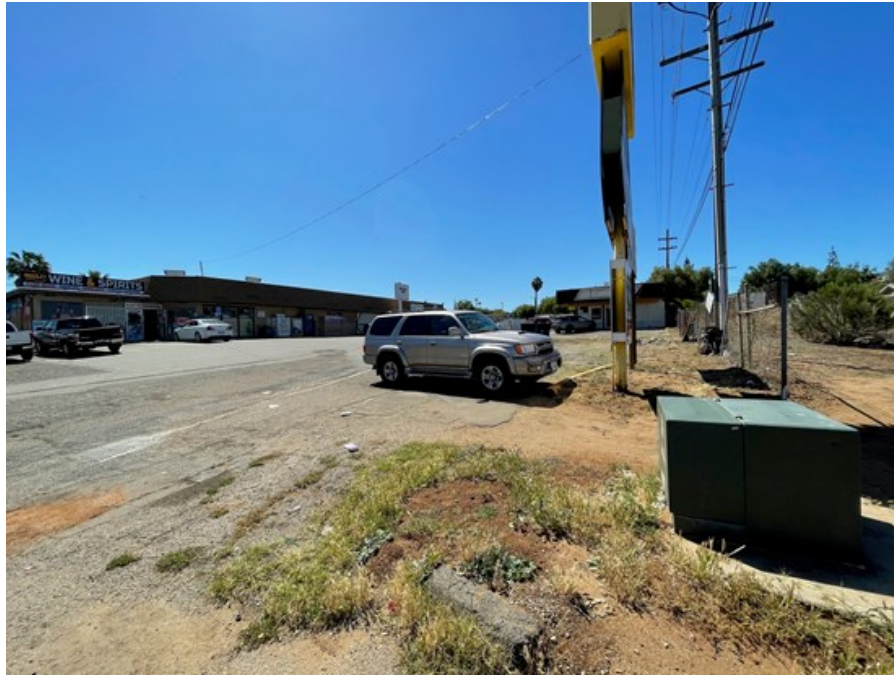
31. Adjoining property to the east. Note transformer and former groundwater monitoring well and remediation piping locations.

- **Potential Sources of Polychlorinated Biphenyls (PCBs)** – GSI did not observe transformers or any other potential sources of PCBs onsite. One pad-mounted transformer was observed on an adjoining property to the southeast. The transformers appeared to be in relatively good condition with no obvious visible leakage. Given the age of the surrounding properties, it is possible that the dielectric fluid present in the transformers contains PCBs. The transformers are owned by San Diego Gas & Electric, the local electricity provider; thus, if the transformers were to leak it should be the responsibility of the utility provider to mitigate. Thus, the transformers are not considered RECs.

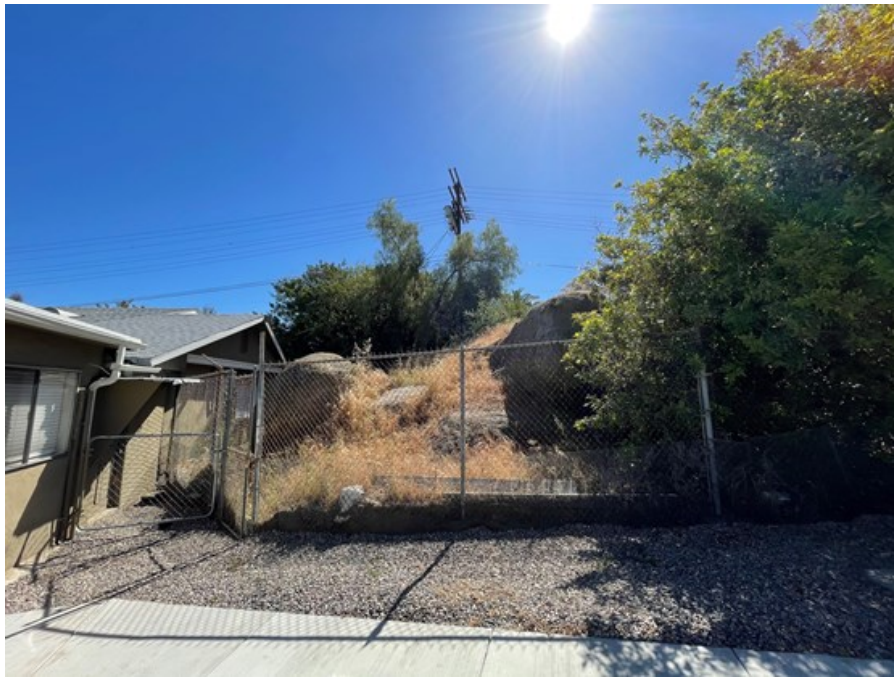
34. Transformers on adjoining property to the east.

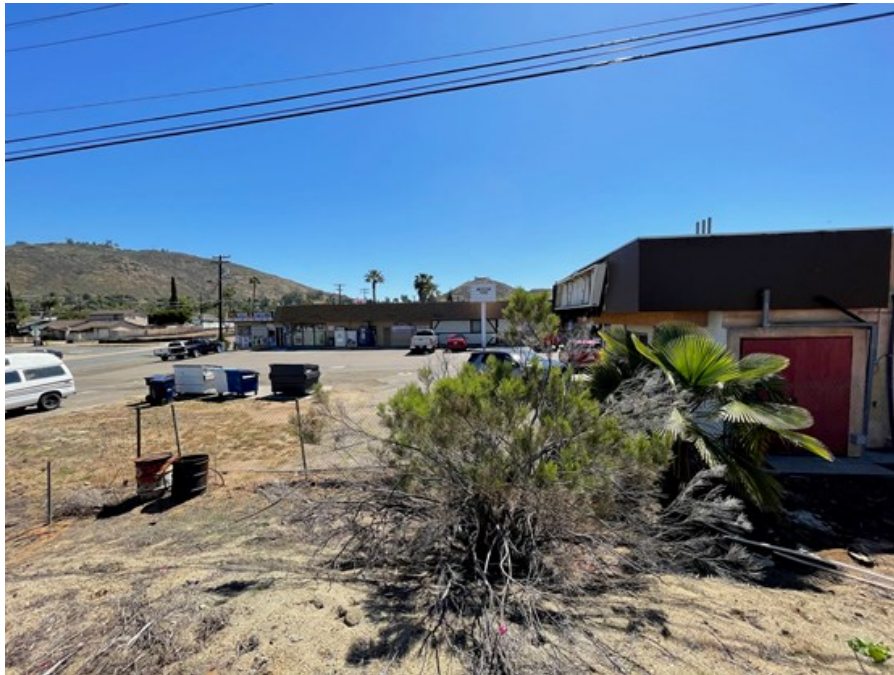
36. Adjoining property to the east. Note drums on subject site.
